Activation ID: EMSR130 Product N.: 02BOGALE, v2, English

# Bogale - Myanmar Flood - 01/08/2015 Delineation Map

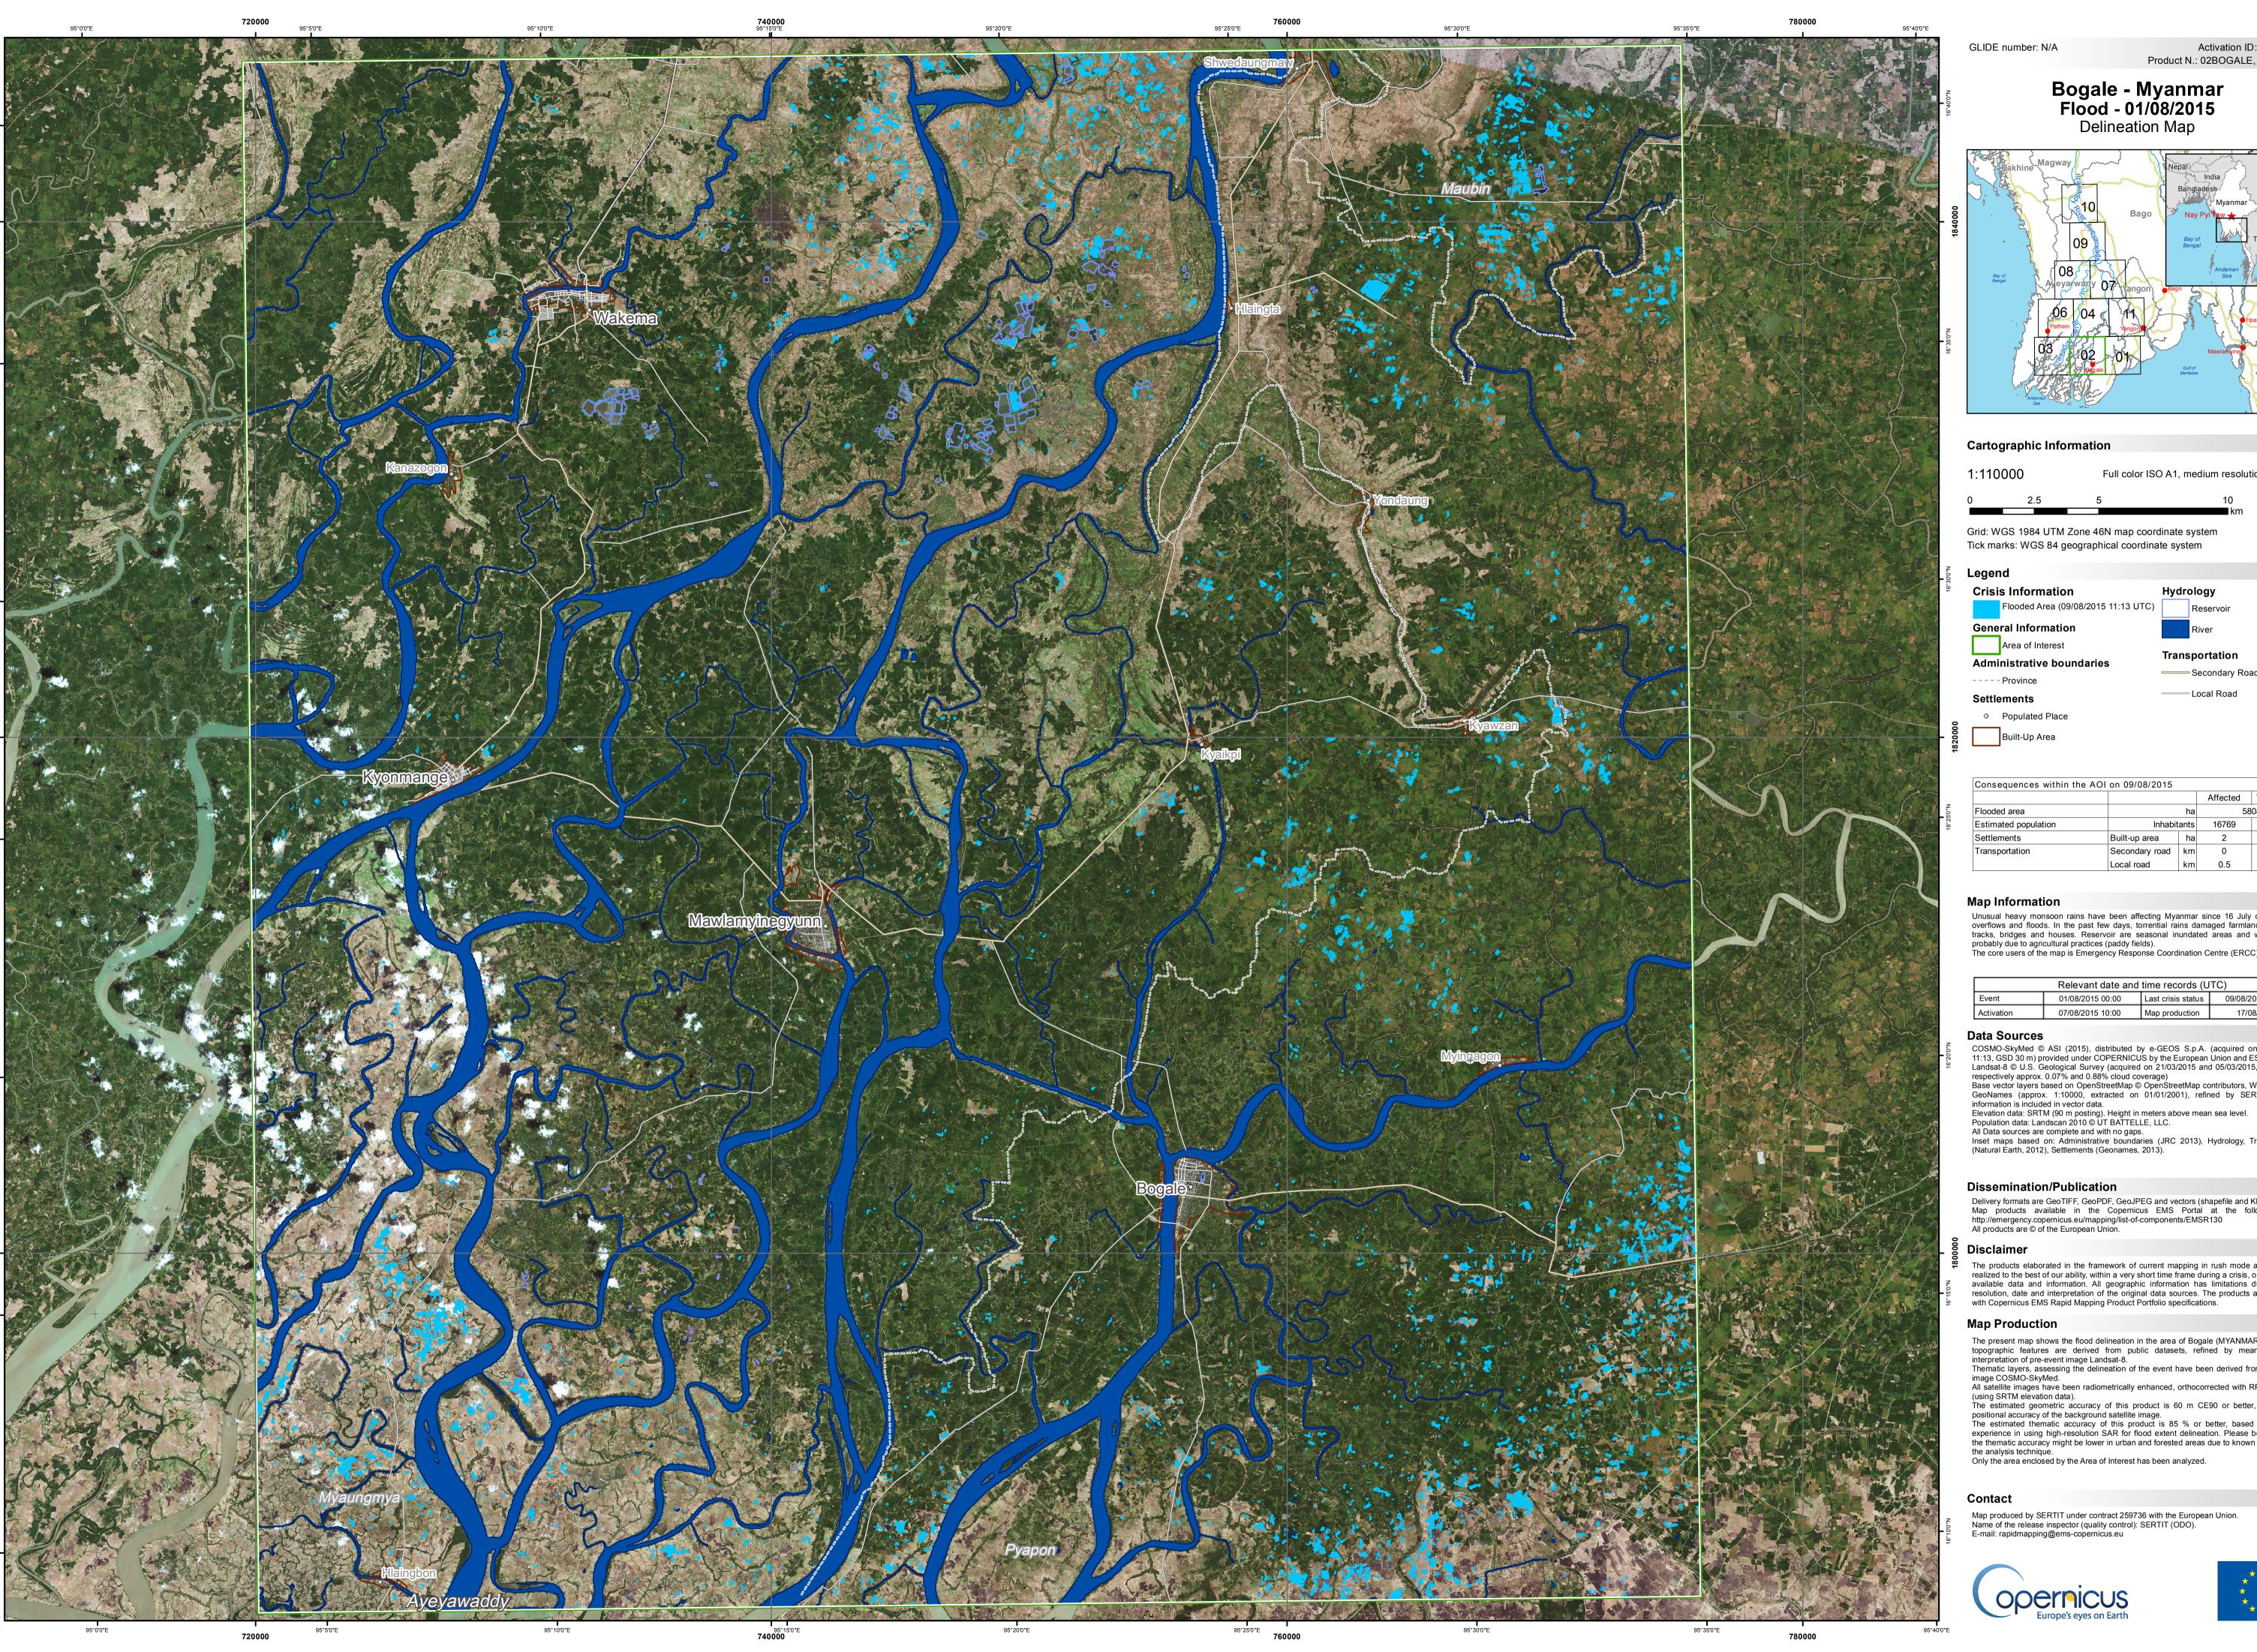
Affected	Total in AOI		
16°25'0"N	Flooded area	ha		5808			
	Estimated population	Inhabitants		16769	1125011		
	Settlements	Built-up area	ha	2	1789		
	Transportation	Secondary road	km	0	128		
		Local road	km	0.5	334

The present map shows the flood delineation in the area of Bogale (MYANMAR). The basic topographic features are derived from public datasets, refined by means of visual interpretation of pre-event image Landsat-8. Thematic layers, assessing the delineation of the event have been derived from post-event
