GLIDE number: N/A      Activation ID: EMSR130  
Product N.: 03LABUTTA, v3, English

**Labutta - Myanmar**  
**Flood - 01/08/2015**  
Delineation Map - Monit02

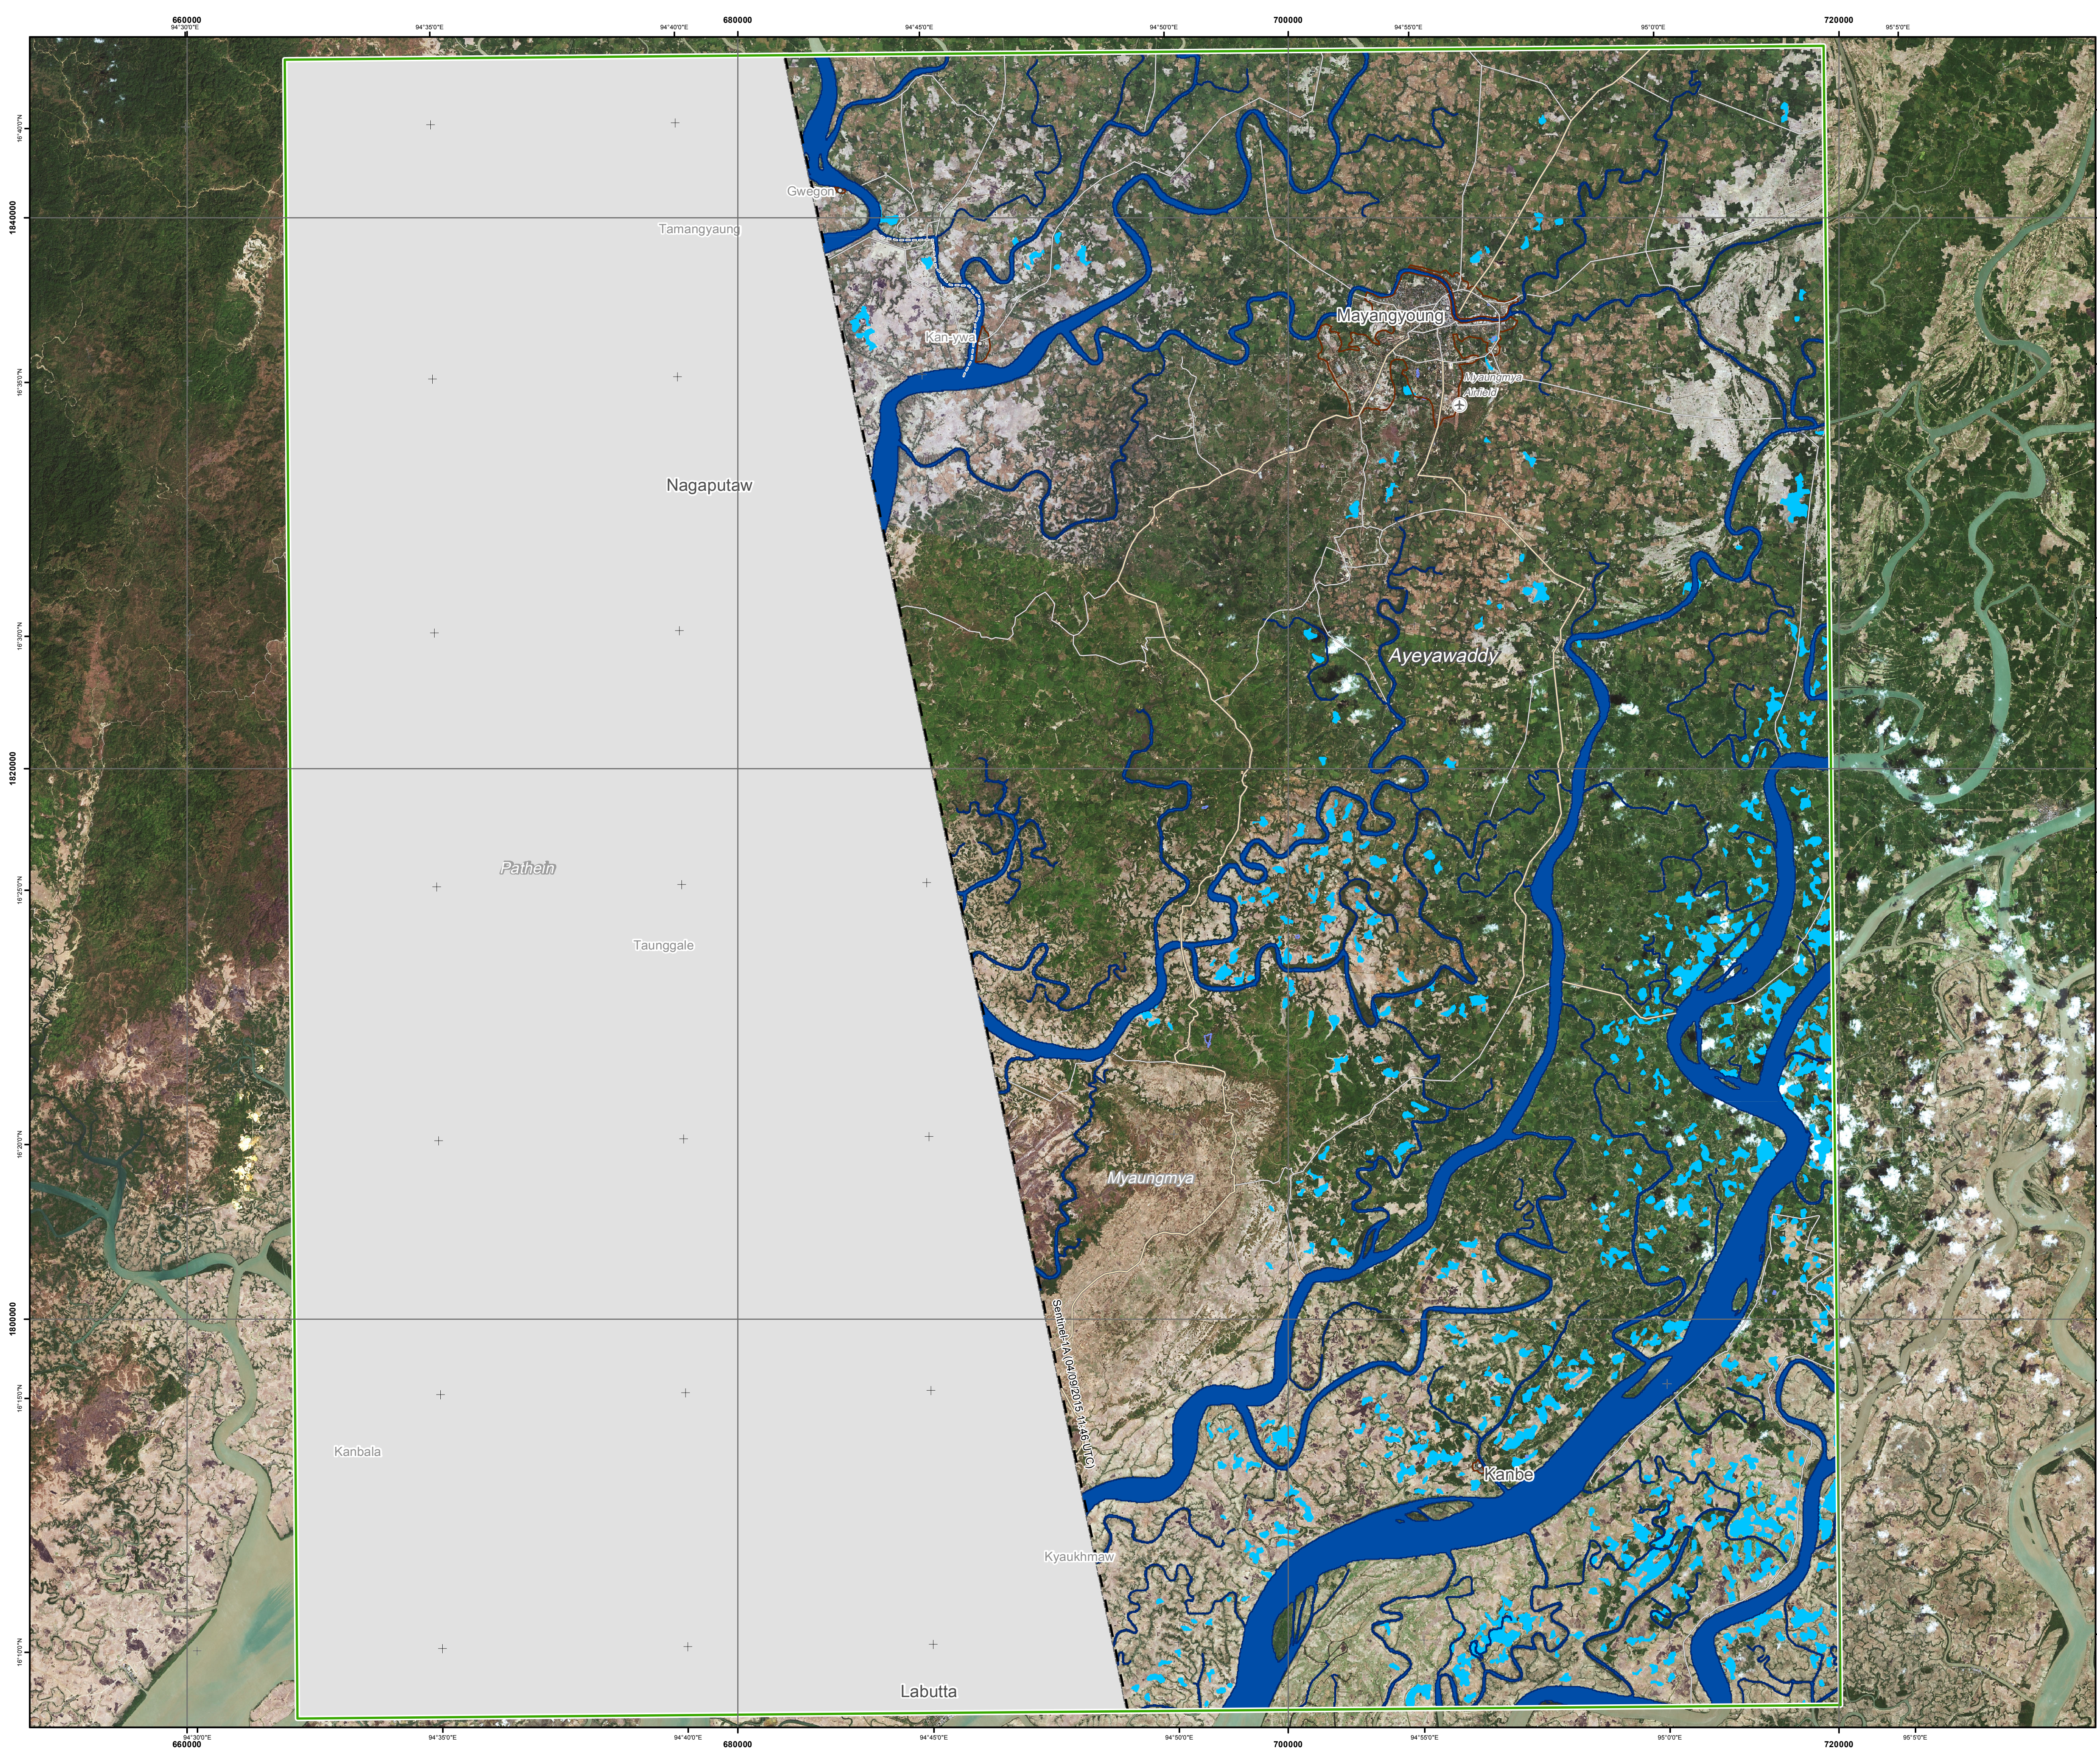
- Flooded Area (04/09/2015 11:45UTC)

The present map shows the flood delineation in the area of Labutta (MYANMAR). The basic topographic features are derived from public datasets, refined by means of visual interpretation of pre-event image Landsat-8.

Thematic layers, assessing the delineation of the event have been derived from post-event image Sentinel-1A.

The estimated geometric accuracy of this product is 40 m CE90 or better, from native positional accuracy of the background satellite image.

The estimated thematic accuracy of this product is 85 % or better, based on previous experience in using high-resolution SAR for flood extent delineation. Please be aware that the thematic accuracy might be lower in urban and forested areas due to known limitations of the analysis technique.

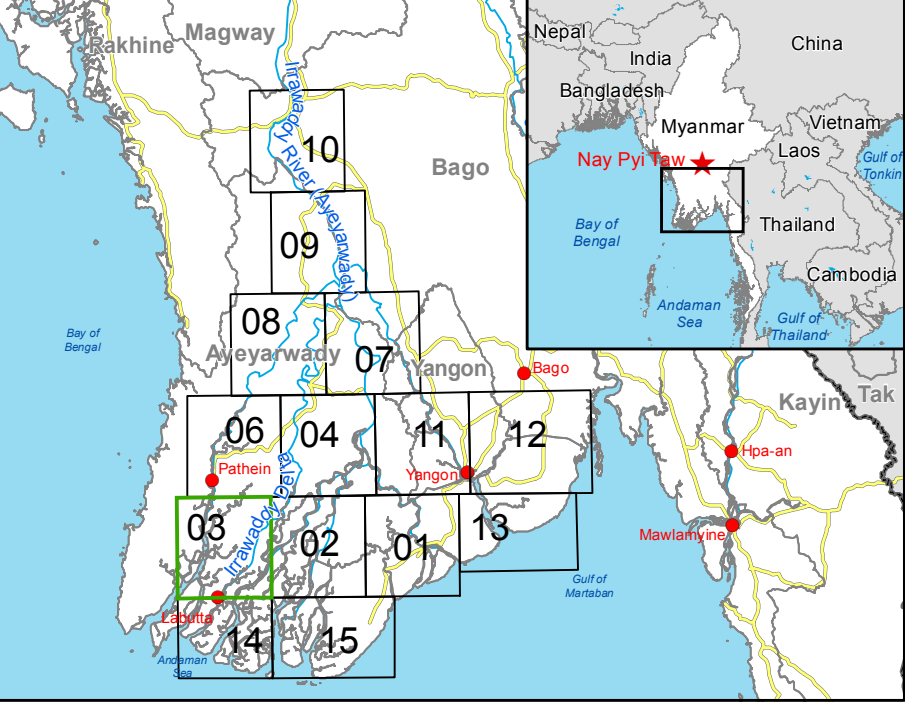
Unusual heavy monsoon rains have been affecting Myanmar since 16 July causing river overflows and floods. In the past few days, torrential rains damaged farmland, roads, rail tracks, bridges and houses. Reservoirs are seasonal inundated areas and water bodies probably due to agricultural practices (paddy fields).

| Consequences within the AOI on 04/09/2015 | | | | |
| Flooded area | | | 14594 | 626028 |
