Activation ID: EMSR130 Product N.: 03LABUTTA, v1, English

Labutta - Myanmar Flood - 01/08/2015 Delineation Map - Monit03

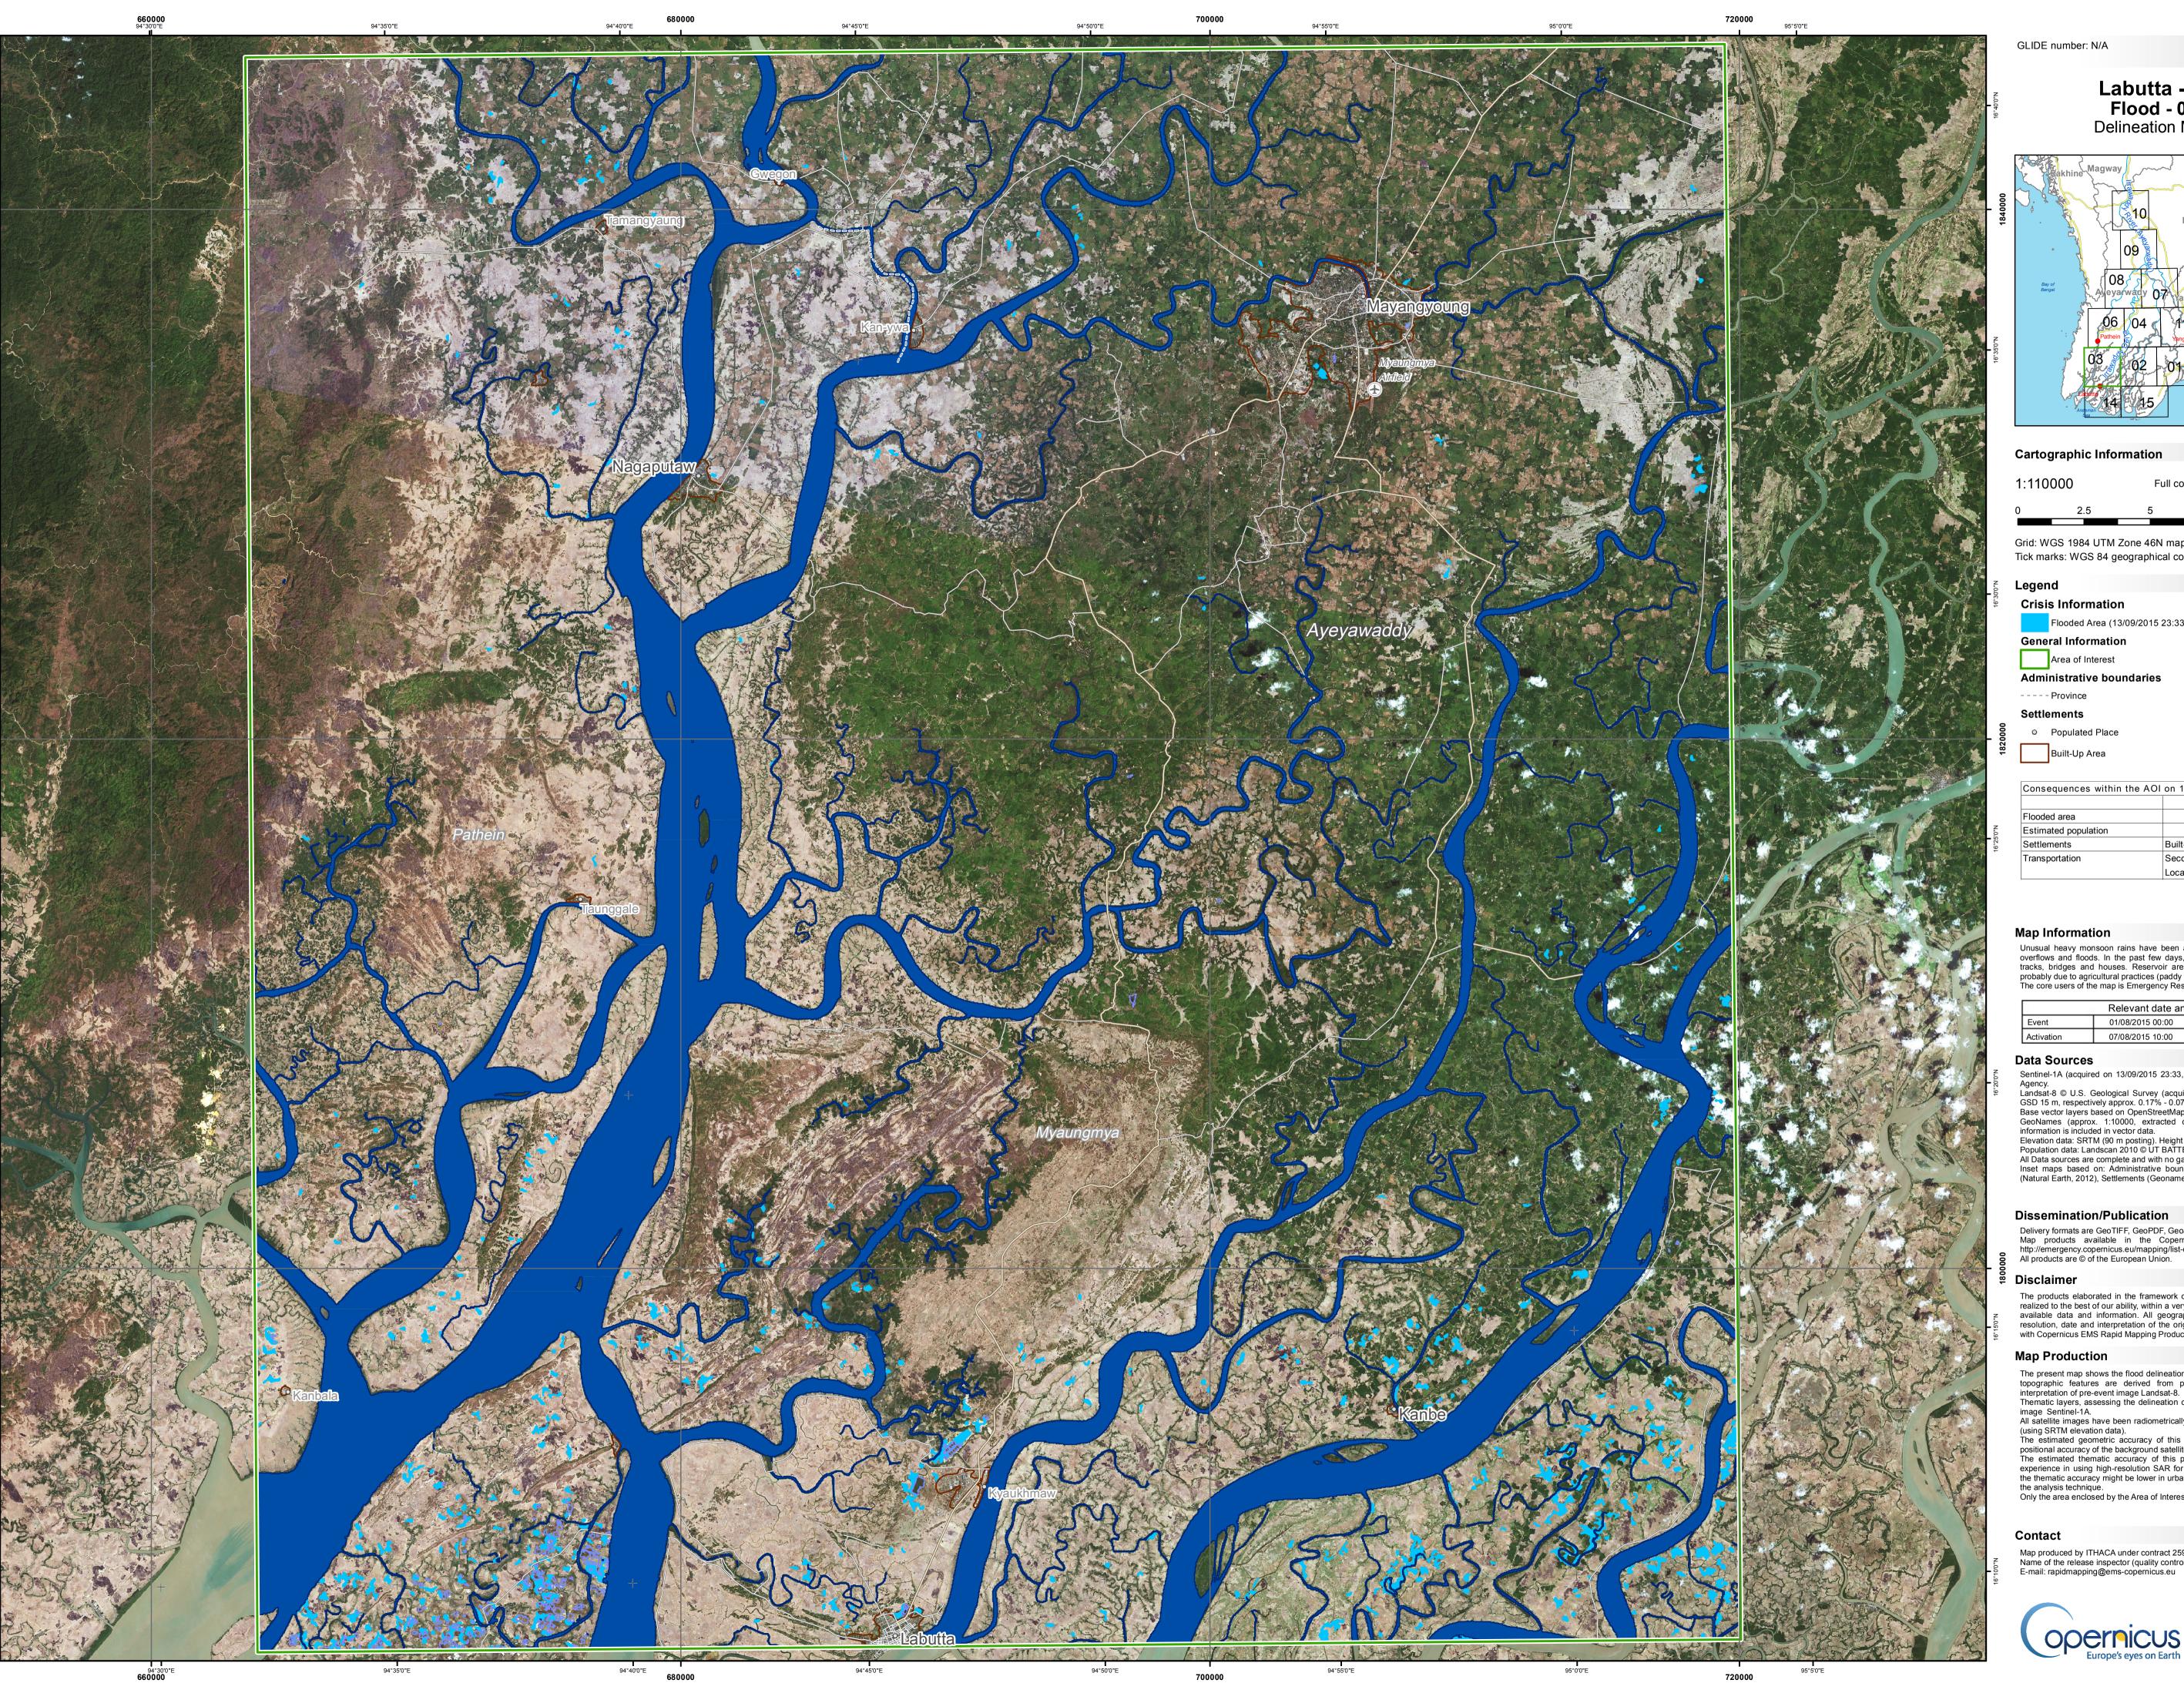
**Crisis Information** Hydrology Flooded Area (13/09/2015 23:33 UTC) **General Information** Area of Interest **Transportation** Administrative boundaries Aerodrome

Consequences within the AOI on 13/09/2015						
			Affected	Total in AOI		
Flooded area	ha 2738		38			
Estimated population	Inhabitants		11208	626028		
Settlements	Built-up area	ha	0.9	2664		
Transportation	Secondary	km	0	113		
	Local roads	km	3.8	401

The present map shows the flood delineation in the area of Labutta (MYANMAR). The basic topographic features are derived from public datasets, refined by means of visual interpretation of pre-event image Landsat-8. Thematic layers, assessing the delineation of the event have been derived from post-event

All satellite images have been radiometrically enhanced, orthocorrected with RPC approach (using SRTM elevation data). The estimated geometric accuracy of this product is 40 m CE90 or better, from native positional accuracy of the background satellite image.

The estimated thematic accuracy of this product is 85 % or better, based on previous experience in using high-resolution SAR for flood extent delineation. Please be aware that the thematic accuracy might be lower in urban and forested areas due to known limitations of the analysis technique.
