GLIDE number: N/A      Activation ID: EMSR130  
Product N.: 03LABUTTA, v2, English

## Labutta - Myanmar Flood - 01/08/2015 Delineation Map

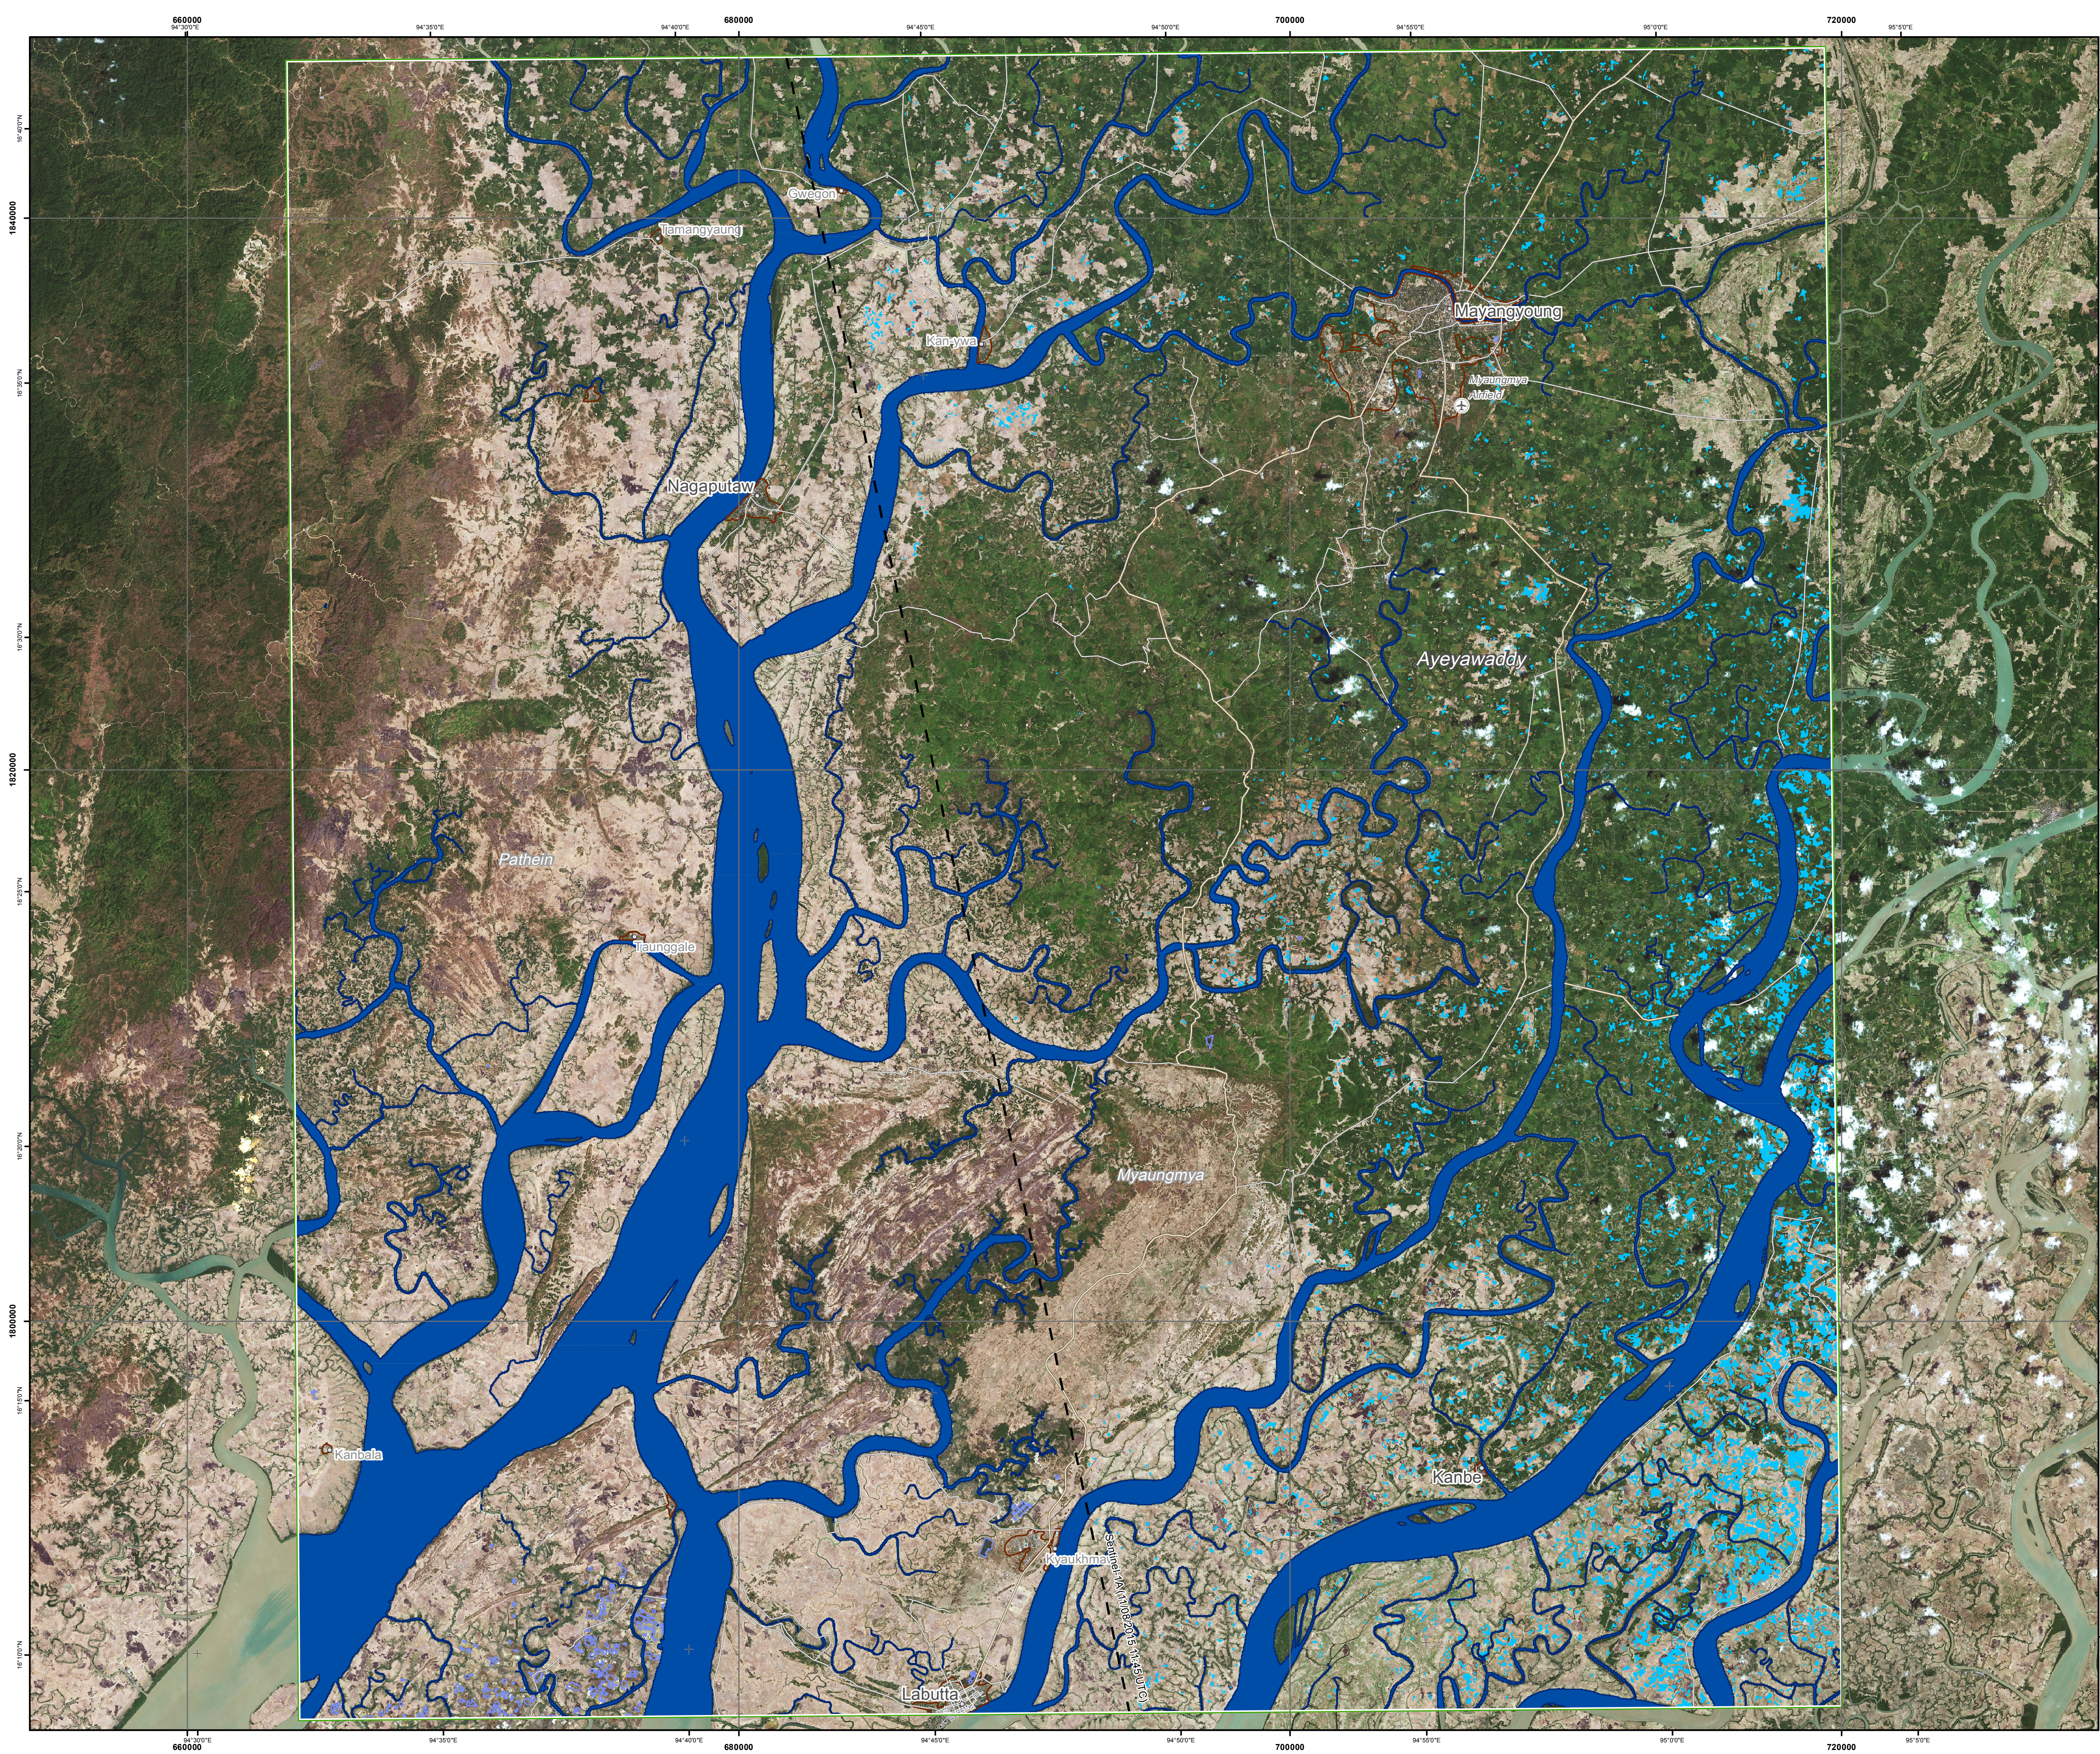
The present map shows the flood delineation in the area of Labutta (MYANMAR). The basic topographic features are derived from public datasets, refined by means of visual interpretation of pre-event image Landsat-8.

Thematic layers, assessing the delineation of the event have been derived from post-event image Sentinel-1A.

The estimated thematic accuracy of this product is 85 % or better, based on previous experience in using high-resolution SAR for flood extent delineation. Please be aware that the thematic accuracy might be lower in urban and forested areas due to known limitations of the analysis technique.
