GLIDE number: N/A
Activation ID: EMSR130
Product N.: 04PATHWE, v2, English

Pathwe - Myanmar Flood - 01/08/2015 Delineation Map

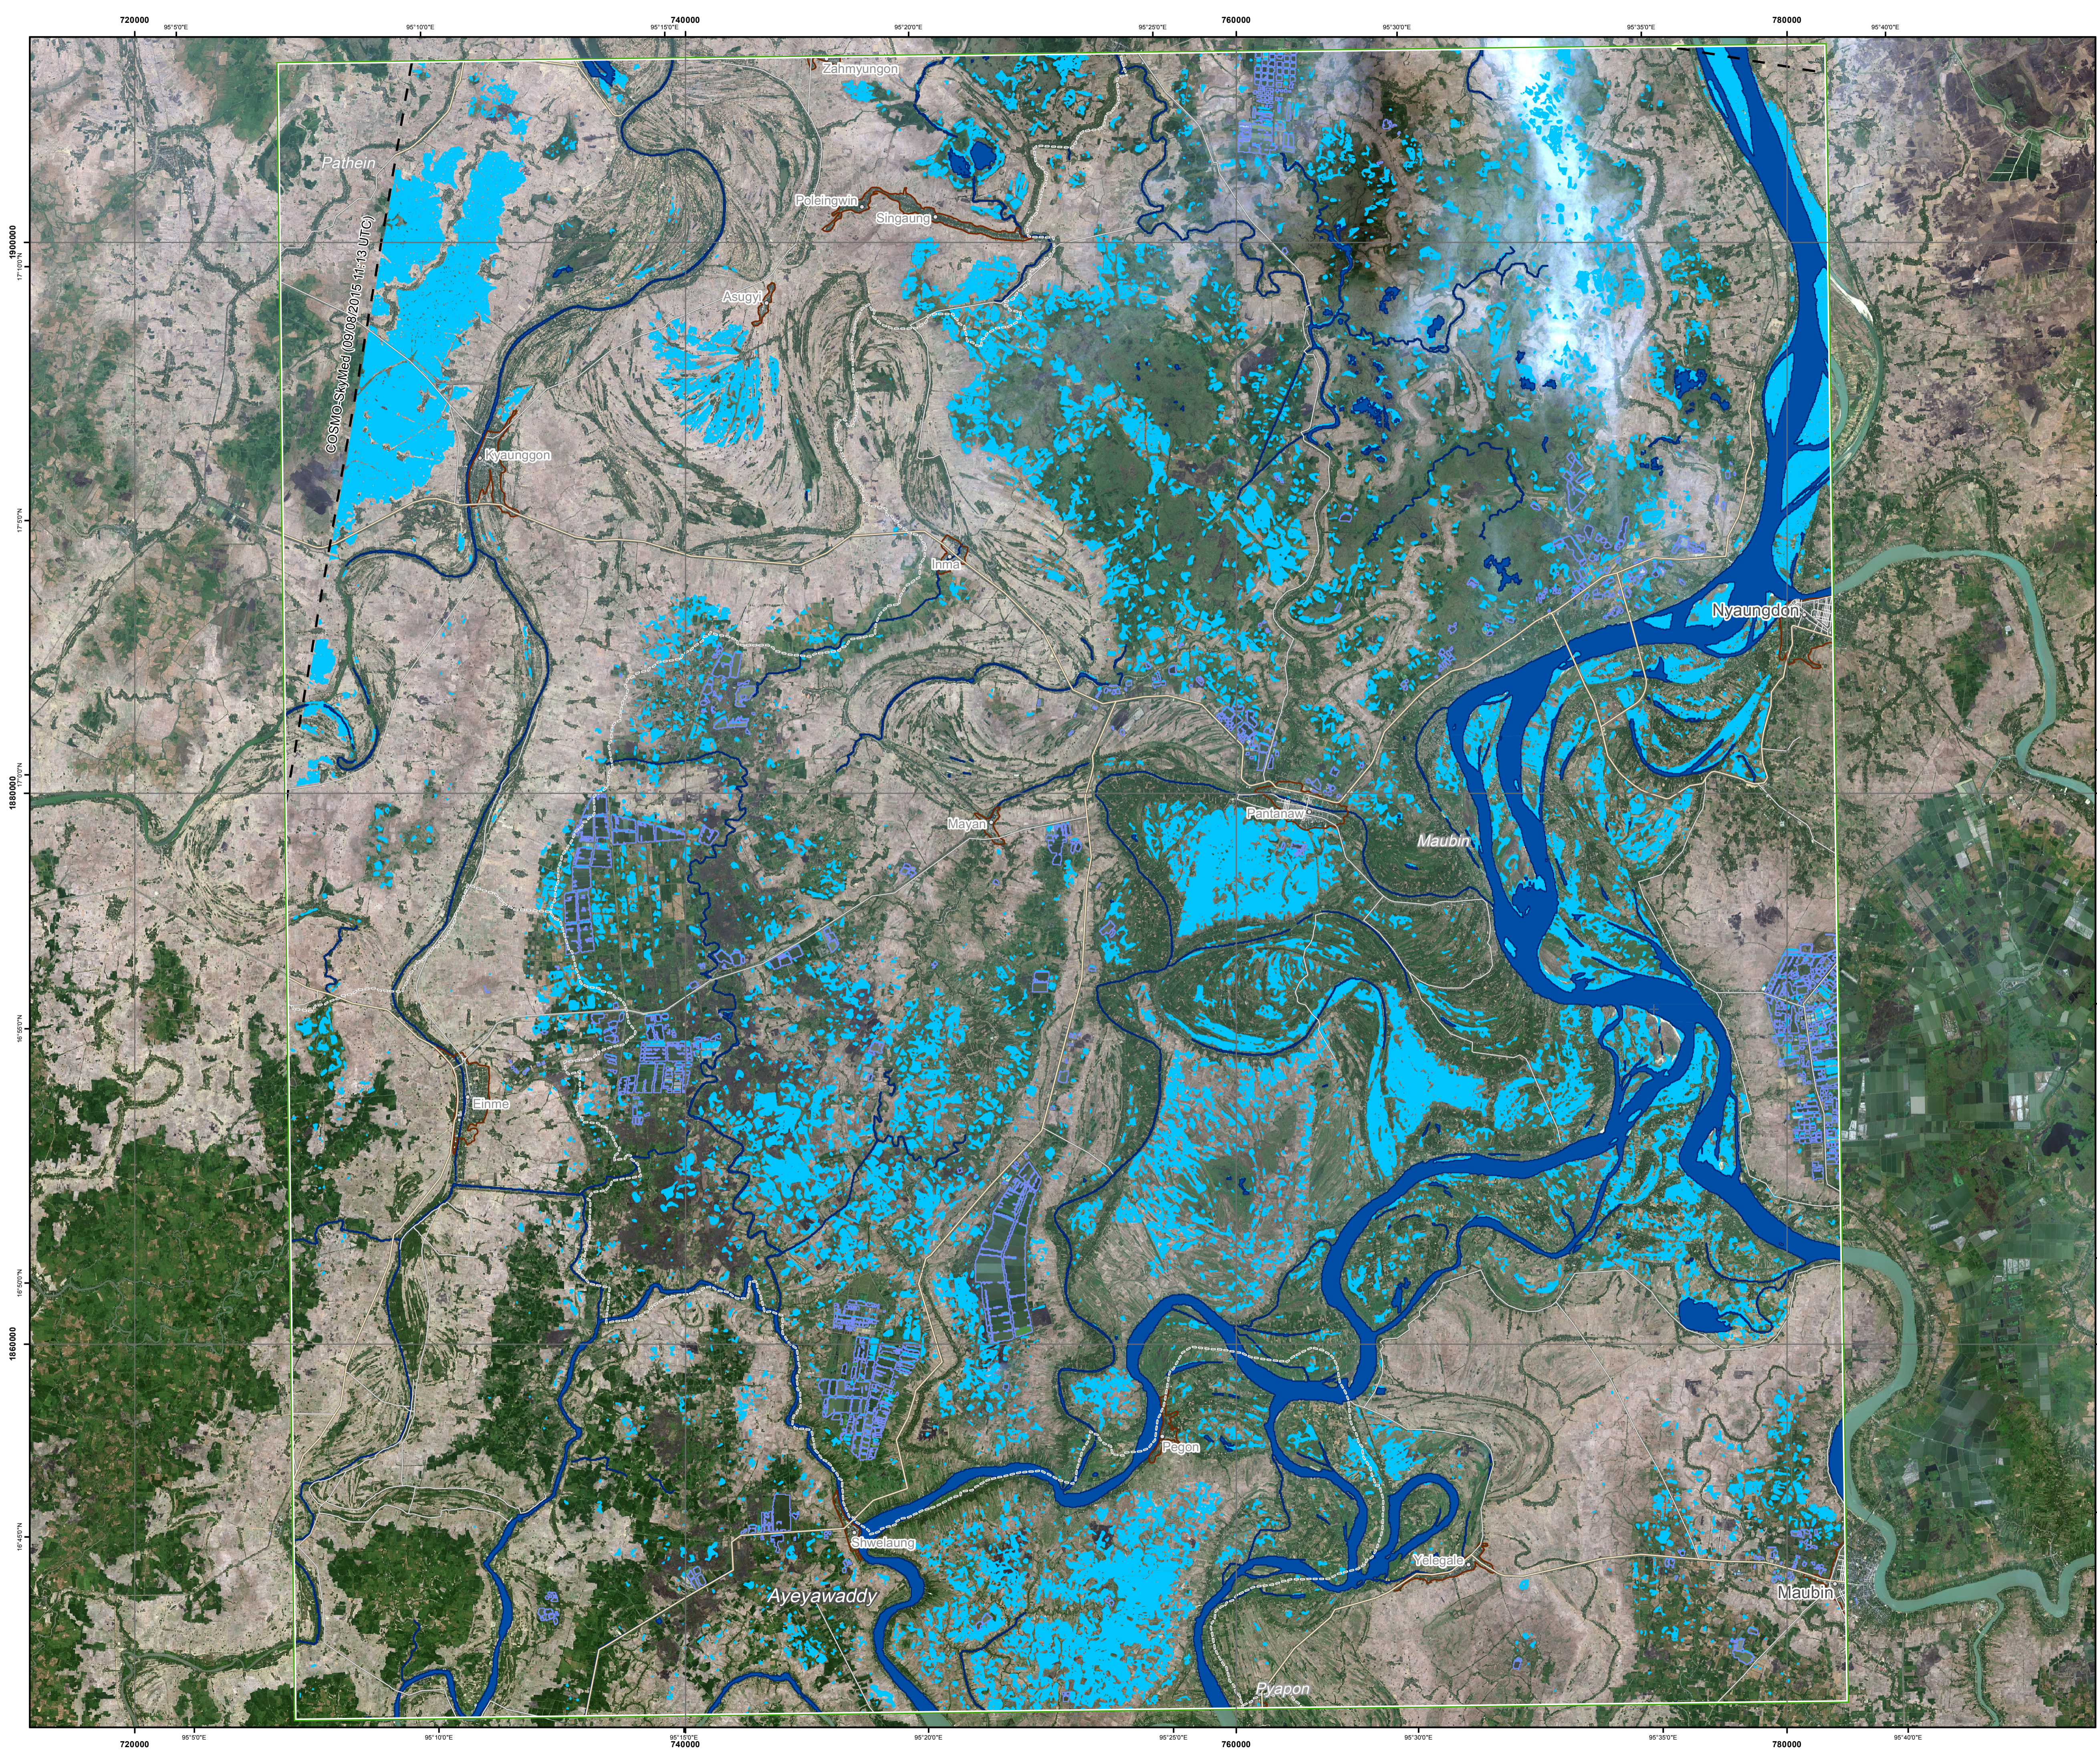
Crisis Information
Flooded Area (09/08/2015 11:13 UTC)

Consequences within the AOI on 09/08/2015		Affected	Total in AOI
Flooded area	ha	63040	871551
Estimated population	Inhabitants	6	2143
Settlements	Built-up area	0	200
Transportation	Secondary road	8	391
	Local road

The present map shows the flood delineation in the area of Pathwe (MYANMAR). The basic topographic features are derived from public datasets, refined by means of visual interpretation of pre-event image Landsat-8.
Thematic layers, assessing the delineation of the event have been derived from post-event image COSMO-SkyMed.
All satellite images have been radiometrically enhanced, orthorectified with RPC approach (using SRTM elevation data).
The estimated geometric accuracy of this product is 60 m CE90 or better, from native positional accuracy of the background satellite image.
The estimated thematic accuracy of this product is 85 % or better, based on previous experience in using high-resolution SAR for flood extent delineation. Please be aware that the thematic accuracy might be lower in urban and forested areas due to known limitations of the analysis technique.
Only the area enclosed by the Area of Interest has been analyzed.

Unusual heavy monsoon rains have been affecting Myanmar since 16 July causing river overflows and floods. In the past few days, torrential rains damaged farmland, roads, rail tracks, bridges and houses. Reservoir are seasonal inundated areas and water bodies probably due to agricultural practices (paddy fields).
The core users of the map is Emergency Response Coordination Centre (ERCC).
