Activation ID: EMSR130 Product N.: 06PATHEIN, v2, English

Pathein - Myanmar Flood - 01/08/2015
Delineation Map - Monit01

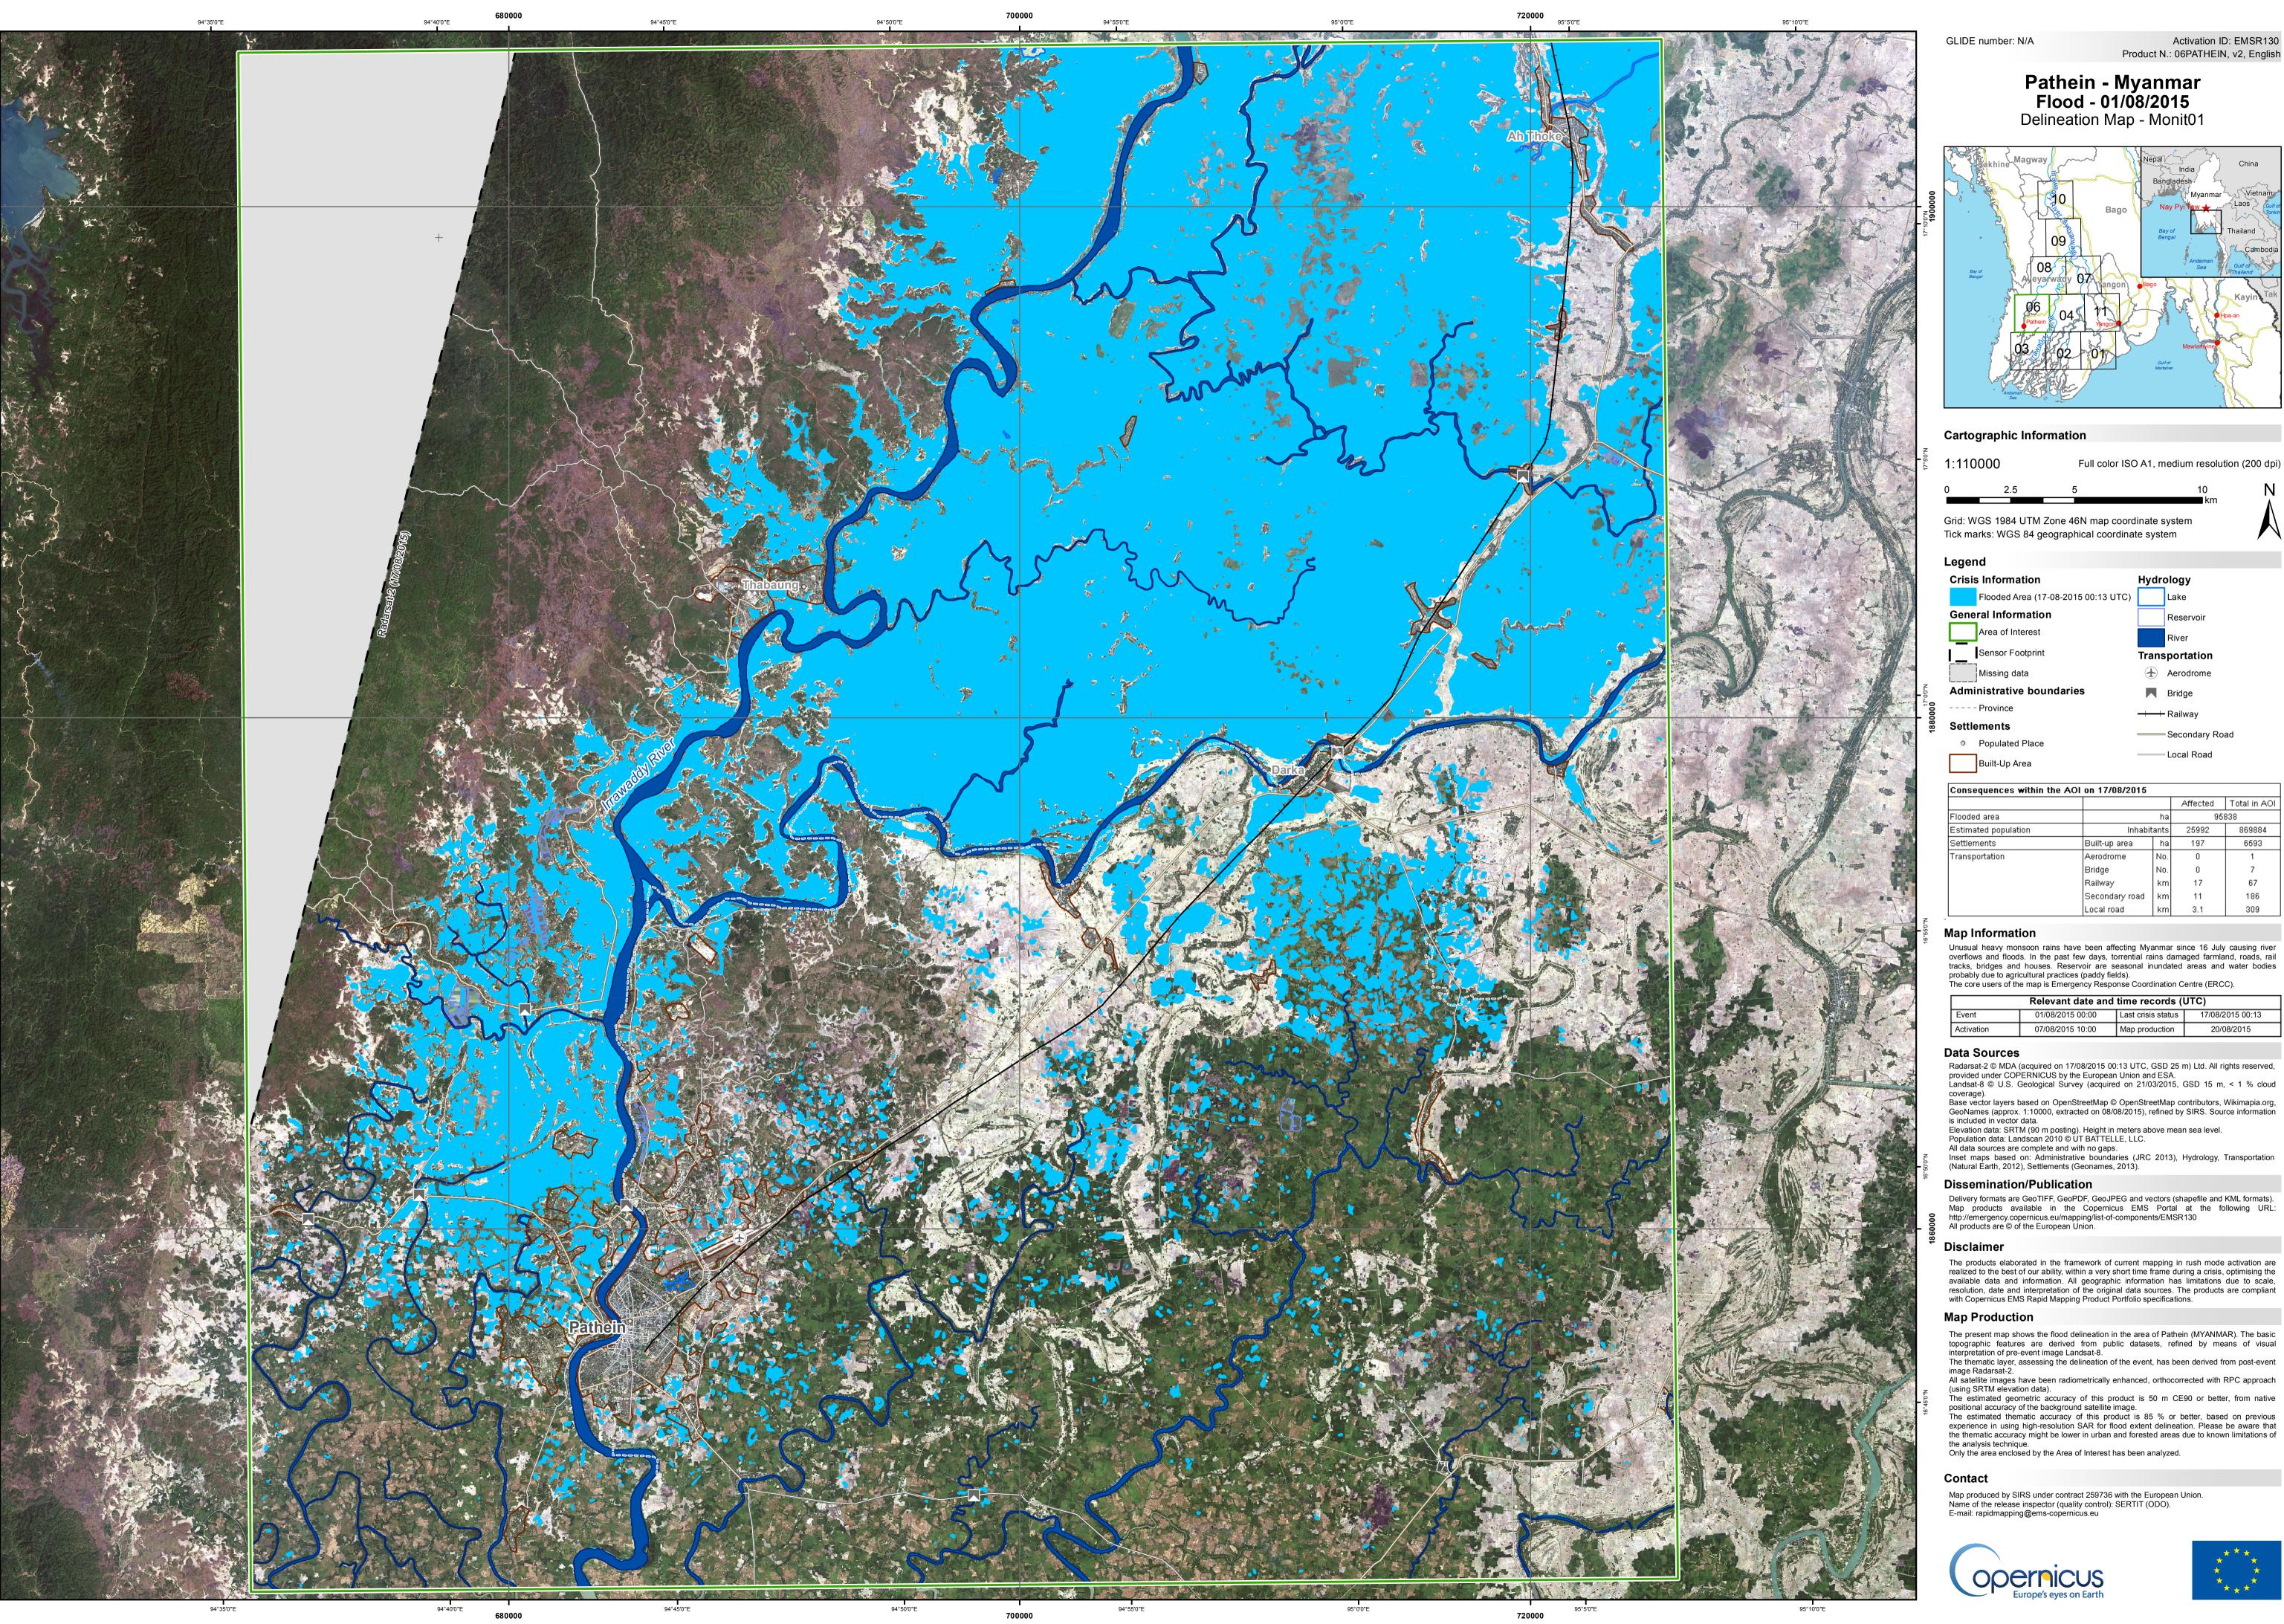
Unusual heavy monsoon rains have been affecting Myanmar since 16 July causing river overflows and floods. In the past few days, torrential rains damaged farmland, roads, rail tracks, bridges and houses. Reservoir are seasonal inundated areas and water bodies probably due to agricultural practices (paddy fields).

The present map shows the flood delineation in the area of Pathein (MYANMAR). The basic topographic features are derived from public datasets, refined by means of visual interpretation of pre-event image Landsat-8.

All satellite images have been radiometrically enhanced, orthocorrected with RPC approach The estimated geometric accuracy of this product is 50 m CE90 or better, from native positional accuracy of the background satellite image. The estimated thematic accuracy of this product is 85 % or better, based on previous experience in using high-resolution SAR for flood extent delineation. Please be aware that
