# Yangon West - Myanmar Flood - 01/08/2015 Delineation Map - Monit03

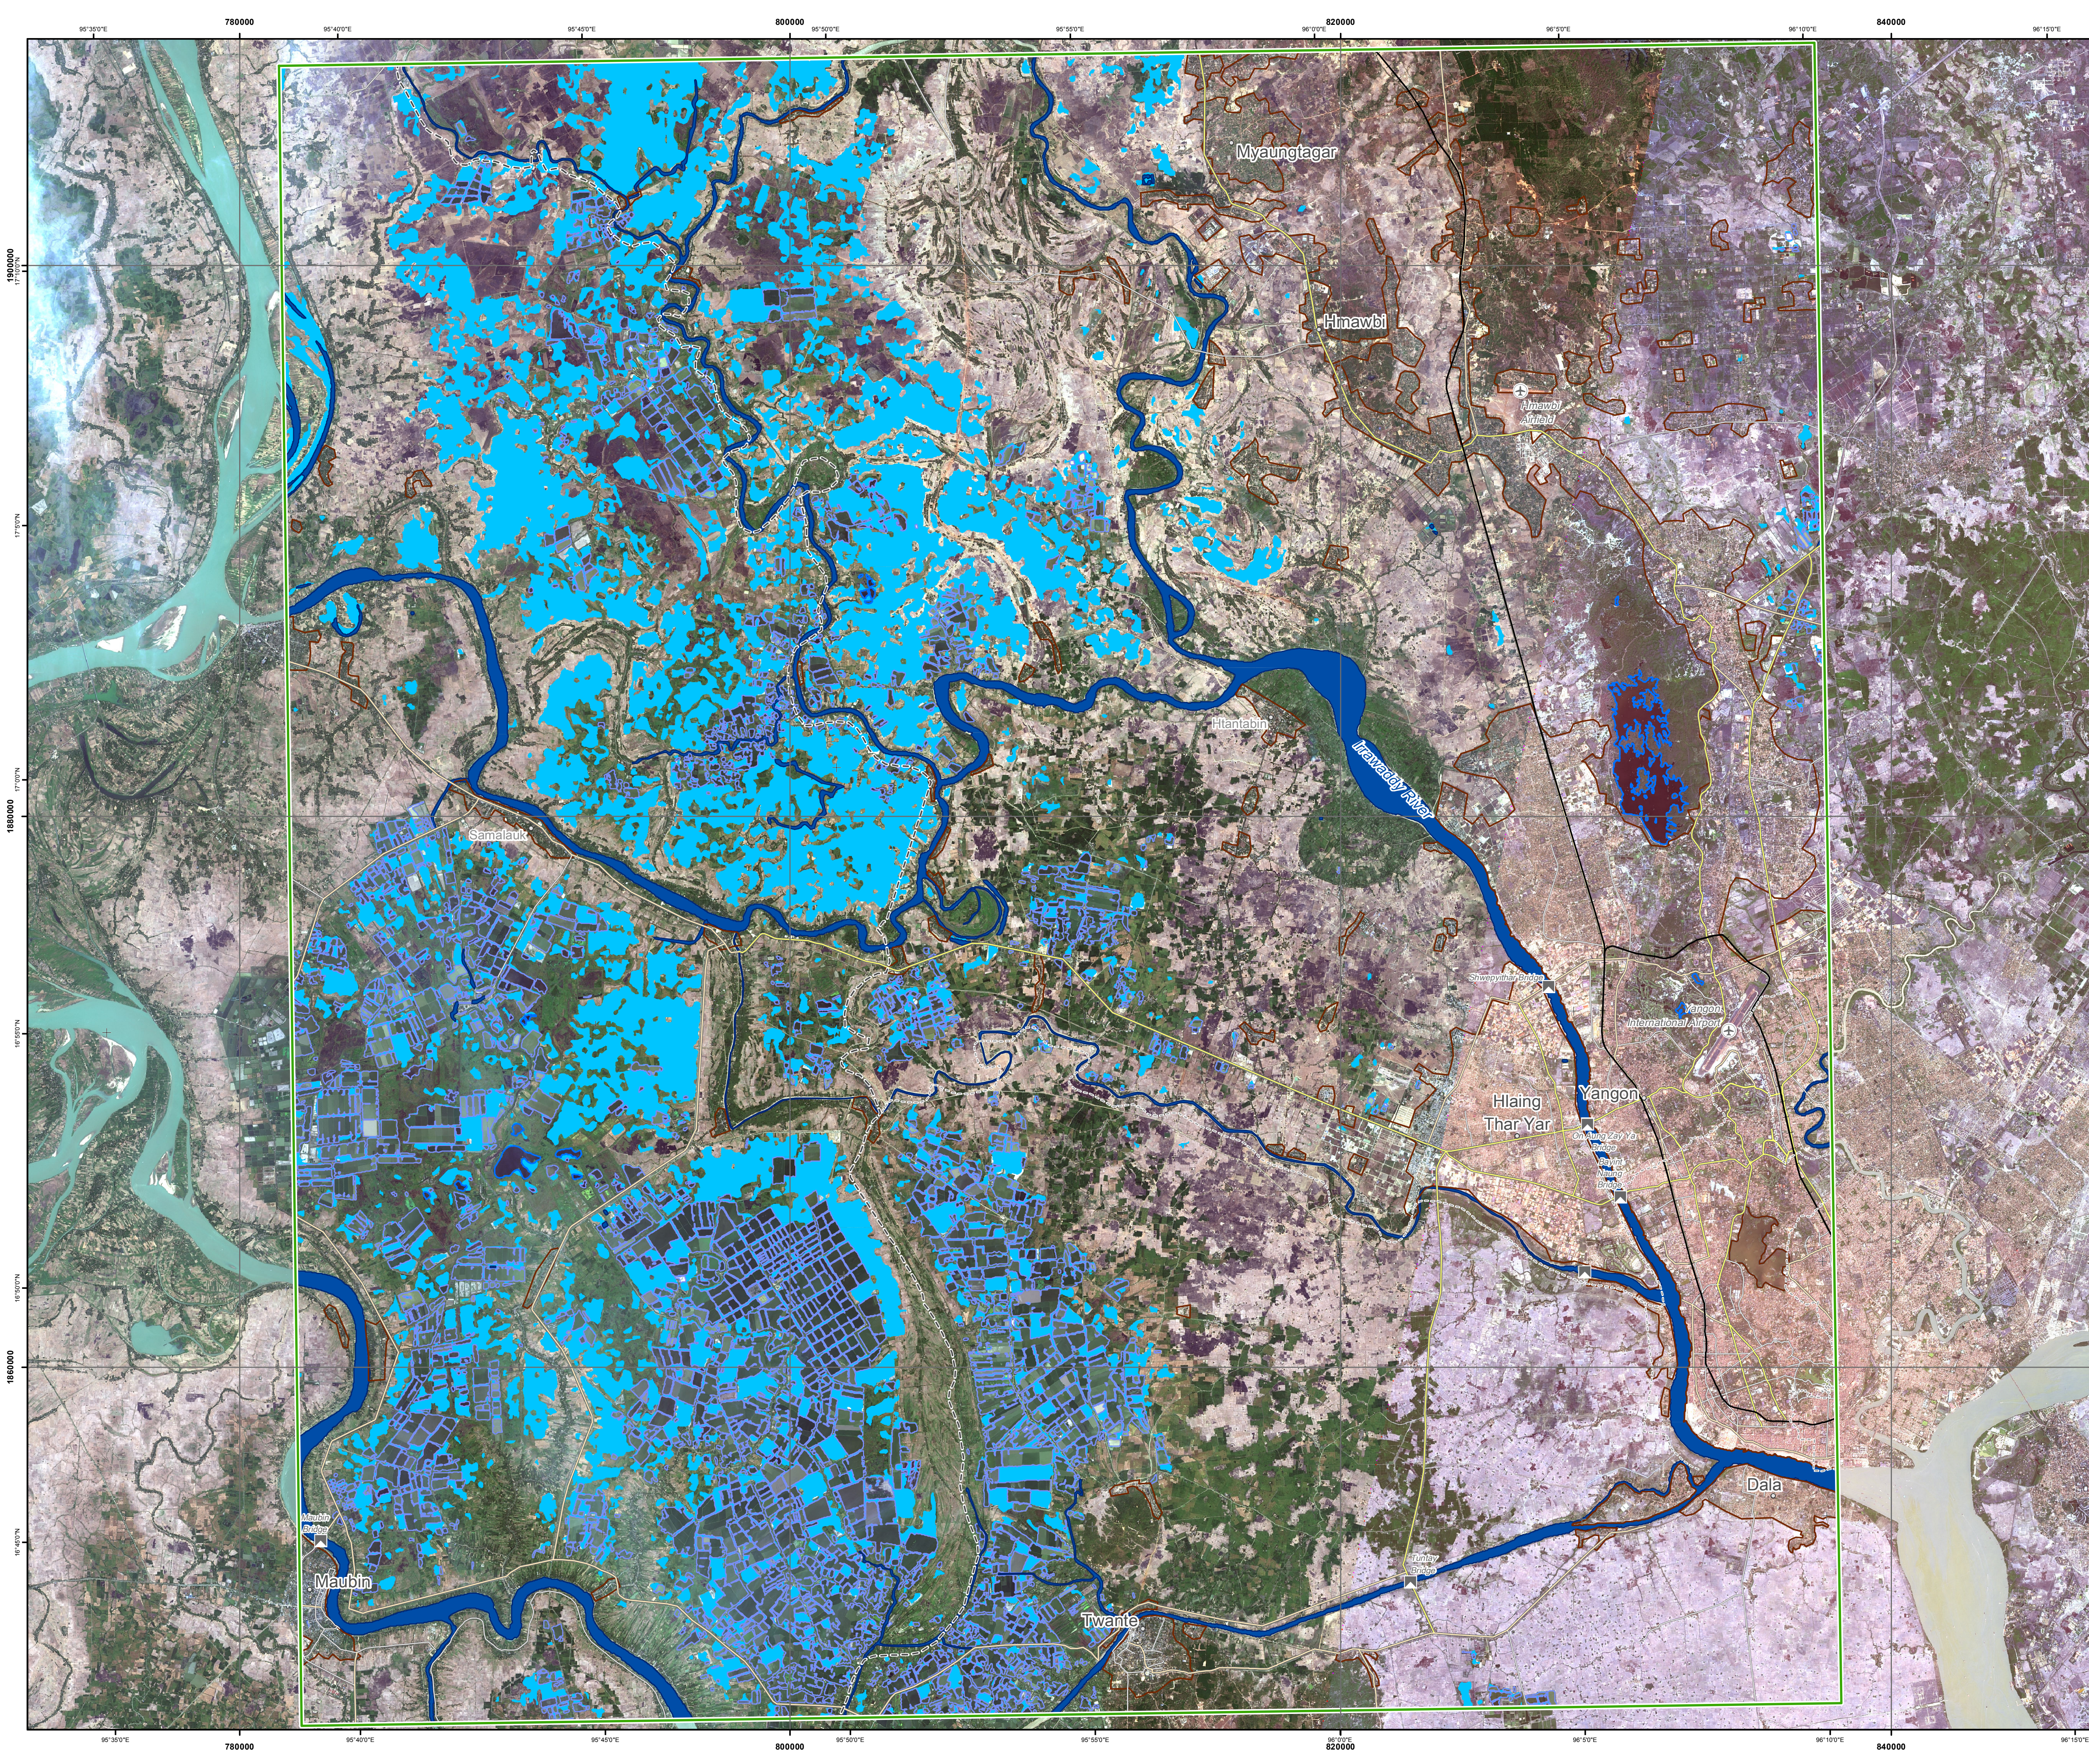
Unusual heavy monsoon rains have been affecting Myanmar since 16 July causing river overflows and floods. In the past few days, torrential rains damaged farmland, roads, rail tracks, bridges and houses. Reservoir are seasonal inundated areas and water bodies probably due to agricultural practices (paddy fields).  
The core users of the map is Emergency Response Coordination Centre (ERCC).

The present map shows the flood delineation in the area of Yangon West (MYANMAR). The basic topographic features are derived from public datasets, refined by means of visual interpretation of pre-event image Landsat-8.  
The thematic layer, assessing the delineation of the event, has been derived from post-event image Sentinel-1.  
All satellite images have been radiometrically enhanced, orthorectified with RPC approach (using SRTM elevation data).  
The estimated geometric accuracy of this product is 40 m CE90 or better, from native positional accuracy of the background satellite image.  
The estimated thematic accuracy of this product is 85 % or better, based on previous experience in using high-resolution SAR for flood extent delineation. Please be aware that the thematic accuracy might be lower in urban and forested areas due to known limitations of the analysis technique.  
Only the area enclosed by the Area of Interest has been analyzed.

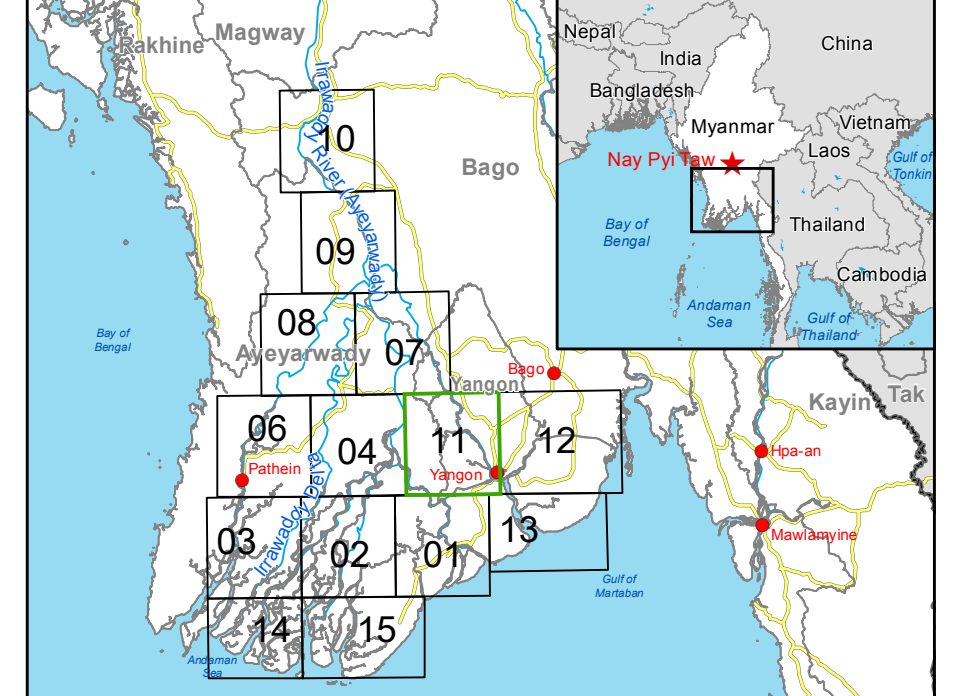
- Flooded Area (08-09-2015 23:24 UTC)

| Consequences within the AOI on 08/09/2015 | | | | |
| Flooded area | | ha | Affected | Total in AOI |
| Estimated population | | Inhabitants | 48129 | 3749921 |
| Settlements | Built-up area | ha | 5.4 | 40136 |
