GLIDE number: N/A Activation ID: EMSR287
Product N.: 07BADELSTER, v1, English

Bad Elster - GERMANY

Flood - Situation as of 28/05/2018

Delineation Map - MONIT01

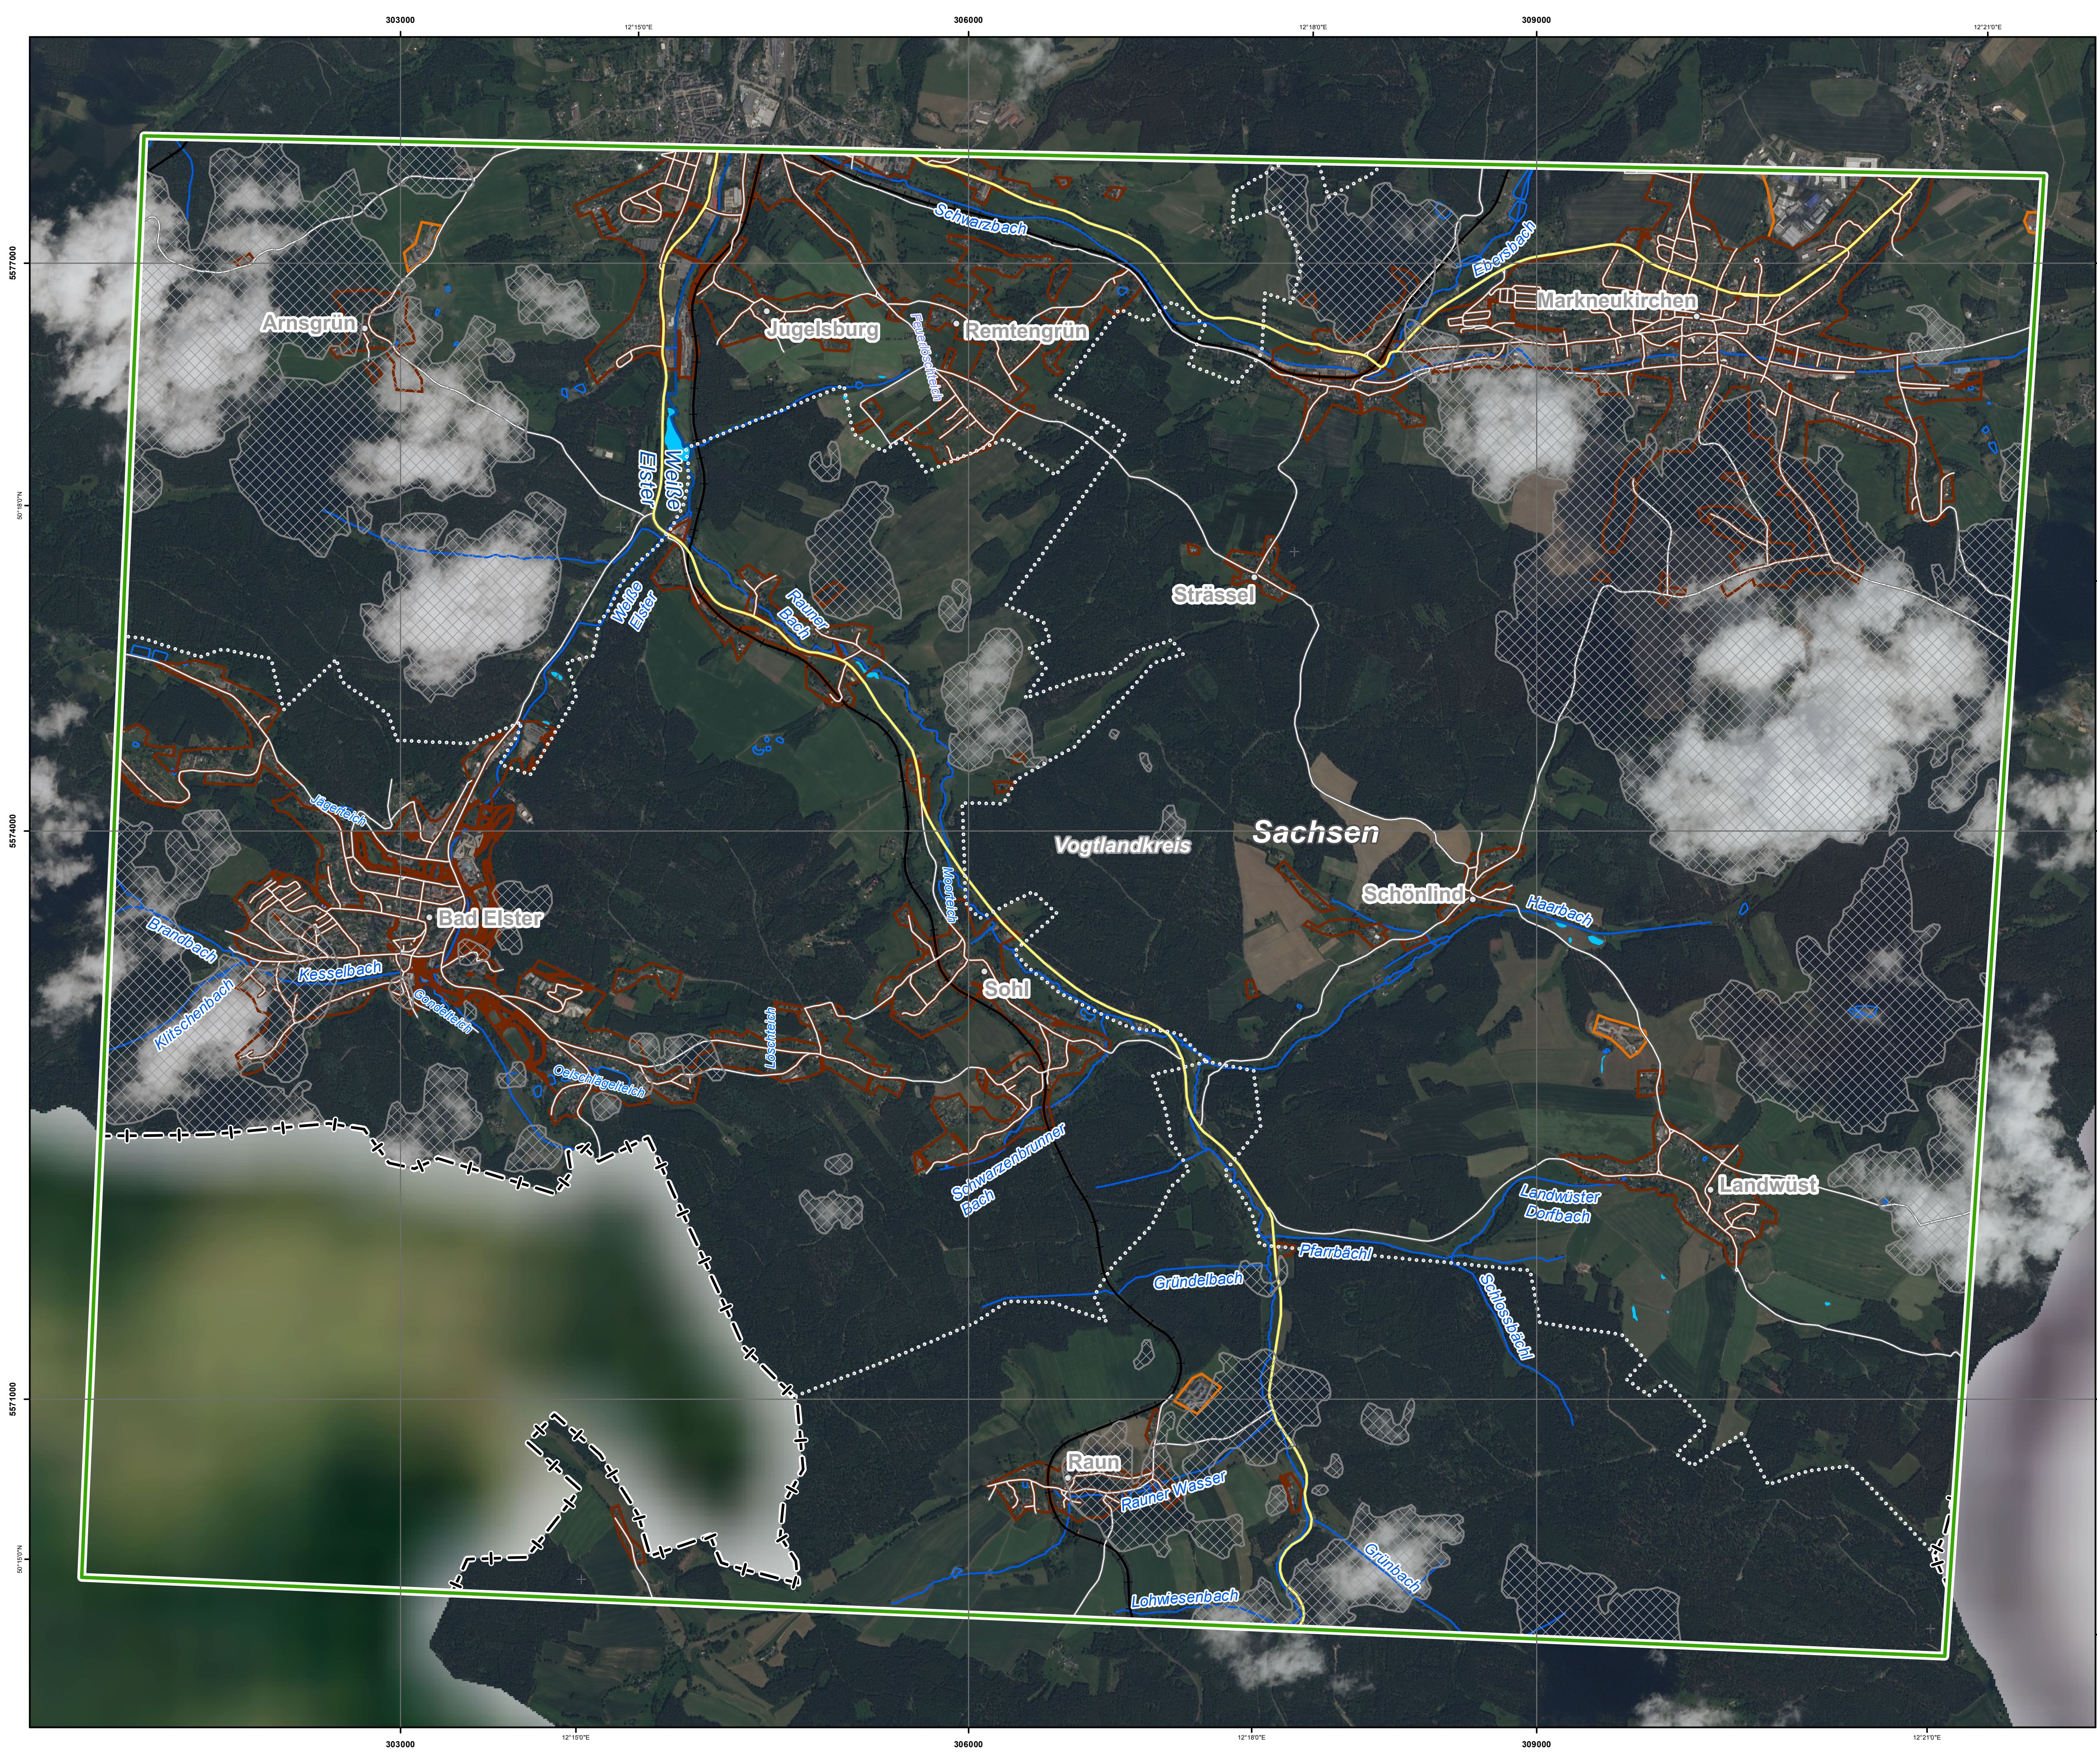
Consequences within the AOI		Unit of measurement	Affected	Total in AOI
Flooded area		ha	6	2.9
Estimated population		Number of inhabitants	6	10839
Settlements	Residential	ha	0.4	766.2
	Multi-functional	ha	0.0	70.8
Transportation	Primary Road	km	0.0	16
	Local Road	km	0.0	109.7
	Long-distance railway	km	0.0	14.6

The present map shows the flood delineation in the area of Bad Elster (Germany). The thematic layer has been derived from post-event satellite image by means of visual interpretation. The estimated geometric accuracy is 5 m CE90 or better, from native positional accuracy of the background satellite image.
