Bogale - Myanmar Flood - 01/08/2015 Delineation Map - Monit02

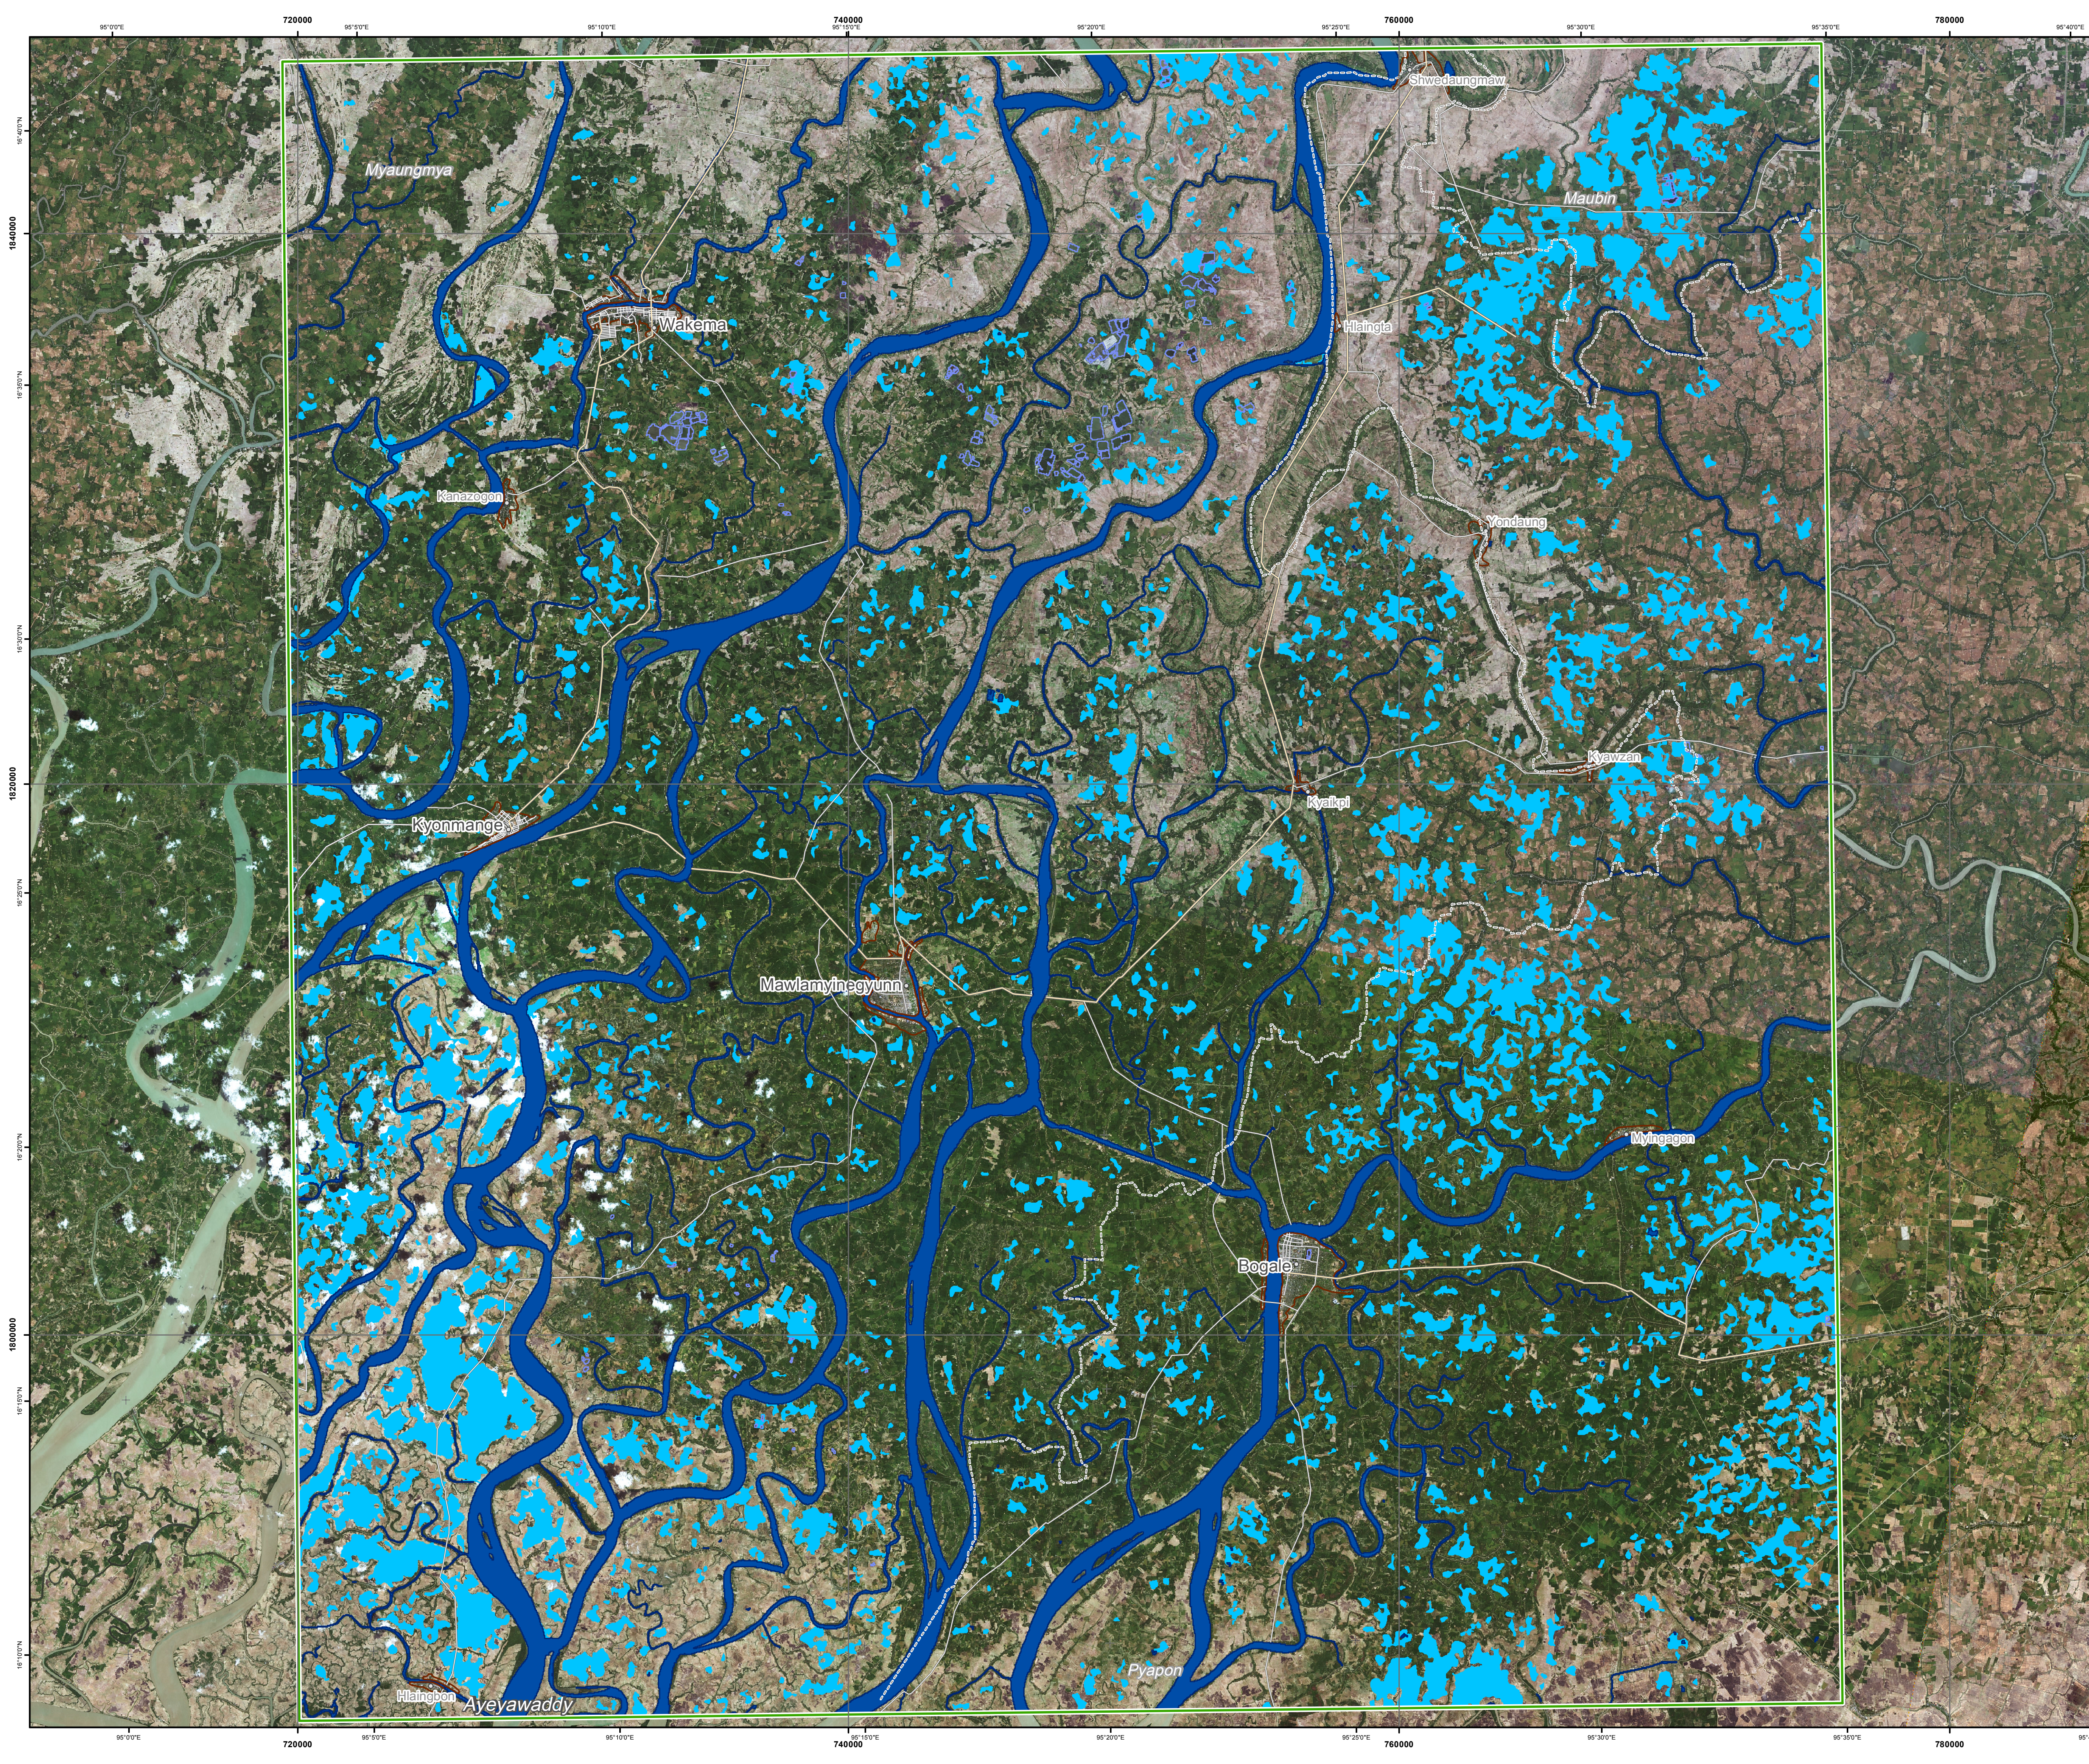
Consequences within the AOI on 04/09/2015				
Flooded area	ha		Affected	Total in AOI
			85191	1125011
Estimated population	Inhabitants		0	1789
Settlements	Built-up area		1.67	128
Transportation	Secondary		11.31	334
	Local roads

The present map shows the flood delineation in the area of Bogale (MYANMAR). The basic topographic features are derived from public datasets, refined by means of visual interpretation of pre-event image Landsat-8.
Thematic layers, assessing the delineation of the event have been derived from post-event image Sentinel-1A.
All satellite images have been radiometrically enhanced, orthorectified with RPC approach (using SRTM elevation data).
The estimated geometric accuracy of this product is 40 m CE90 or better, from native positional accuracy of the background satellite image.
The estimated thematic accuracy of this product is 85 % or better, based on previous experience in using high-resolution SAR for flood extent delineation. Please be aware that the thematic accuracy might be lower in urban and forested areas due to known limitations of the analysis technique.
Only the area enclosed by the Area of Interest has been analyzed.
