GLIDE number: N/A Activation ID: EMSR130
Product N.: 02BOGALE, v1, English

Bogale - Myanmar Flood - 01/08/2015 Delineation Map - Monit03

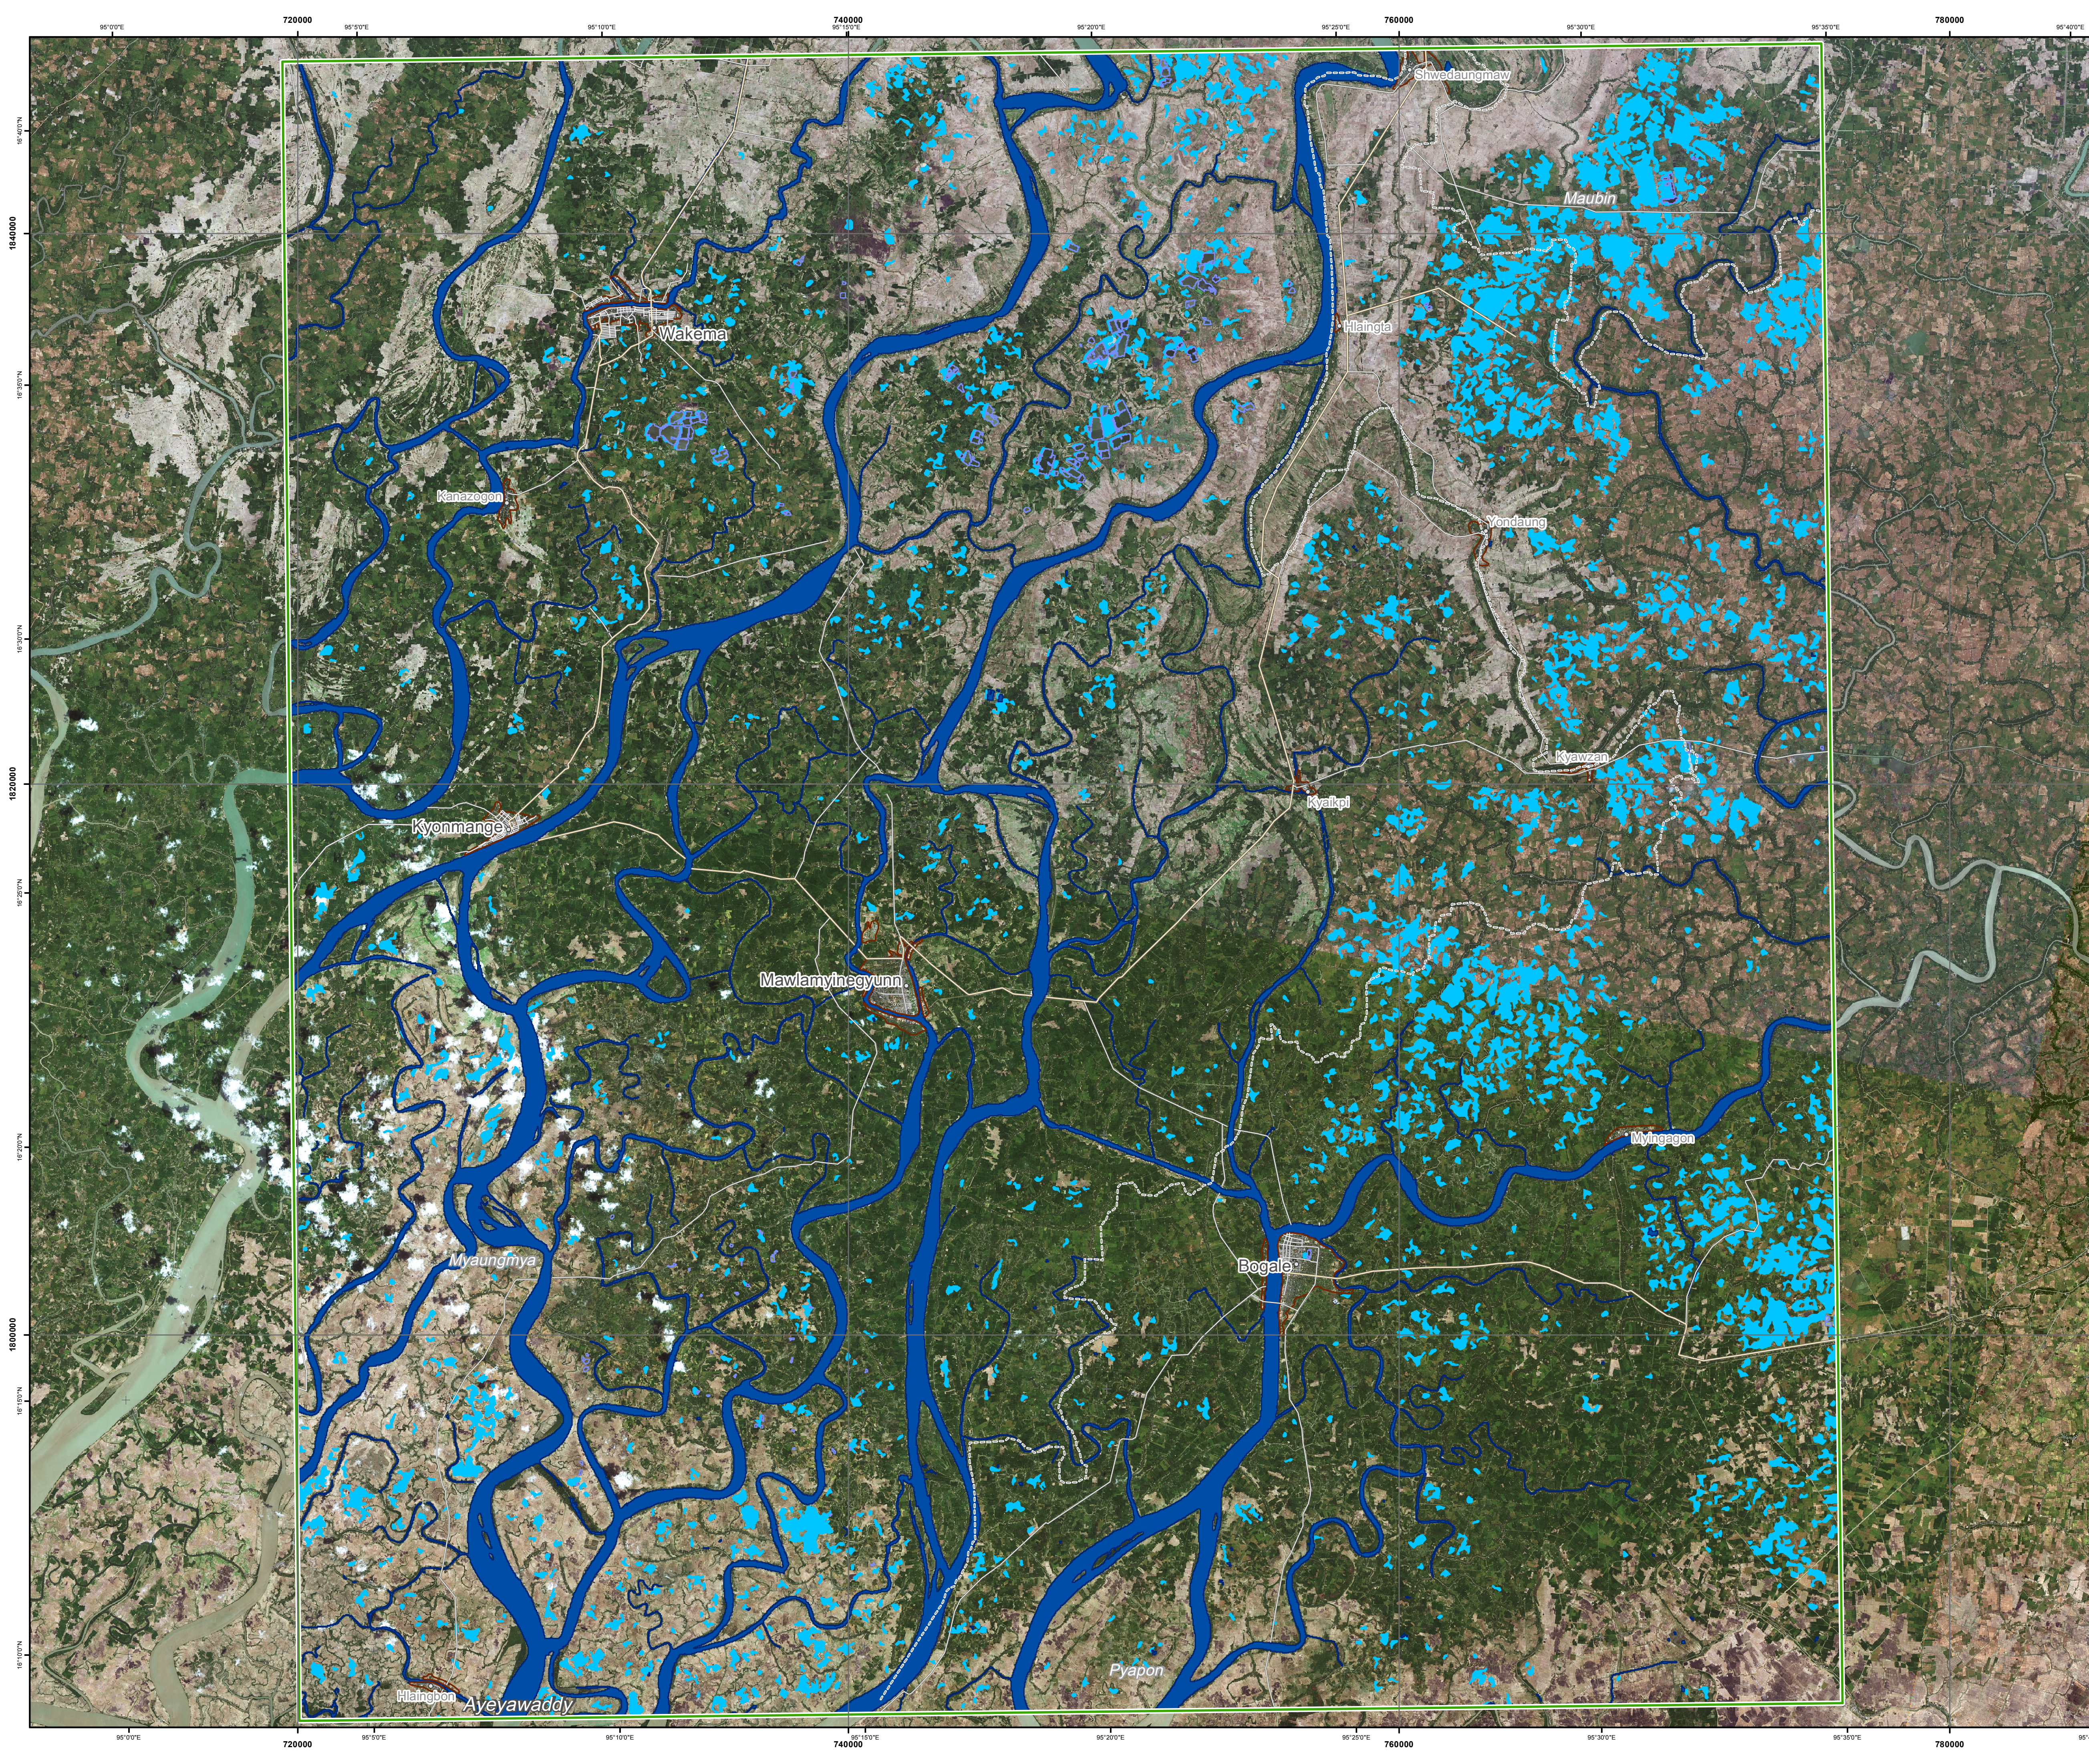
Consequences within the AOI on 13/09/2015			
		Affected	Total in AOI
Flooded area	ha	18784	
Estimated population	Inhabitants	38890	1125011
Settlements	Built-up area	ha	4
Transportation	Secondary	km	1.18
	Local roads	km	5.53

The present map shows the flood delineation in the area of Bogale (MYANMAR). The basic topographic features are derived from public datasets, refined by means of visual interpretation of pre-event image Landsat-8.
Thematic layers, assessing the delineation of the event have been derived from post-event image Sentinel-1A.
All satellite images have been radiometrically enhanced, orthorectified with RPC approach (using SRTM elevation data).
The estimated geometric accuracy of this product is 40 m CE90 or better, from native positional accuracy of the background satellite image.
The estimated thematic accuracy of this product is 85 % or better, based on previous experience in using high-resolution SAR for flood extent delineation. Please be aware that the thematic accuracy might be lower in urban and forested areas due to known limitations of the analysis technique.
Only the area enclosed by the Area of Interest has been analyzed.
