GLIDE number: N/A Activation ID: EMSR130 Product N.: 06PATHEIN, v1, English

> Pathein - Myanmar Flood - 01/08/2015
> Delineation Map - Monit02

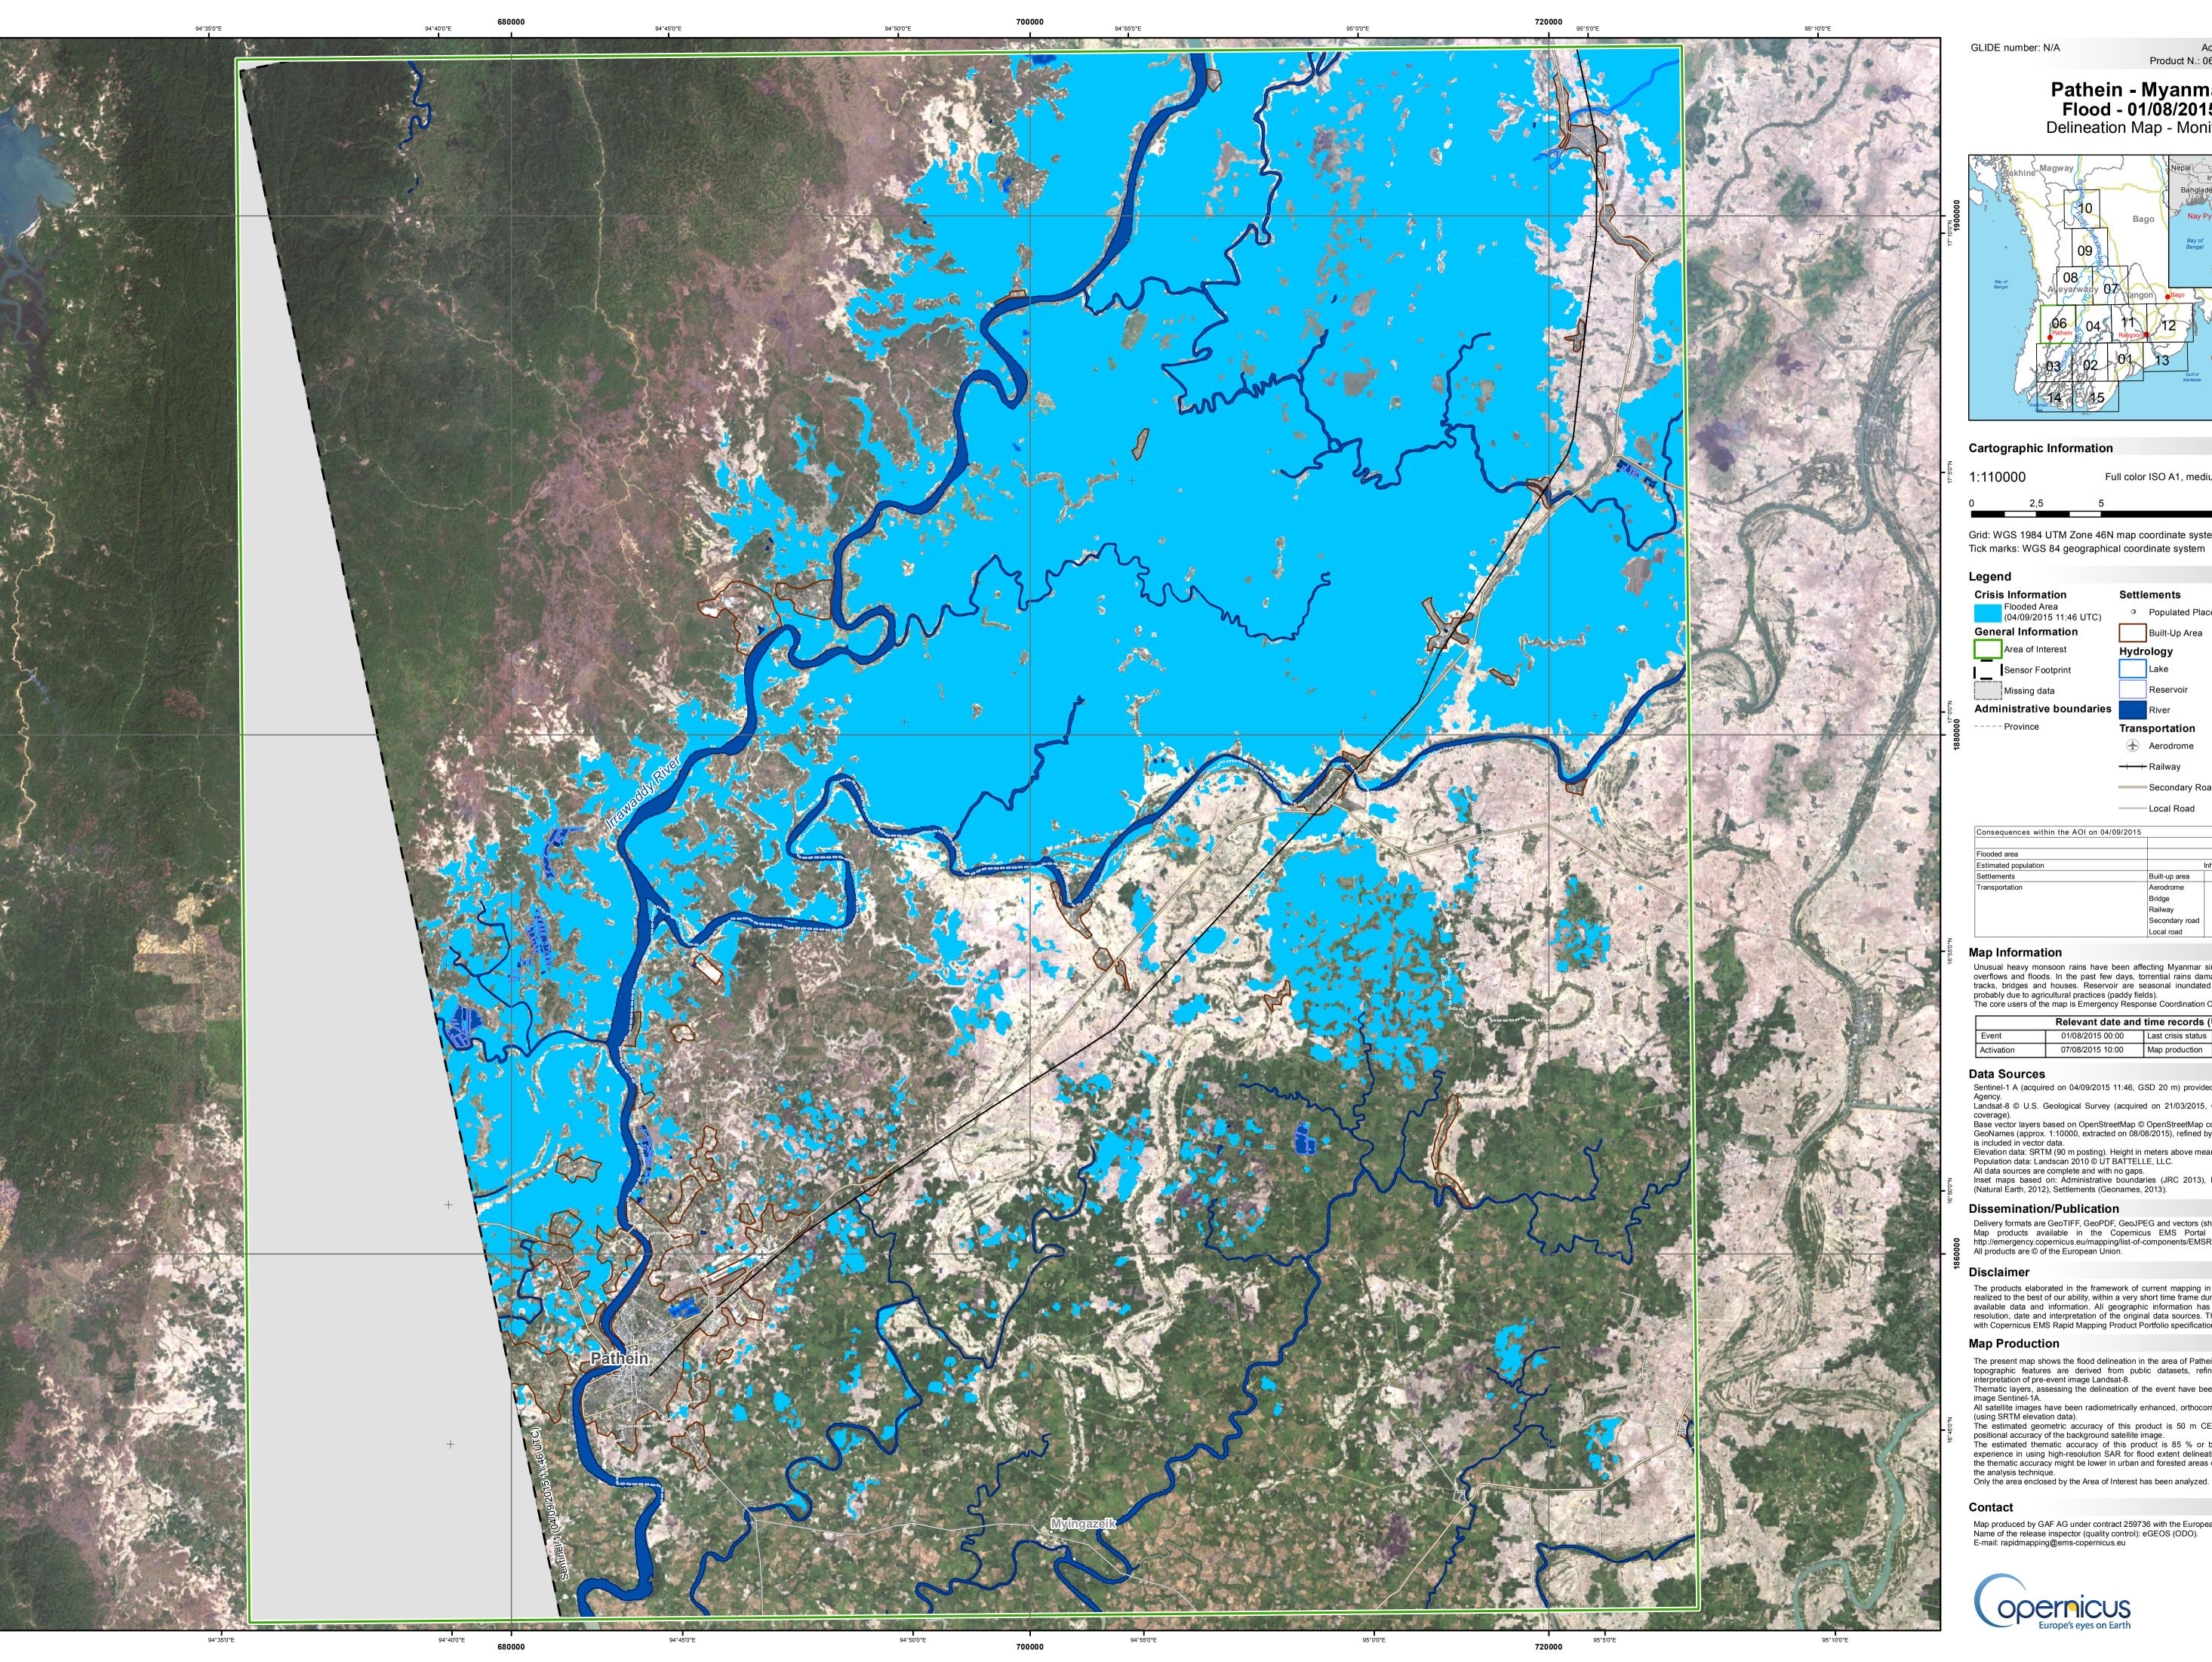
**Crisis Information** Settlements Flooded Area (04/09/2015 11:46 UTC) Populated Place Built-Up Area **General Information** Area of Interest Sensor Footprint Missing data

Consequences within the AOI on 04/09/2015					
			Affected	Total in	
Flooded area	ha		264	264219	
Estimated population	Inhabitants		1538	869884	
Settlements	Built-up area	ha	467	6593	
Transportation	Aerodrome	No.	0	1	
	Bridge	No.	0	7	
	Railway	km	0	67	
	Secondary road	km	14,4	186	
	Local road	km	0	309

The present map shows the flood delineation in the area of Pathein (MYANMAR). The basic topographic features are derived from public datasets, refined by means of visual interpretation of pre-event image Landsat-8.

Thematic layers, assessing the delineation of the event have been derived from post-event

All satellite images have been radiometrically enhanced, orthocorrected with RPC approach (using SRTM elevation data). The estimated geometric accuracy of this product is 50 m CE90 or better, from native

positional accuracy of the background satellite image. The estimated thematic accuracy of this product is 85 % or better, based on previous experience in using high-resolution SAR for flood extent delineation. Please be aware that the thematic accuracy might be lower in urban and forested areas due to known limitations of
