GLIDE number: N/A Activation ID: EMSR130
Product N.: 07HINTHADA, v1, English

Hinthada - Myanmar
Flood - 01/08/2015
Delineation Map - Monit03

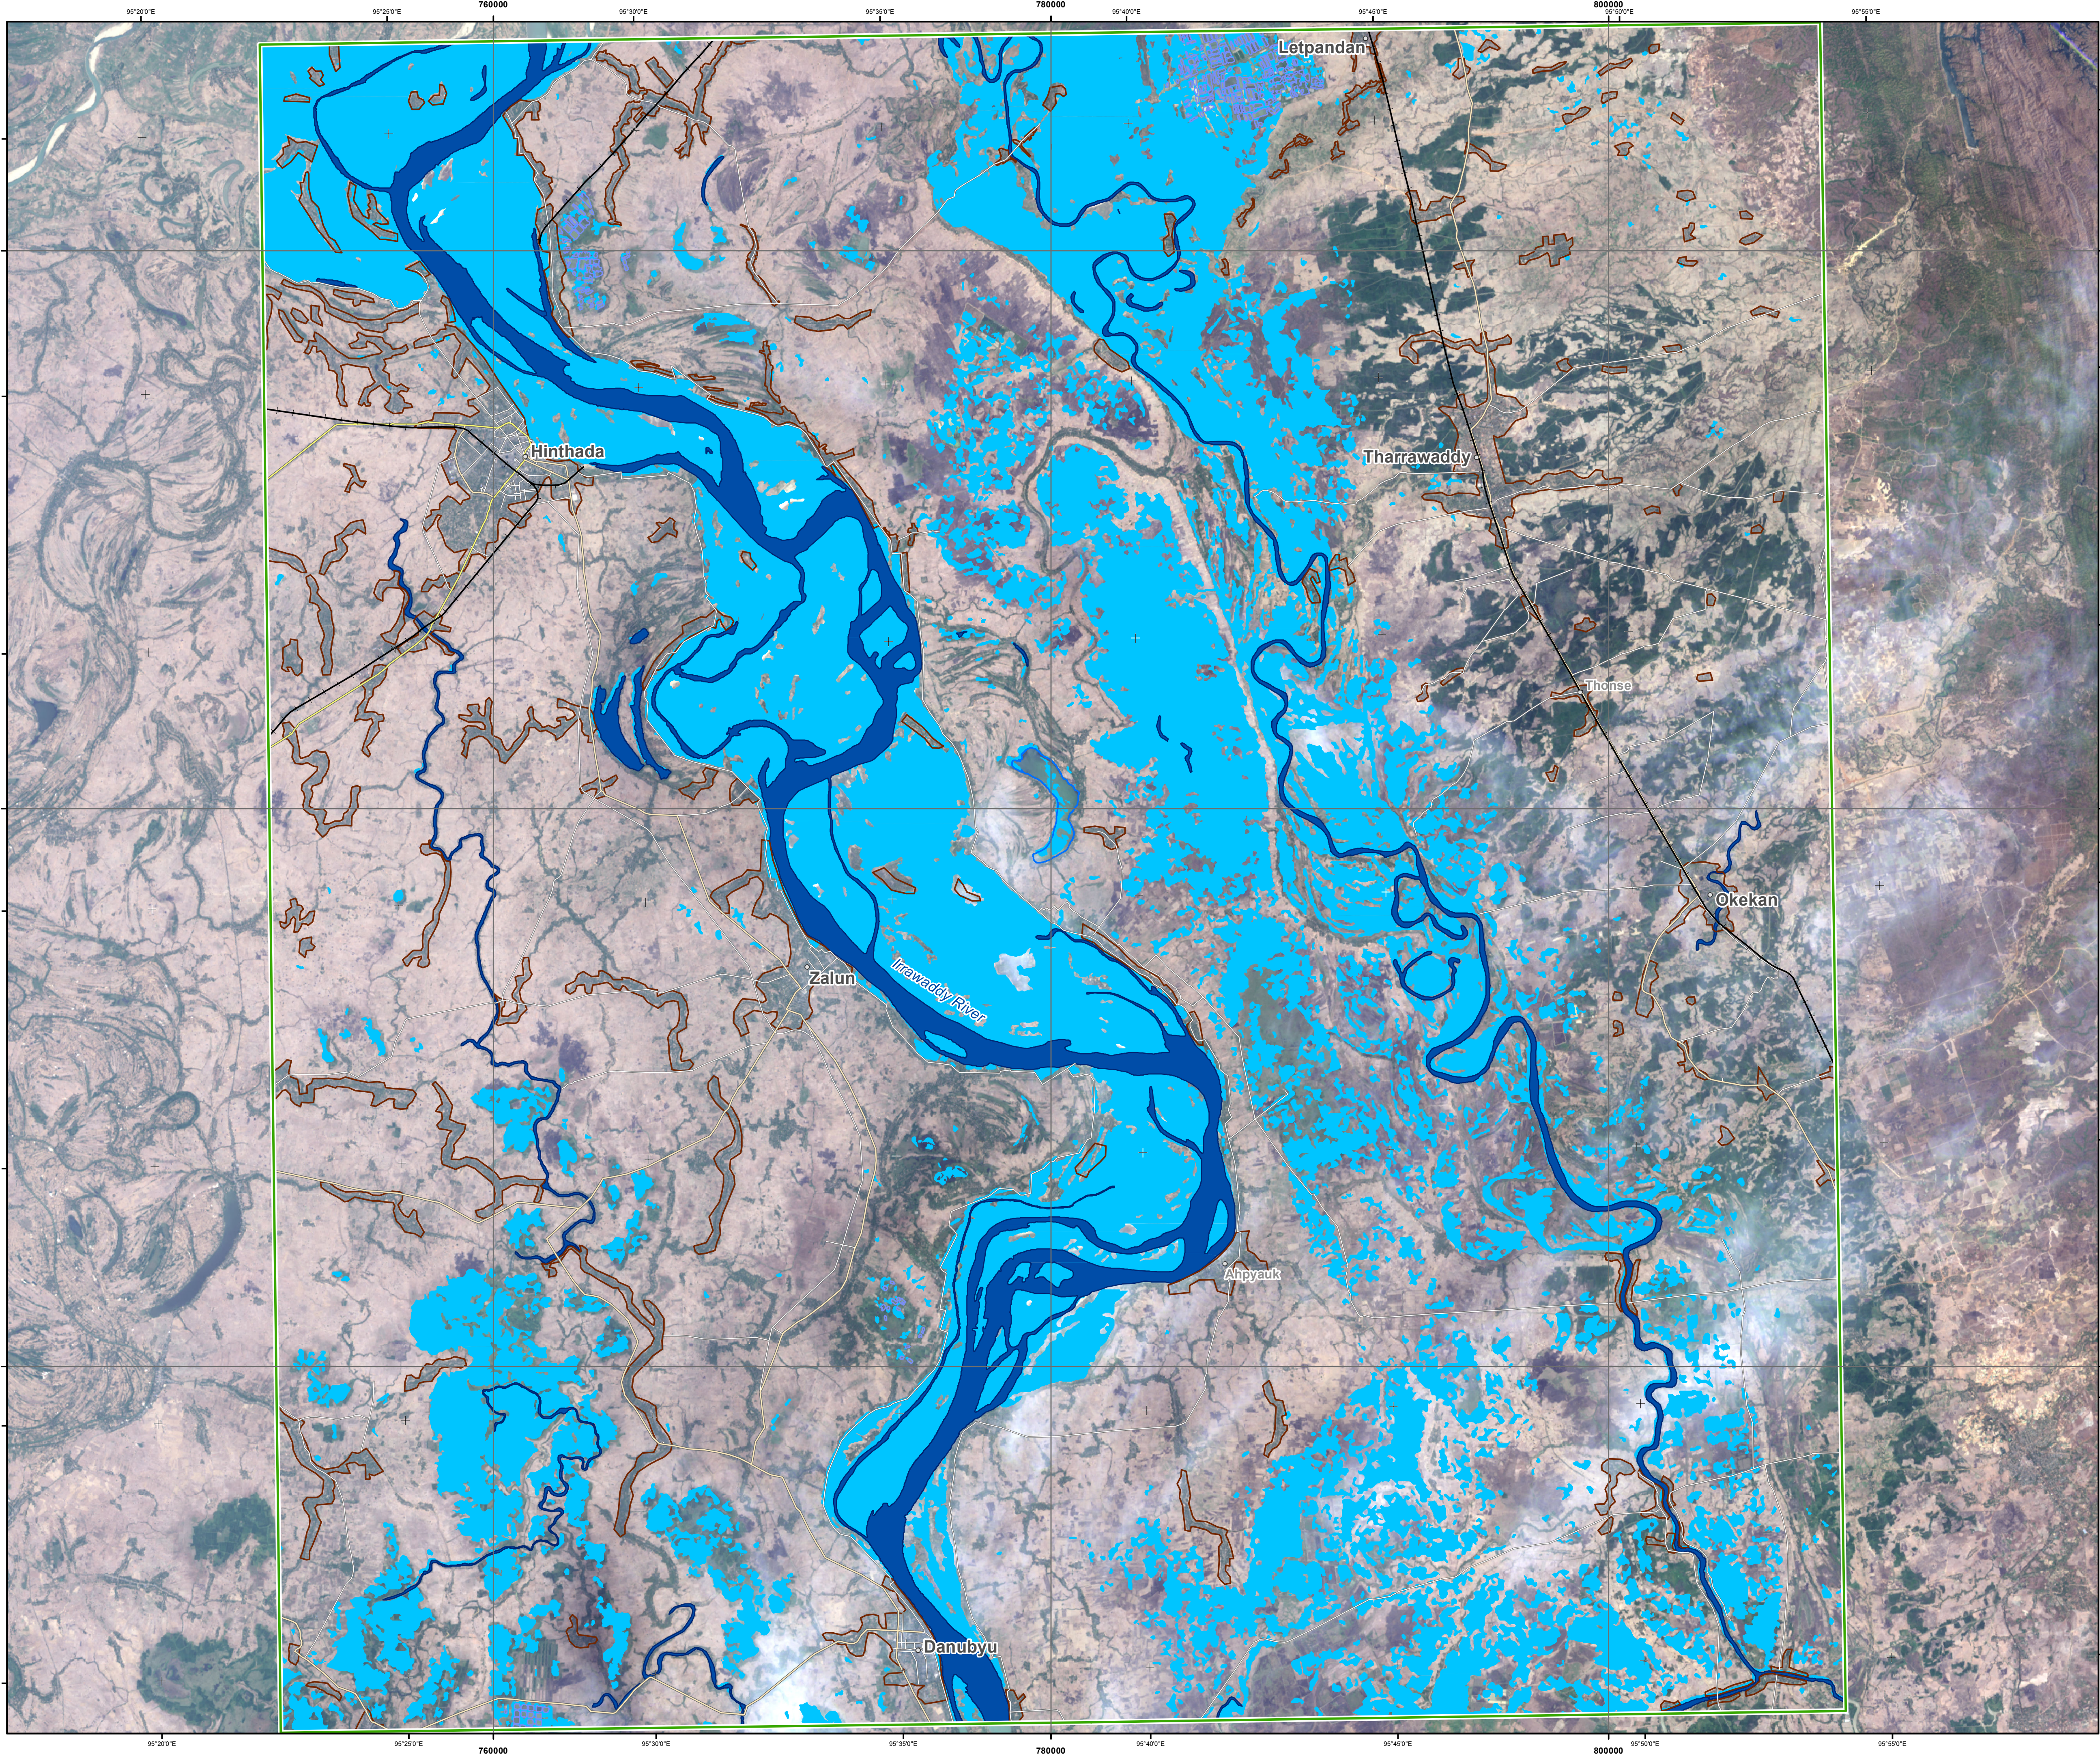
Consequences within the AOI on 13/09/2015			
		Affected	Total in AOI
Flooded area	ha	86230	
Estimated population	Inhabitants	140019	1156590
Settlements	Built-up area	ha	14875
Transportation	Primary roads	km	0
	Secondary roads	km	2
	Local roads	km	57
	Railways	km	1

The present map shows the flood delineation in the area of Hinthada (MYANMAR). The basic topographic features are derived from public datasets, refined by means of visual interpretation of pre-event image Landsat-8.
The thematic layer, assessing the delineation of the event, has been derived from post-event image Sentinel-1A.
All satellite images have been radiometrically enhanced, orthorectified with RPC approach (using SRTM elevation data).
The estimated geometric accuracy of this product is 40 m CE90 or better, from native positional accuracy of the background satellite image.
The estimated thematic accuracy of this product is 85 % or better, based on previous experience in using high-resolution SAR for flood extent delineation. Please be aware that the thematic accuracy might be lower in urban and forested areas due to known limitations of the analysis technique.
Only the area enclosed by the Area of Interest has been analyzed.
