Activation ID: EMSR130 Product N.: 08YEGYI, v1, English

Yegyi - MYANMAR Flood - 01/08/2015 Delineation Map - Monit03

The present map shows the flood delineation in the area of Yegyi (MYANMAR). The basic topographic features are derived from public datasets, refined by means of visual interpretation of pre-event image Landsat-8.

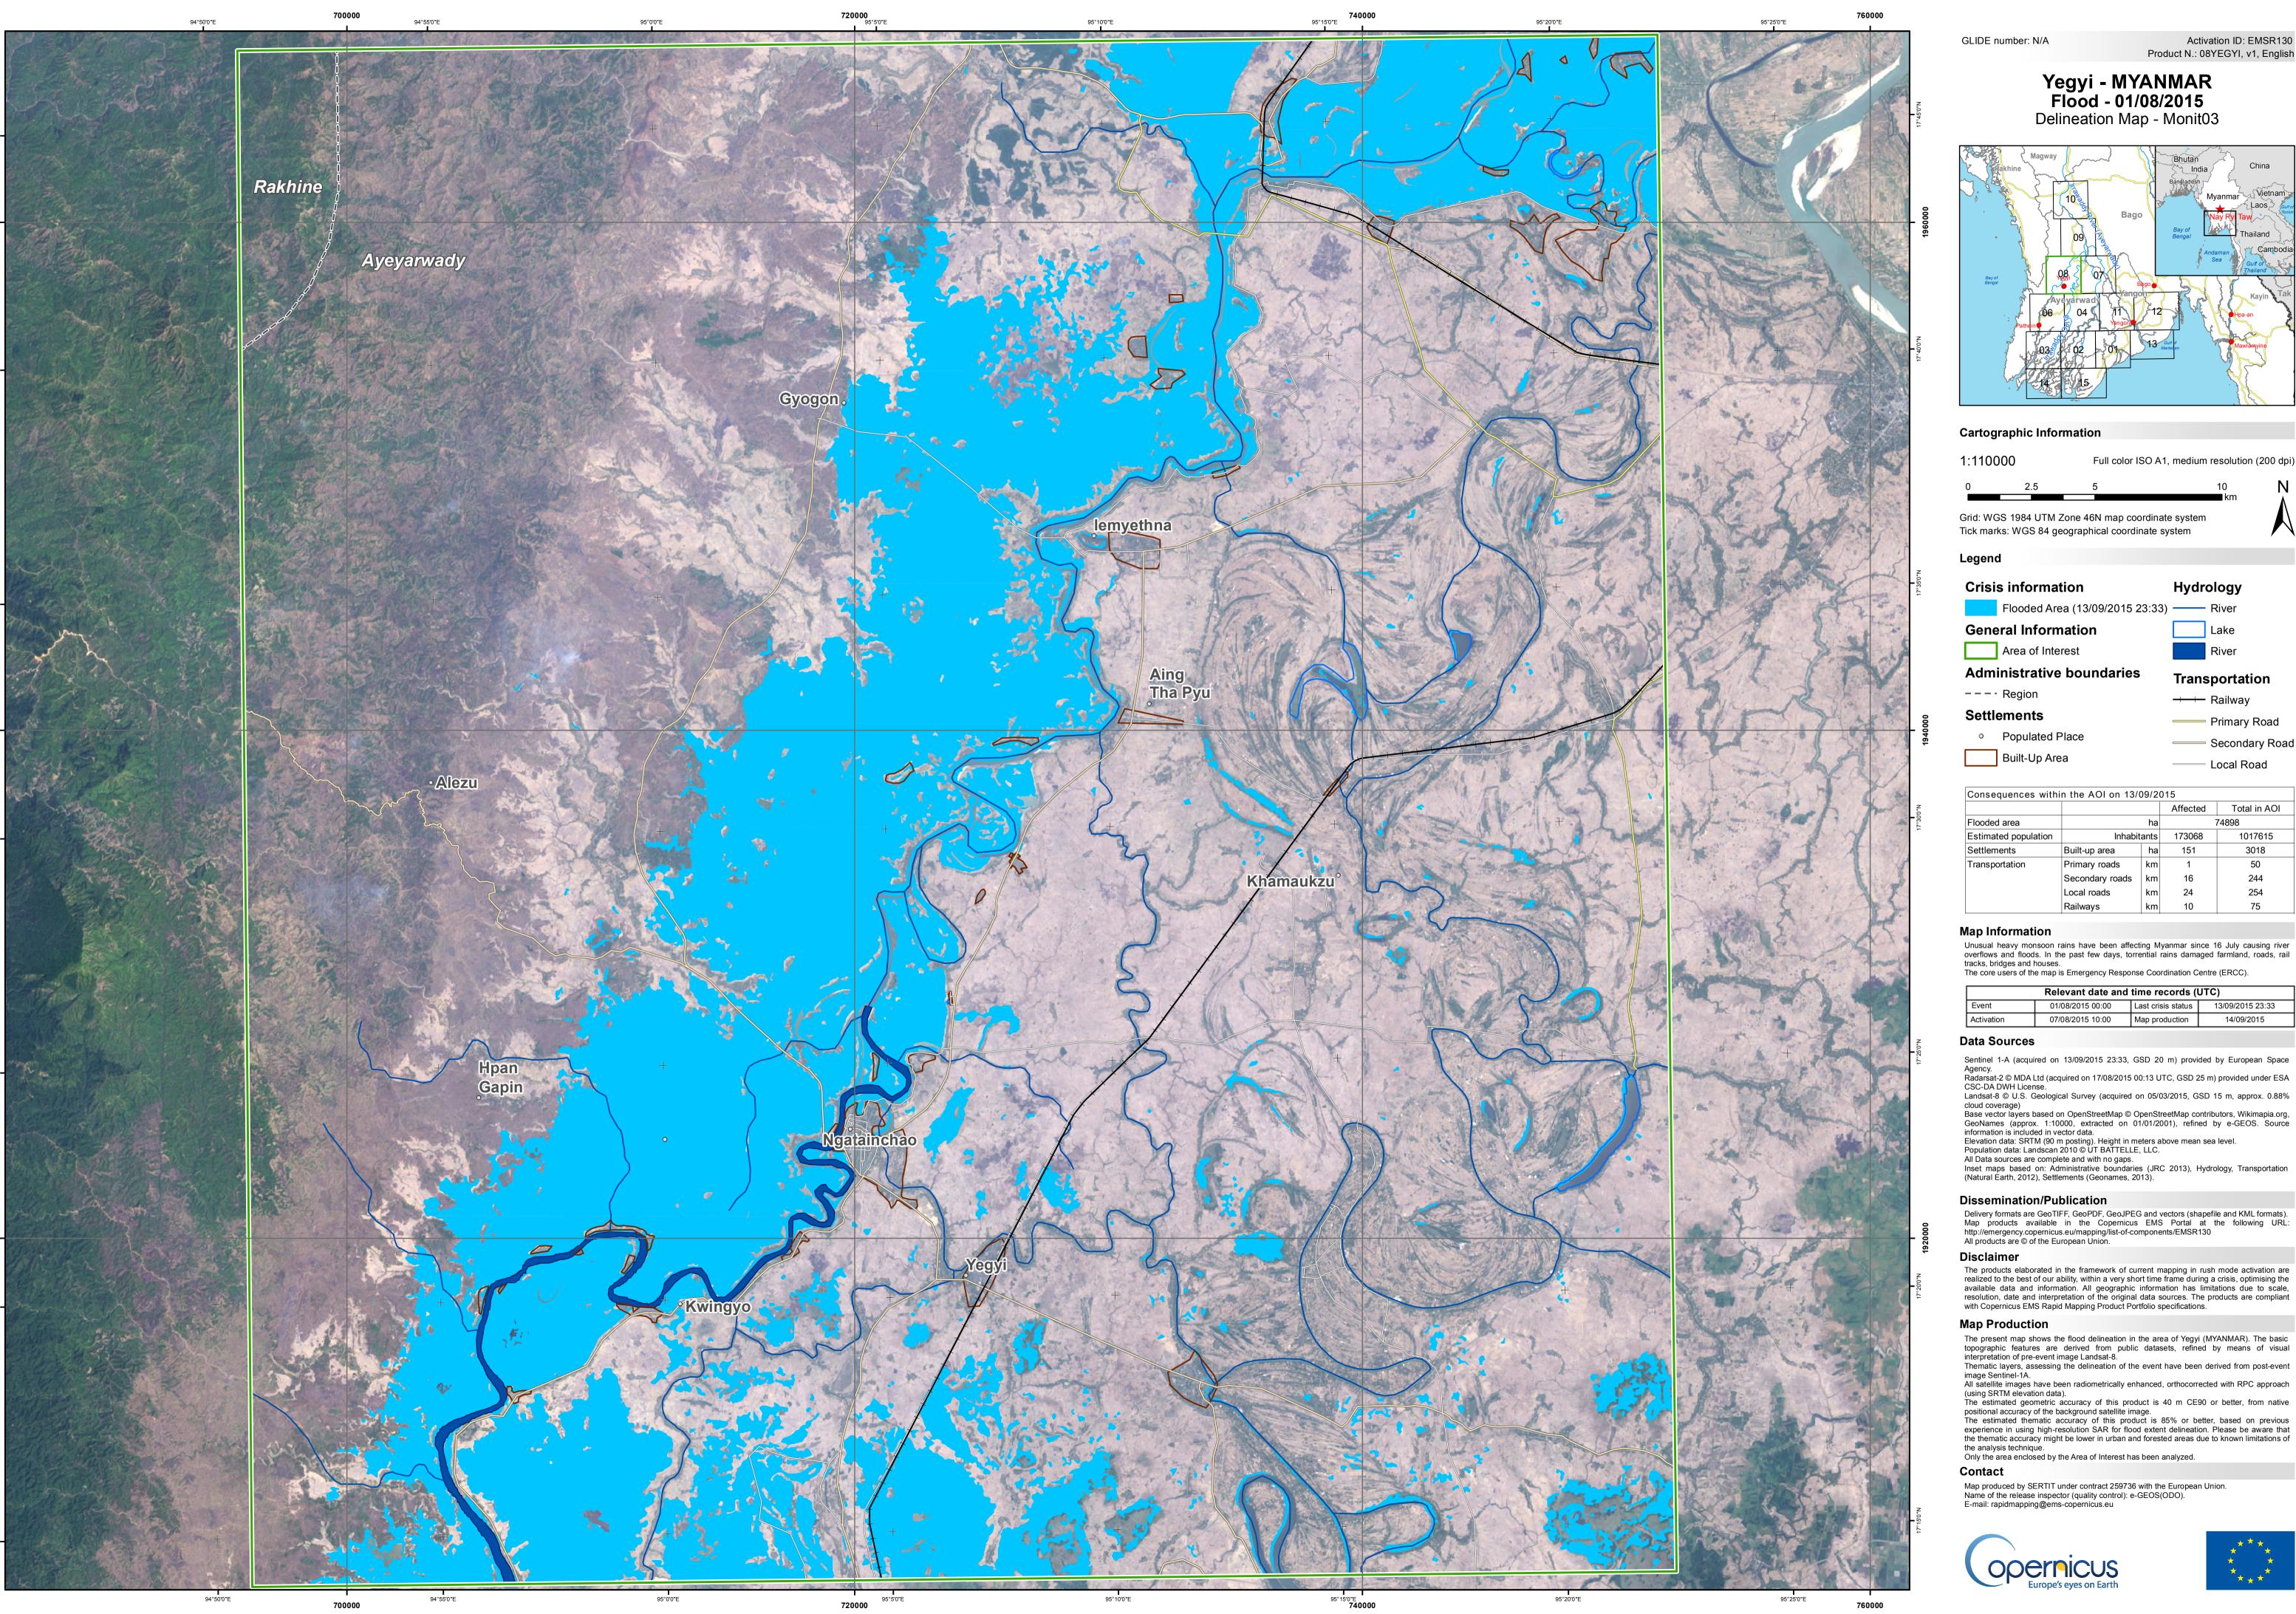
image Sentinel-1A. All satellite images have been radiometrically enhanced, orthocorrected with RPC approach (using SRTM elevation data).

The estimated geometric accuracy of this product is 40 m CE90 or better, from native positional accuracy of the background satellite image. The estimated thematic accuracy of this product is 85% or better, based on previous experience in using high-resolution SAR for flood extent delineation. Please be aware that the thematic accuracy might be lower in urban and forested areas due to known limitations of

the analysis technique. Only the area enclosed by the Area of Interest has been analyzed.

Consequences within the AOI on 13/09/2015 Affected Total in AOI Flooded area Estimated population Inhabitants 173068 Built-up area ha 151 Settlements
