Activation ID: EMSR130 Product N.: 10PYAY, v1, English

Pyay - MYANMAR Flood - 01/08/2015 Delineation Map

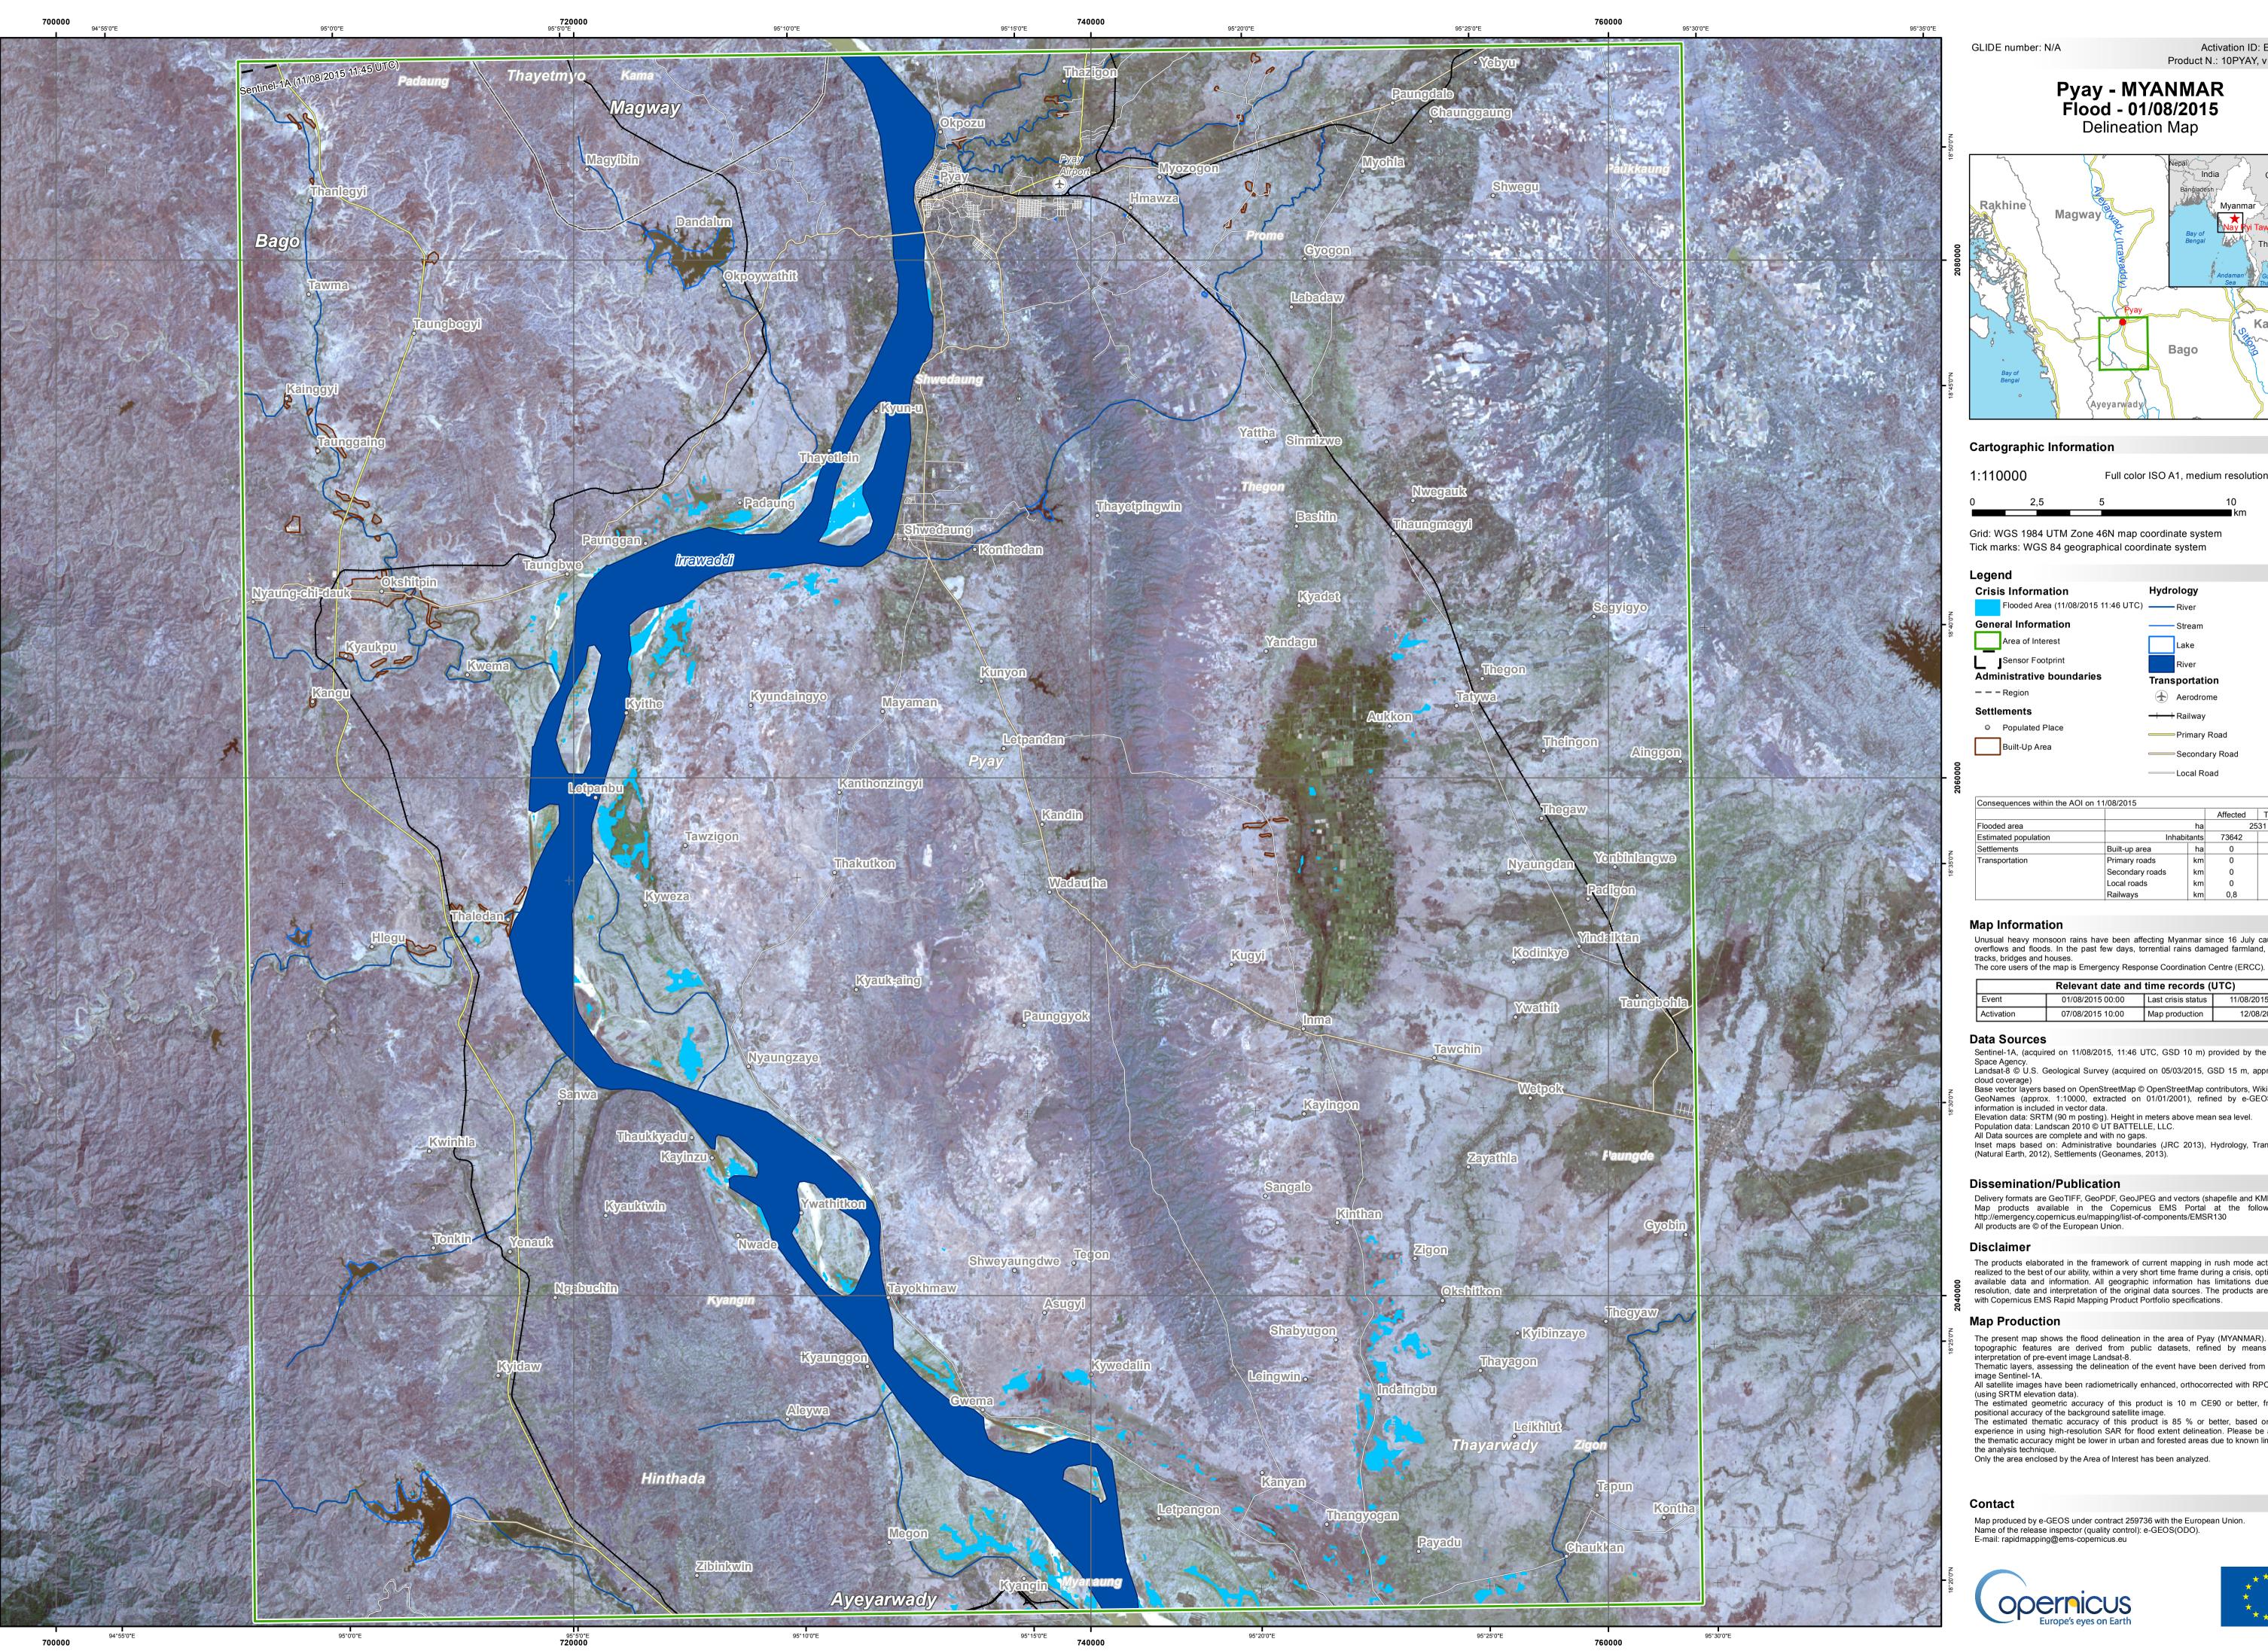
Flooded Area (11/08/2015 11:46 UTC) ——— River **General Information** Area of Interest

Consequences within the AC	71 011 1 1/00/2013			
			Affected	Total in AOI
Flooded area		ha 2531		531
Estimated population	Inha	Inhabitants 73642 85814		858144
Settlements	Built-up area	ha	0	590
Transportation	Primary roads	km	0	75,9
	Secondary roads	km	0	146,3
	Local roads	km	0	415.3

The present map shows the flood delineation in the area of Pyay (MYANMAR). The basic topographic features are derived from public datasets, refined by means of visual interpretation of pre-event image Landsat-8. Thematic layers, assessing the delineation of the event have been derived from post-event
