GLIDE number: N/A      Activation ID: EMSR130  
Product N.: 11YANGONWEST, v3, English

## Yangon West - Myanmar Flood - 01/08/2015 Delineation Map - Monit01

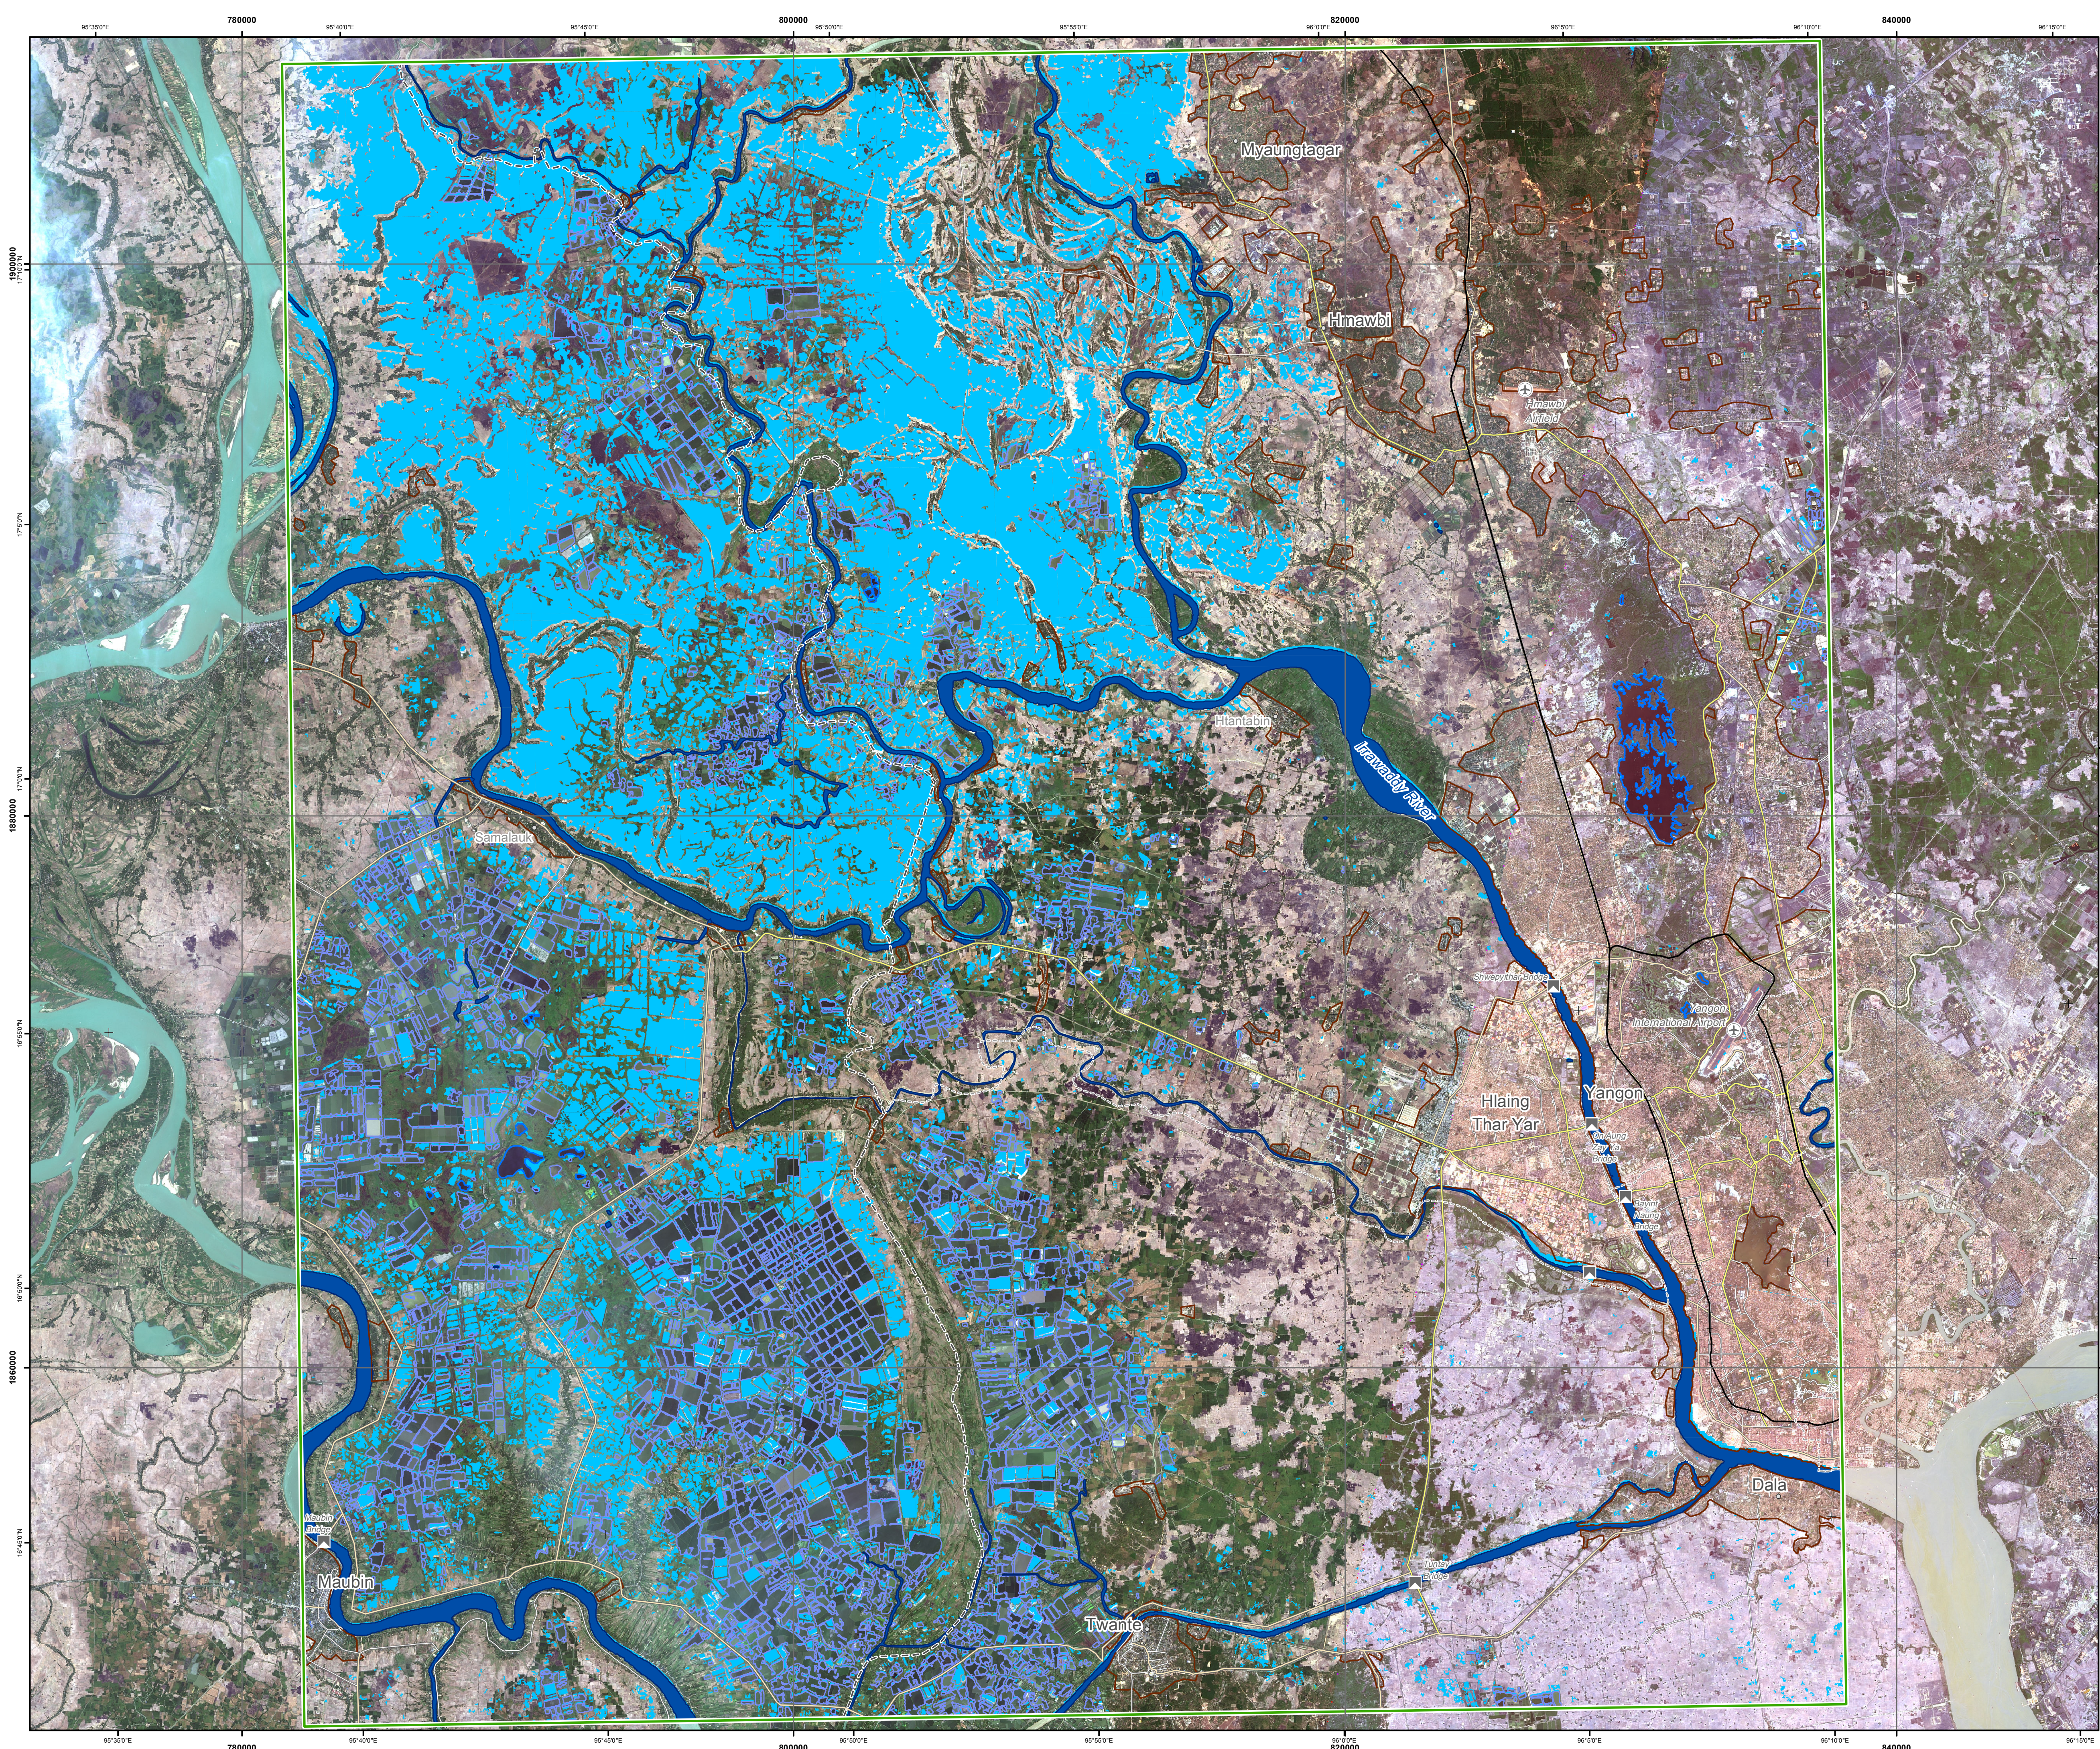
Consequences within the AOI on 15/08/2015					Affected	Total in AOI
Flooded area					ha	60649
Estimated population					Inhabitants	22049
Settlements	Built-up area				ha	236
Transportation	Aerodrome	No.	0			2
	Bridge	No.	0			6
	Railway	km	0			74
	Primary road	km	0.5			198
	Secondary road	km	2.5			241
	Local road	km	2.5			209

The present map shows the flood delineation in the area of Yangon West (MYANMAR). The basic topographic features are derived from public datasets, refined by means of visual interpretation of pre-event image Landsat-8.  
The thematic layer, assessing the delineation of the event, has been derived from post-event image Sentinel-1.  
All satellite images have been radiometrically enhanced, orthorectified with RPC approach (using SRTM elevation data).  
The estimated geometric accuracy of this product is 40 m CE90 or better, from native positional accuracy of the background satellite image.  
The estimated thematic accuracy of this product is 85 % or better, based on previous experience in using high-resolution SAR for flood extent delineation. Please be aware that the thematic accuracy might be lower in urban and forested areas due to known limitations of the analysis technique.  
Only the area enclosed by the Area of Interest has been analyzed.

Unusual heavy monsoon rains have been affecting Myanmar since 16 July causing river overflows and floods. In the past few days, torrential rains damaged farmland, roads, rail tracks, bridges and houses. Reservoir are seasonal inundated areas and water bodies probably due to agricultural practices (paddy fields).  
The core users of the map is Emergency Response Coordination Centre (ERCC).
