Activation ID: EMSR130 Product N.: 11YANGONWEST, v1, English

# Yangon West - Myanmar Flood - 01/08/2015 Delineation Map

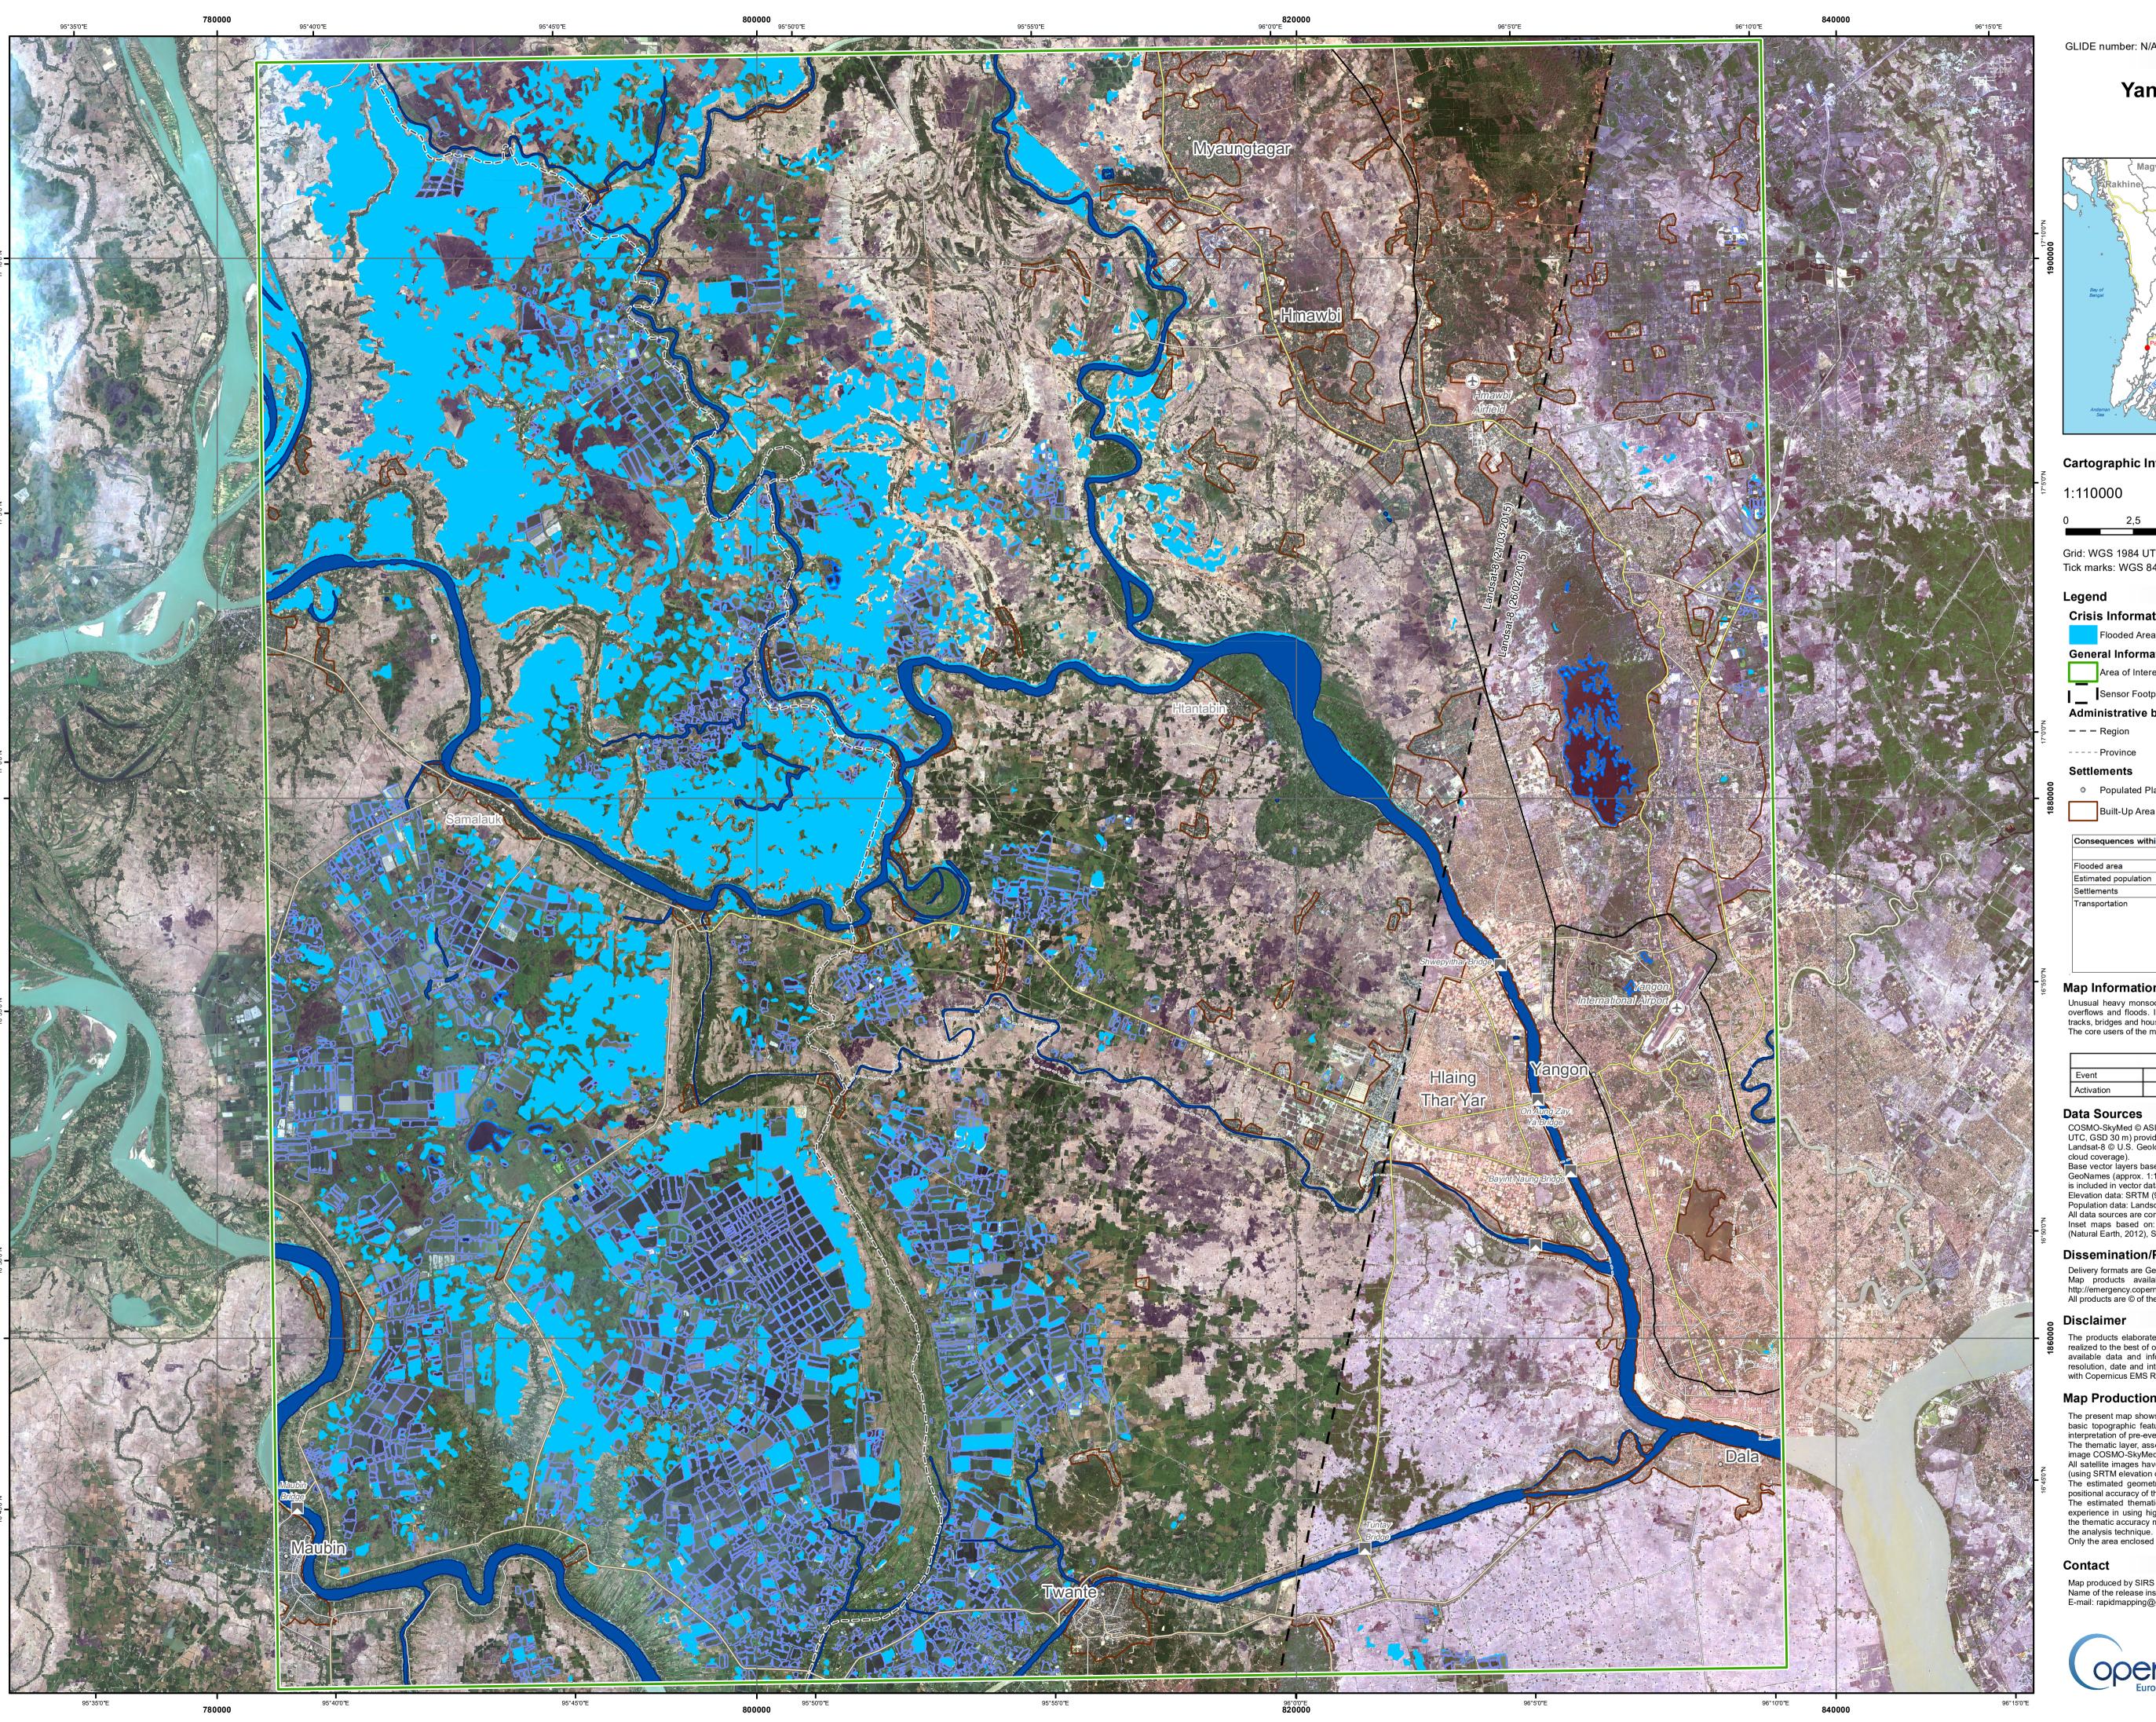
The present map shows the flood delineation in the area of Yangon West (MYANMAR). The basic topographic features are derived from public datasets, refined by means of visual interpretation of pre-event image Landsat-8.

The thematic layer, assessing the delineation of the event, has been derived from post-event image COSMO-SkyMed.

All satellite images have been radiometrically enhanced, orthocorrected with RPC approach (using SRTM elevation data). The estimated geometric accuracy of this product is 100 m CE90 or better, from native

The estimated thematic accuracy of this product is 85 % or better, based on previous experience in using high-resolution SAR for flood extent delineation. Please be aware that the thematic accuracy might be lower in urban and forested areas due to known limitations of
