GLIDE number: N/A Activation ID: EMSR330
Product N.: 01PIAZZAARMERINA, v1, English

Piazza Armerina - ITALY

Flood - Situation as of 26/10/2018

Delineation Map - MONIT01

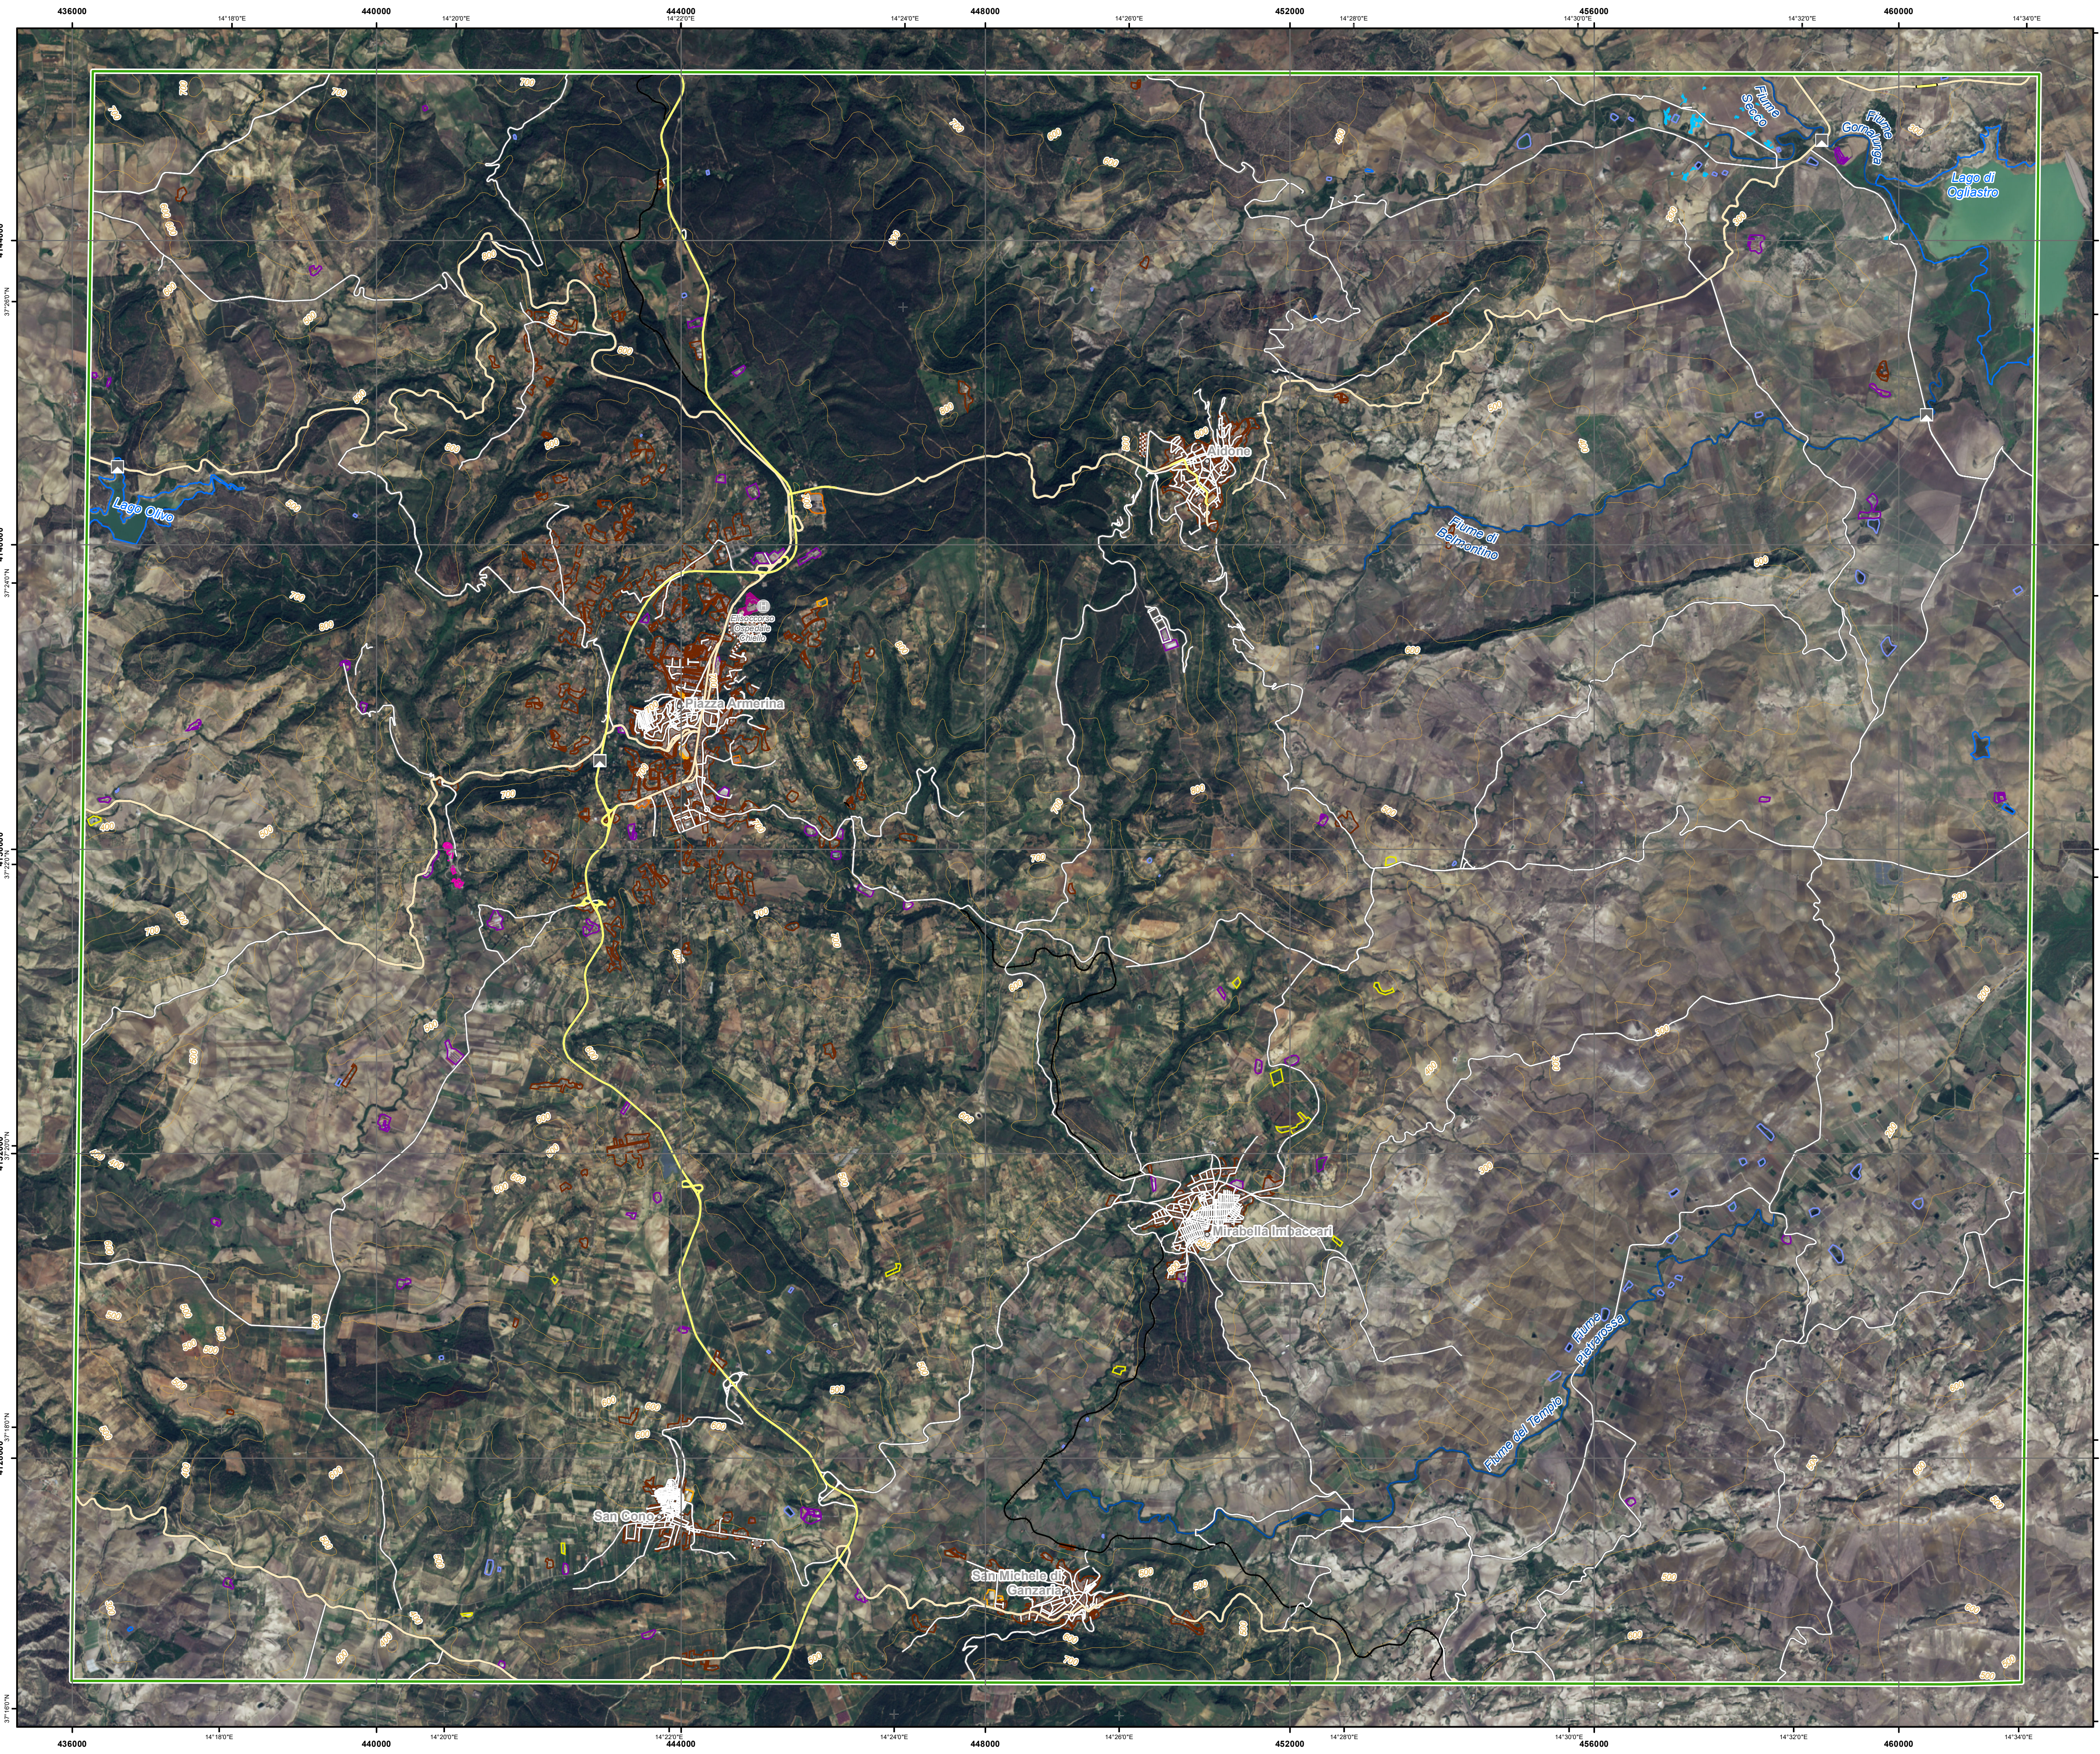
From the late evening of 18th October to the first hours of 19th an intense weather event with heavy rain occurred in Sicily. The most affected area was the south-eastern part of the region. In the previous 10 days the region, in particular along the East coast, had already been affected by heavy rainfall. The highest intensity of precipitation has been recorded by the rain gauge of Patagonia (Catania) with 240 mm of rain in a few hours. Moreover, Simeto river overflowed and flooded the surrounding areas.

The present map shows the flood delineation in the area of Piazza Armerina. The thematic layer has been derived from post-event satellite image using a semi-automatic approach. The estimated geometric accuracy is 5 m CE90 or better, from native positional accuracy of the background satellite image.

Consequences within the AOI		Unit of measurement		Affected	Total in AOI
Flooded area		ha		6.8	
Estimated population		Number of inhabitants		0	7290
Settlements	Residential	ha	0.0	352.7	
	Industrial building and warehouse	ha	0.0	85.3	
	Reservoir, silos and warehouse	ha	0.0	15.2	
	Museum and library	ha	0.0	1.0	
	Sports hall	ha	0.0	9.3	
	Hospital or institutional care	ha	0.0	3.7	
	Multi-functional	ha	0.0	8.6	
	Cemetery	ha	0.0	11.0	
Transportation	Helipad	No.	0	2	
	Bridge and elevated highway	No.	0	5	
	Primary Road	km	0.0	33.8	
	Secondary Road	km	0.0	14.7	
	Local Road	km	0.2	2004.6	
	Long-distance railway	km	0.0	31.5	
Facilities	Dam	No.	0	1.0	
	Construction for mining or extraction	ha	0.0	20.8	
	Power plant construction	ha	0.0	22.0	
Land use	Arable land	ha	17.6	5912.9	
	Permanent crops	ha	0.0	12016.7	
	Heterogeneous agricultural areas	ha	0.0	9169.4	
	Forests	ha	0.0	2314.0	
	Shrub and/or herbaceous vegetation association	ha	0.0	8622.1
