Activation ID: EMSR354
Product N.: 07IBO, v1

Ibo - MOZAMBIQUE

Storm - Situation as of 01/05/2019

Grading - Overview map 01

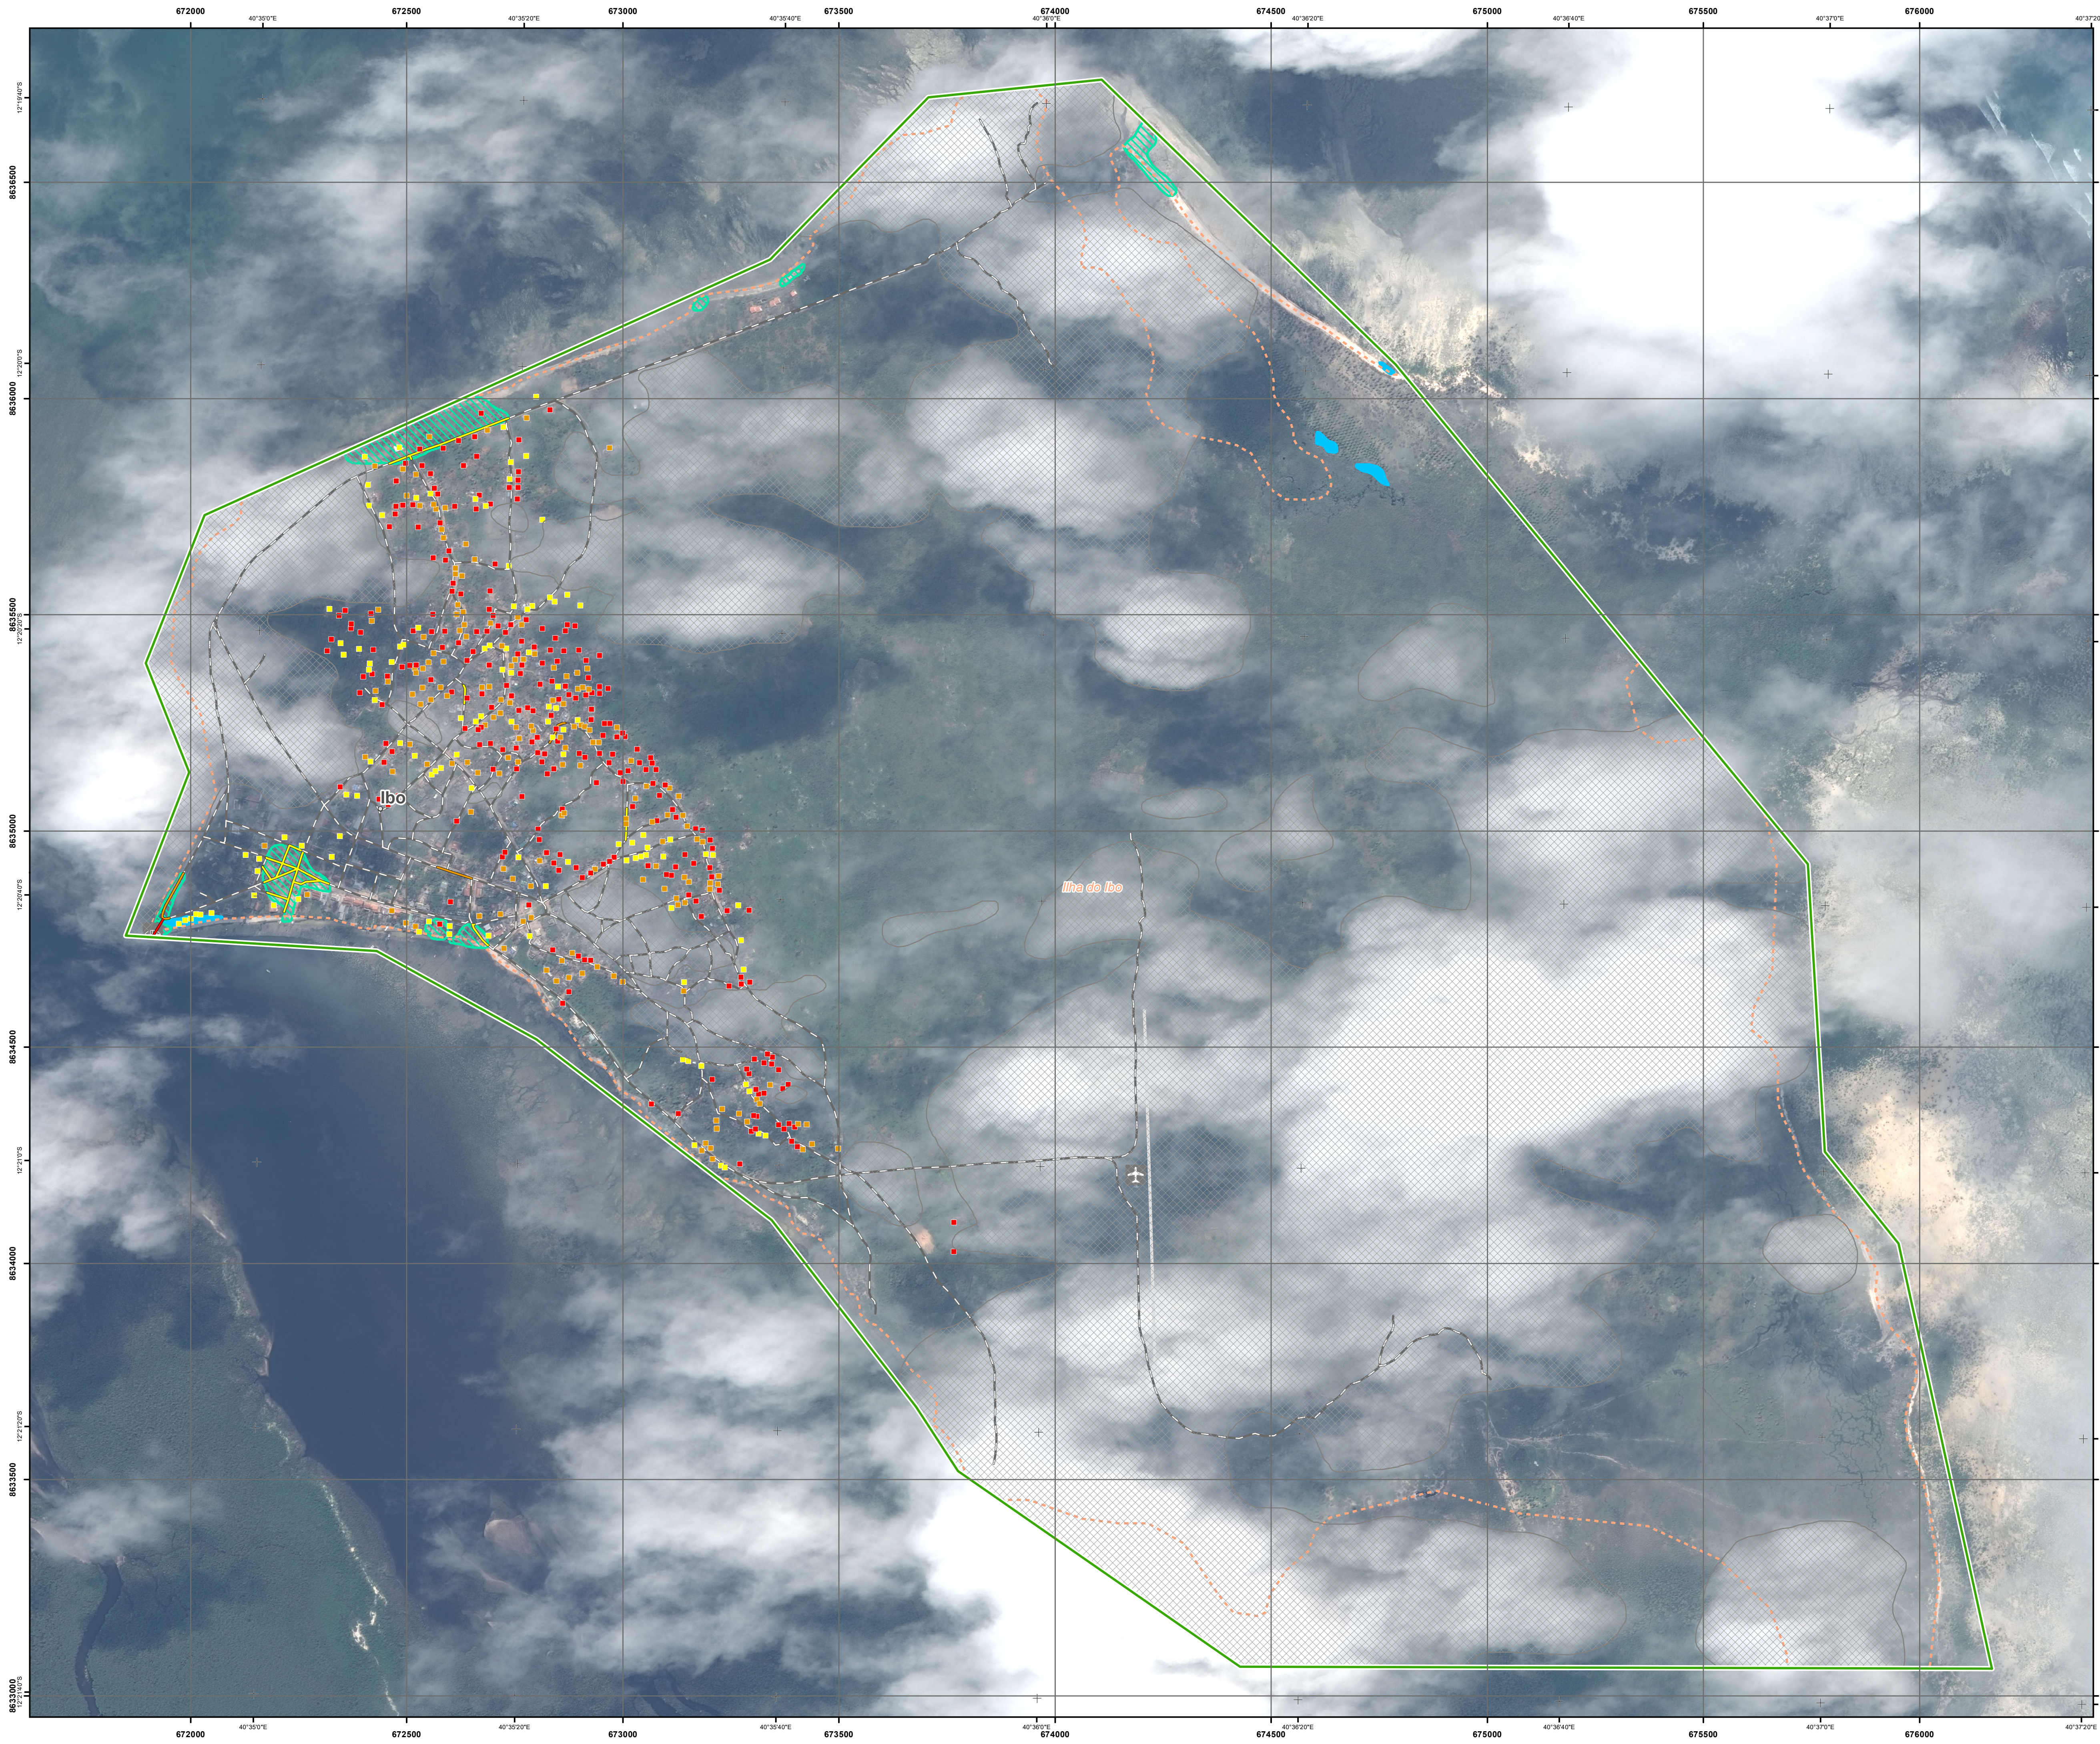
Consequences within the AOI		Unit of measurement	Destroyed	Damaged	Possibly damaged	Total affected	Total in AOI
Flooded area	ha					0.7	
Flood trace	ha					5.7	
Estimated population	Number of inhabitants					NA	5825
Settlements	Residential	No.	245	162	114	521	NA
Transportation	Airfield runway	km	0.0	0.0	0.0	0.0	0.8
	Cart Track	km	0.1	0.3	1.1	1.5	26.6

The present map shows the damage grade assessment in the area of Ibo (Mozambique). The thematic layer has been derived from post-event satellite image by means of visual interpretation. The estimated geometric accuracy (RMSE) is 1.25 m or better, from native positional accuracy of the background satellite image.
