Activation ID: EMSR388
Product N.: 07DOLORES, v1

Dolores - SPAIN

Flood - Situation as of 18/09/2019

Grading - Overview map 01

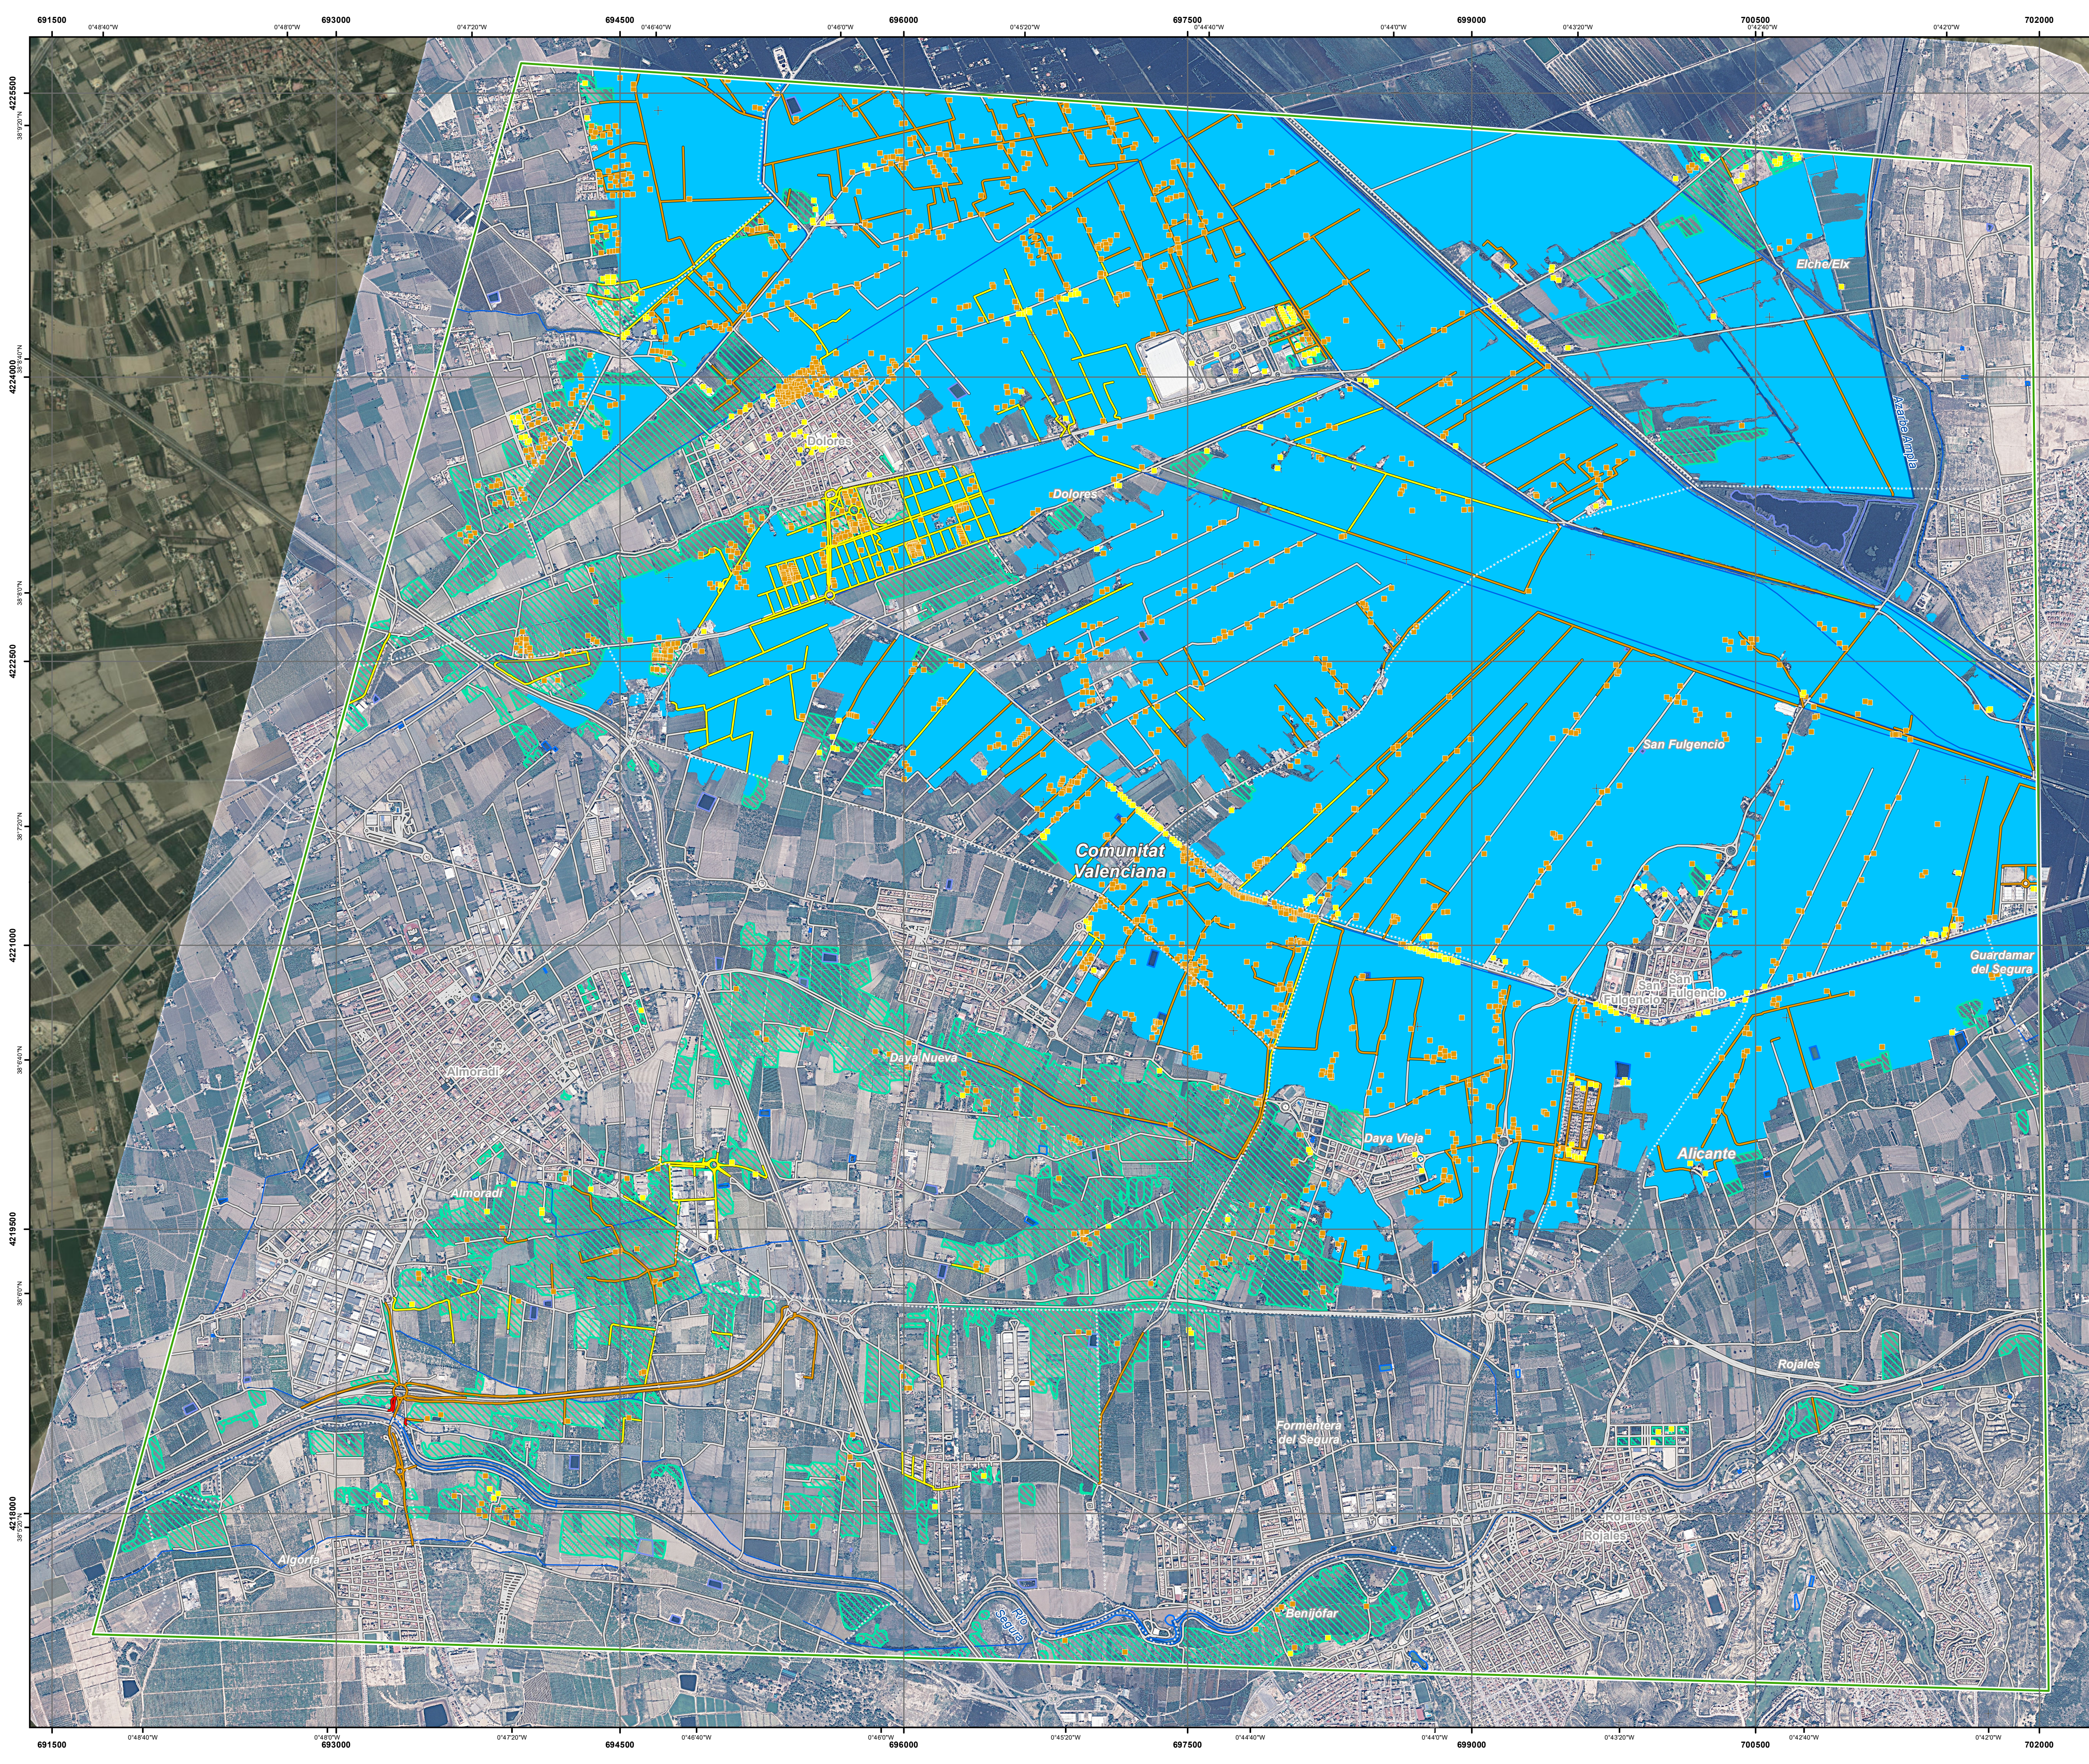
Consequences within the AOI		Unit of measurement	Destroyed	Damaged	Possibly damaged	Total affected	Total in AOI
Flooded area		ha				754.4	2714.8
Flood trace		ha					
Estimated population	Number of inhabitants					N/A	43070
Settlements	Residential	No.	0	170	105	275	N/A
	Industrial building and warehouse	No.	0	1723	244	1967	N/A
	Highway	km	0.0	0.0	0.0	0.0	13.6
	Primary Road	km	0.0	0.3	0.0	0.3	15.3
	Secondary Road	km	0.0	4.5	3.6	8.1	69.6
Transportation	Local Road	km	0.1	13.2	16.1	29.4	327.6
	Cart Track	km	0.1	75.0	21.1	96.2	359.8

The present map shows the flood grading product in the area of Dolores (Spain). The thematic layer has been derived from post-event satellite image using a semi-automatic approach. The estimated geometric accuracy (RMSE) is 1.25 m or better from native positional accuracy of the background satellite image.
