Lake Kyoga - UGANDA

Flood - Situation as of 03/05/2020

Delineation MONIT03 - Overview map 01

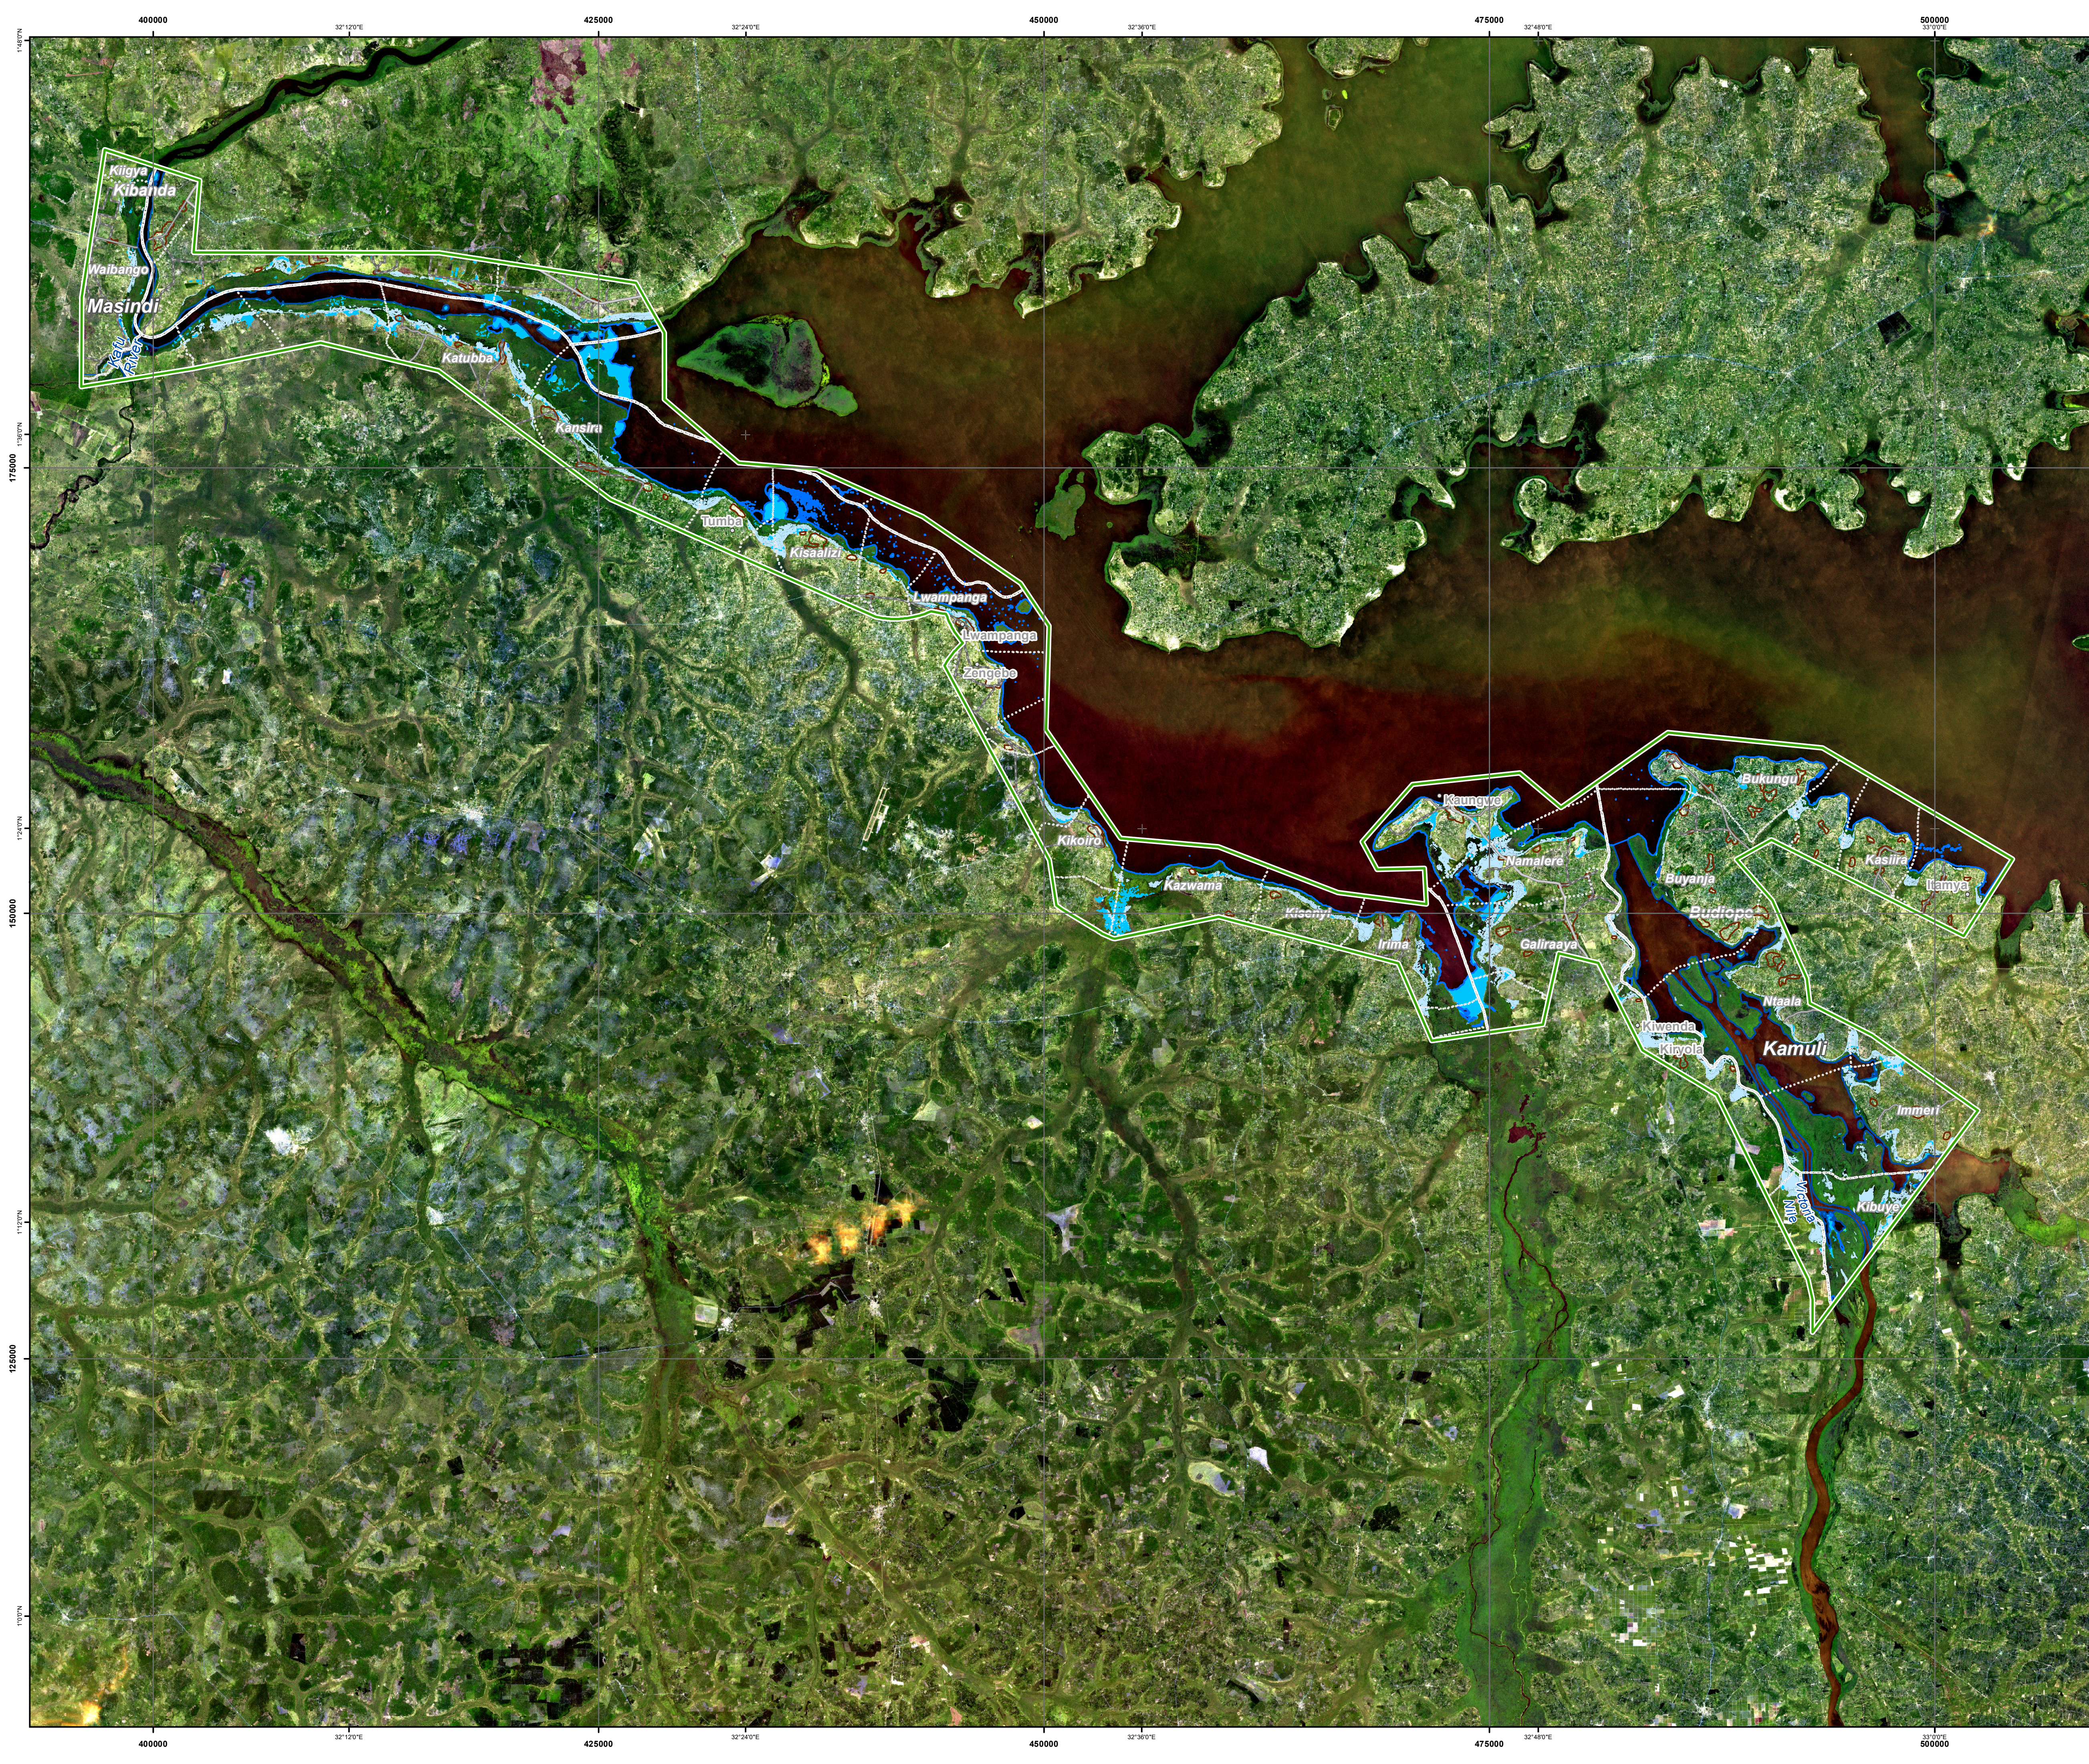
The present map shows the flood delineation in the area of Lake Kyoga (Uganda). The thematic layer has been derived from post-event satellite image by means of visual interpretation.

The estimated geometric accuracy (RMSE) is 15 m or better, from native positional accuracy of the background satellite image.
